File In Section: Product Recalls Bulletin No.: 10282C

### PRODUCT SAFETY RECALL

SUBJECT: Harsh Transmission Shift, Engine Stall, Engine May Not Start, MIL or

2005-2008 Pontiac Vibe MODELS:

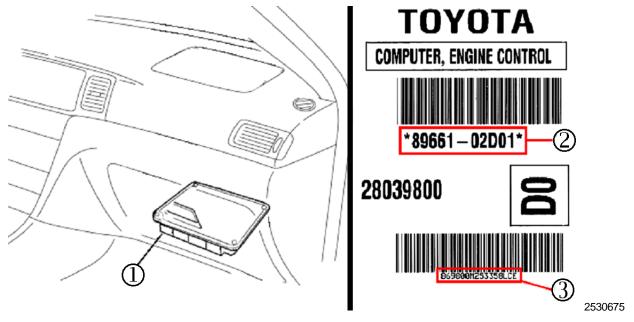
1. Locate the PCM (1) under the glove box compartment.

2. Record the part number (2) and the lot number (3) on the repair order.

3. Confirm the PCM part number to determine the required action using the table below.

- If the LOT number is 7227 or higher, no further action is required.
- If the LOT number is 7226 or lower, replace the PCM. Refer to *PCM Replacement* in this bulletin.
