**Re: Defect Information Report – Supplemental Report No. 1  
11V-283, FL-607, Western Star Airlines  
Interim Notification**

## Subject: Western Star Airlines

**Models Affected: Specific Western Star 4900 vehicles with a standard cab height and a Detroit Diesel DD13 engine manufactured April 1, 2010, through May 13, 2011.**

## INTERIM RECALL BULLETIN

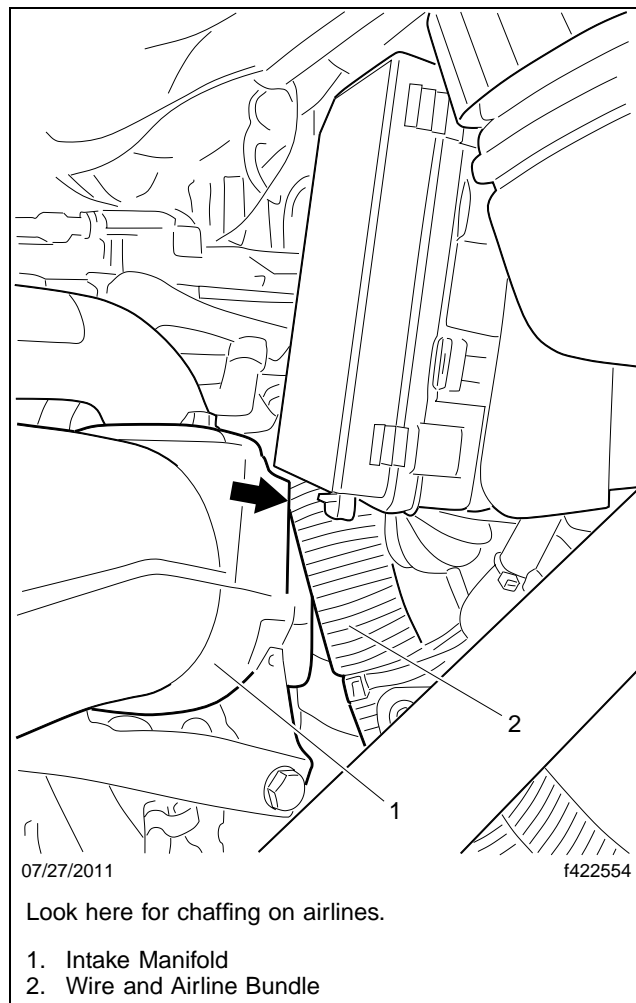
**Fig. 1**

1. Park the vehicle on a level surface, shut down the engine, and set the parking brake. Chock the tires.
2. Open the hood.
3. Inspect the airlines and wire harnesses between the PDM and the air intake manifold in the area indicated in **Fig. 1**.

If there is evidence of chaffing or the lines are within 0.75 in (19 mm) of the intake manifold, take the vehicle to an authorized Daimler Trucks North America dealership for repair.

If there is no chaffing and adequate clearance (0.75 in (19 mm) or more from the intake manifold), no action is needed.

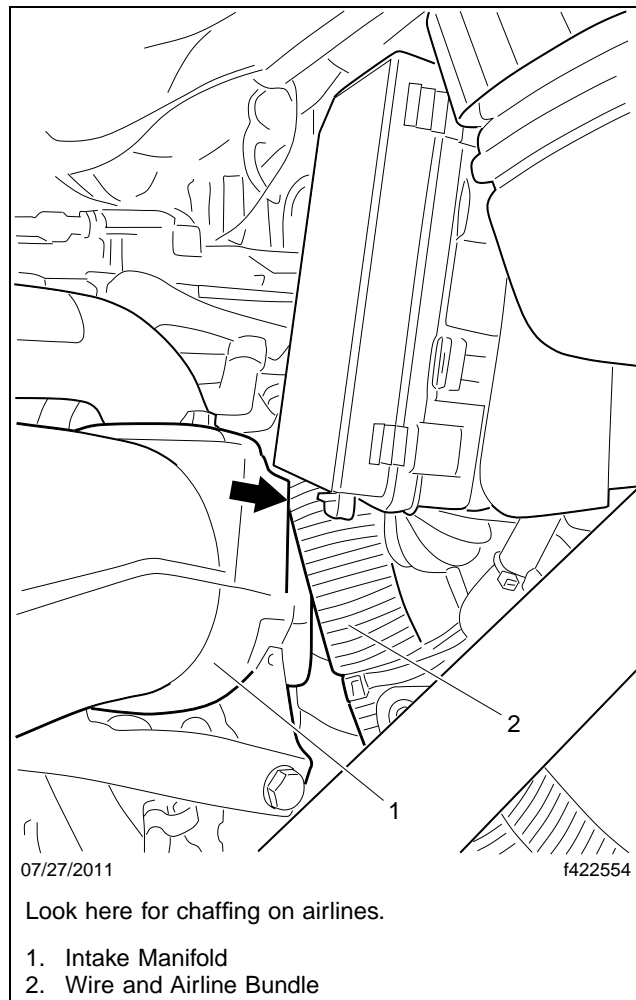
Fig. 1

1. Park the vehicle on a level surface, shut down the engine, and set the parking brake. Chock the tires.
2. Open the hood.
3. Inspect the airlines and wire harnesses between the PDM and the air intake manifold in the area indicated in **Fig. 1**.

If the lines are within 0.75 in (19 mm) of the intake manifold (and the lines are not chuffed), loosen the tiestraps as needed and relocate the lines so they are at least 0.75 in (19 mm) from the manifold. Then secure the lines in the new position with tiestraps.

If there is evidence of chuffing, replace the airlines as needed.
