**CHRYSLER**

July 2011

## **Safety Recall L23**

# **Steering Column Pivot Rivets**

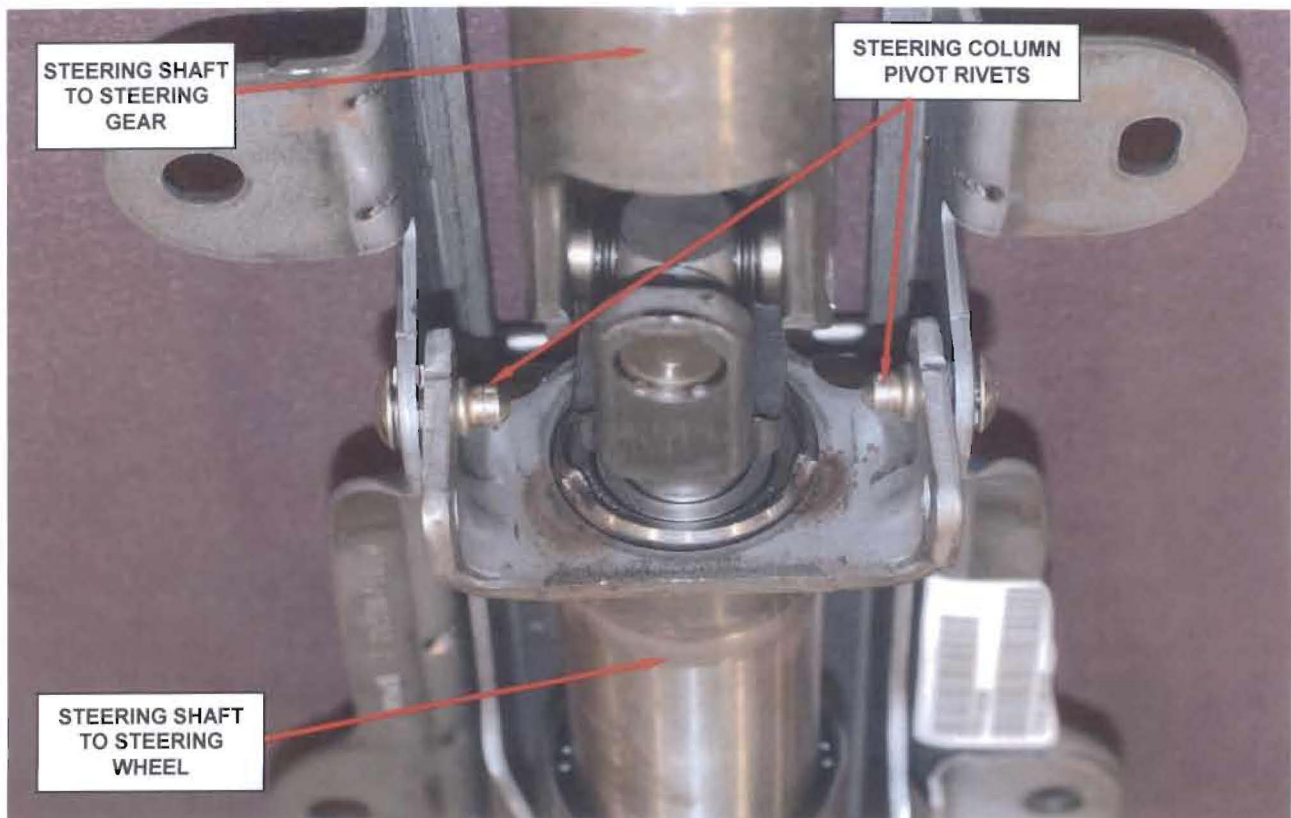
**Figure 1 – Steering Column Pivot Rivets**

1. **For KA/KK models**, remove the fiber hush panel under the steering column.
2. Looking upward under the instrument panel on the driver's side, inspect the steering column pivot rivets (Figure 1):

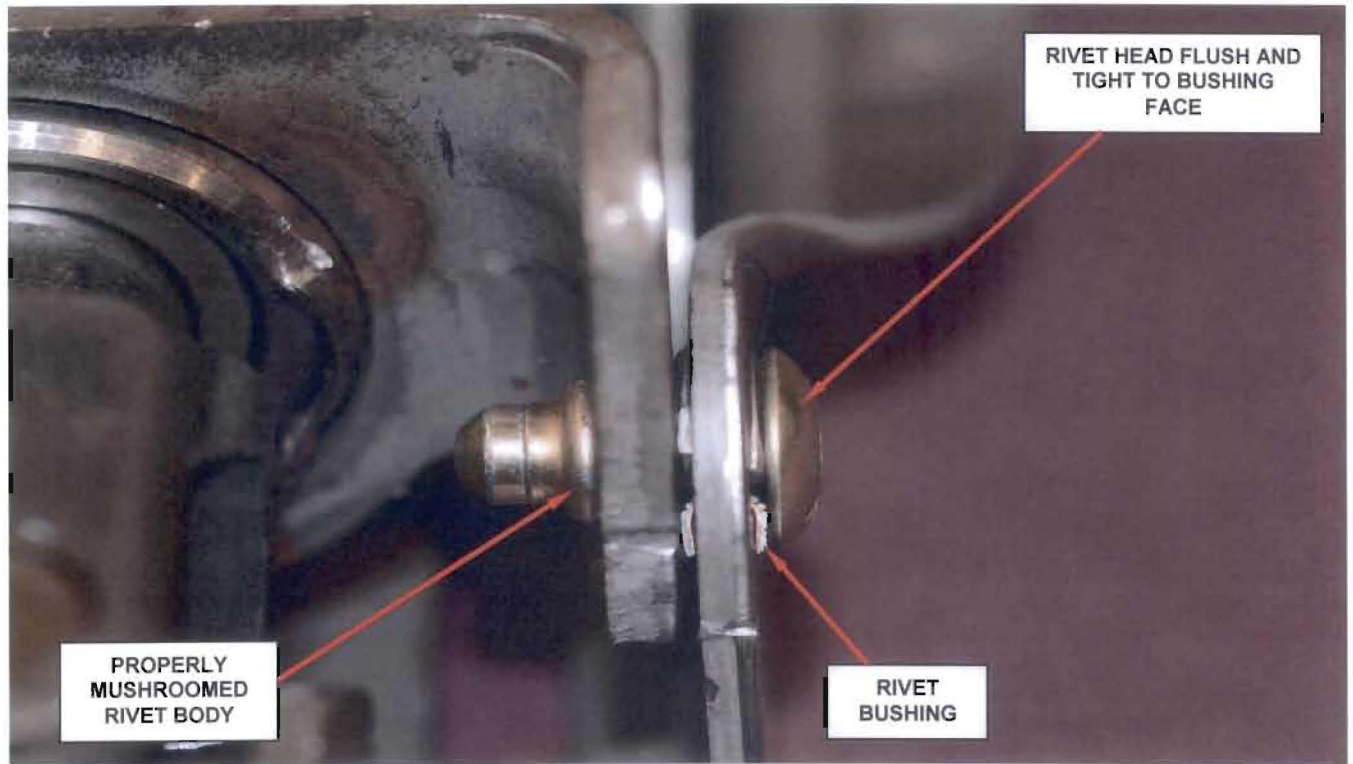
Figure 2 – Correctly Installed Rivet (Above)

- If the rivet head is flush to the bracket and the backside of the rivet is mushroomed, the rivet is good (Figure 2). No further action is required.

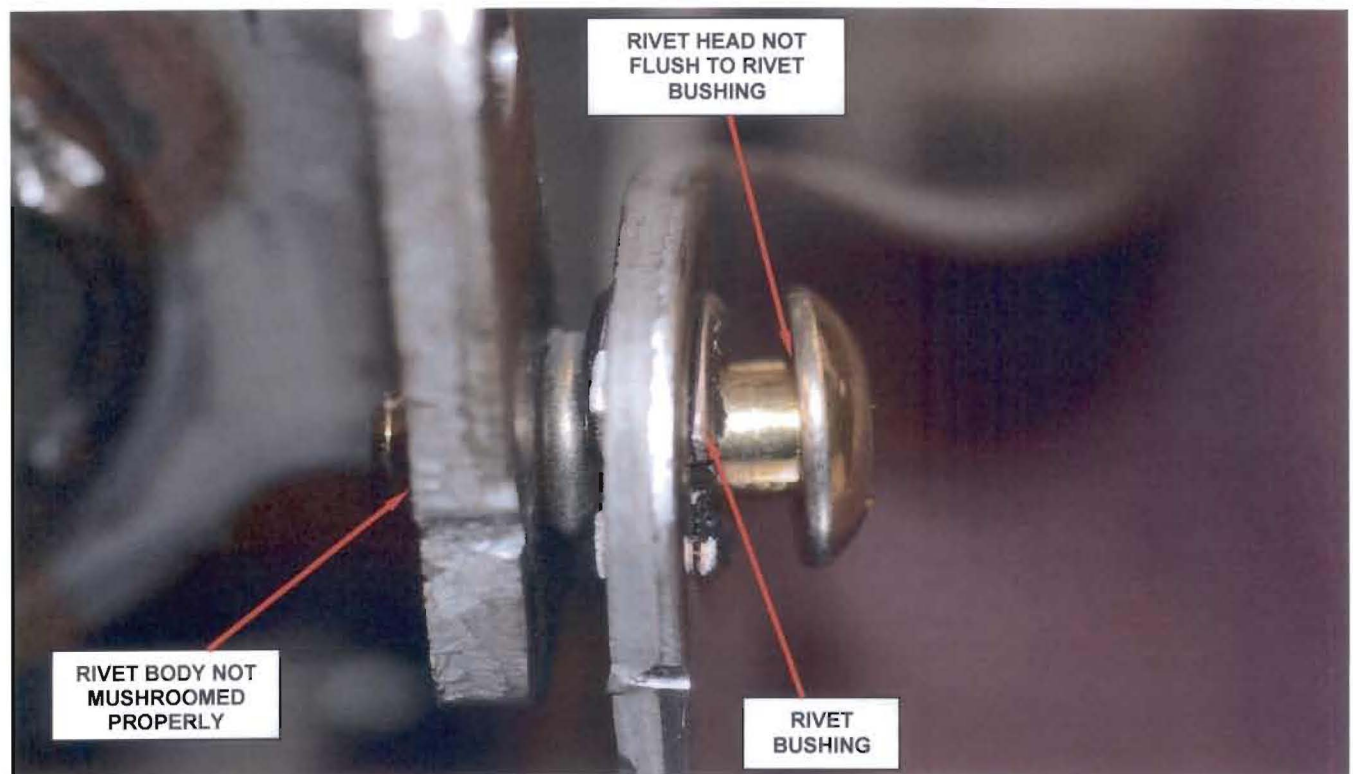
Figure 3 – Incorrectly Installed Rivet

The steering column pivot rivets on about 11,000 of the above vehicles may have been improperly installed and/or missing. This could cause compromised steering column performance in the event of a crash.

- If the rivet head is not flush and/or the backside of the rivet is not mushroomed or only partially mushroomed, the rivet(s) must be replaced (Figure 3). Continue with Section B. - Rivet Replacement.

All involved vehicles must have the steering column pivot rivets inspected. Steering columns found with missing or incorrectly installed rivet(s) will have the rivet(s) replaced.
