**RE: Defect Information Report – Supplemental Report No. 3
11V-478, (11C-2, FL-613) EPA04 MBE 4000 Low Pressure Fuel Lines
Dealer Notice**

Subject: **Safety Recall 11C2**
EPA04 MBE 4000 Low Pressure Fuel Line

**18SP660Rev2 – EPA04 and EPA07 MBE 4000 Steel
Low Pressure Fuel Line Kits
(P/N: A4600702932 and
A4600703032)**

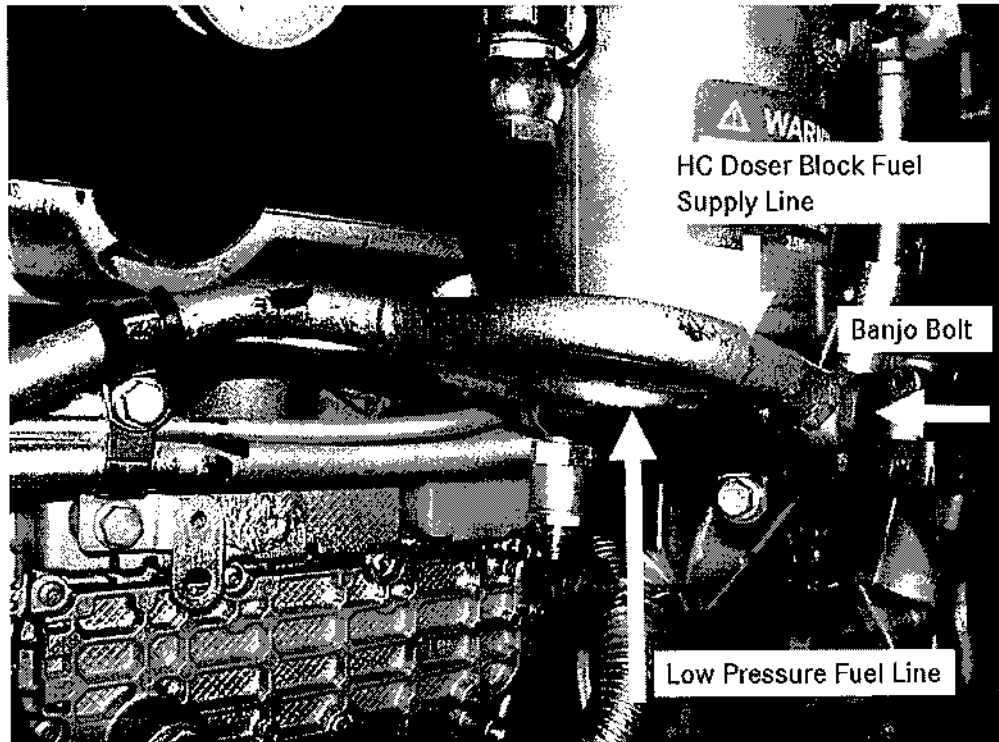
Figure 1 – Steel Low Pressure Fuel Line

1. Apply the parking brake, chock the wheels, disconnect vehicle battery power, and perform any other applicable safety steps.
2. On the left side of the engine, **INSPECT** the low pressure fuel line that runs from fuel filter housing to the left front of the cylinder block. Reference Figure 1 for the location and appearance of the unpainted **NEW** steel fuel line.
 - a. If it is an unpainted **STEEL** line, then it does **NOT** need replacing and the fuel filter housing does **NOT** need to be inspected. Go to step 4.
 - b. If it is a **PLASTIC** line (painted or unpainted), then it **WILL** need to be replaced. Also, the fuel filter housing will need to be inspected on engine serial number range 0460878301 through 0460884090. Go to step 3.

3. **REFERENCE 18SP660Rev2** in the service kits for installation instructions on the new steel low pressure fuel line. New tool J-50161 Go/No-Go Gauge has been shipped to all DDC certified service locations for use in qualifying fuel filter housings on engine serial number range 0460878301 through 0460884090. The gauge has been supplied and shipped at no cost. **REFERENCE** attached tool letter 09 TL-10. If you no longer have tool J-50161, a replacement can be purchased at the repair shop expense.
4. Check the routing of the ECU harness in the engine compartment, and make sure it is not rubbing on any of the fuel lines. As needed, use double tie straps to separate the fuel line(s) from the harness.
5. Reconnect vehicle battery power, start the engine, and verify repairs.

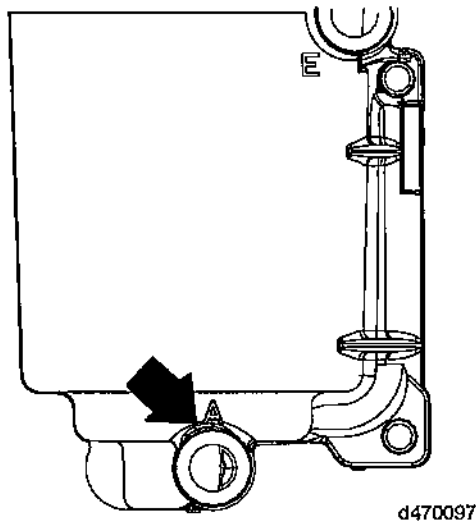
Figure 5 **Low Pressure Fuel Line Hole**

On the Hengst housing, the low pressure fuel line bore is marked with a letter "A" for reference. See Figure 5.

10. Engines equipped with a Hengst fuel filter housing with an EPA04 engine relative to recall 11C2, serial numbers between 0460878301 and 0460884090 or EPA07 engines relative to recall 09C2, serial numbers between 0460847011 and 0460888753 must have the fuel filter housing wall thickness inspected. Insert tool J-50161 into the hole in the fuel filter housing where the low pressure fuel line was removed, until it bottoms out.
