**VERIDIAN ON-SITE AIR BAG NON-DEPLOYMENT INVESTIGATION**

**VERIDIAN CASE NO. CA01-025**

**VEHICLE - 2000 FORD EXPLORER XLS 4X4**

**LOCATION - STATE OF NEW JERSEY**

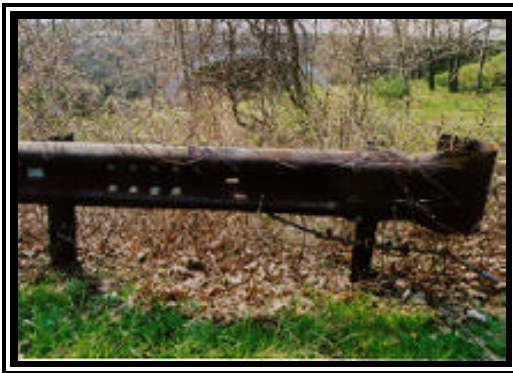
As the Ford Explorer exited the west pavement edge, the front left area impacted a W-beam guardrail (**Figure 2**) resulting in minor damage. At this point, contact separation occurred as the left side surface struck the W-beam guardrail resulting in minor damage. The vehicle sustained contact with the guardrail 4.0 meters (13.1 feet) prior to final separation at the north end post. The Ford continued in a northwesterly direction approximately 32.3 meters (106.0 feet) as the front center area impacted a 41.0 cm (16.1 in) diameter tree resulting in severe damage (**Figure 3**). Impact speeds and velocity changes were computed utilizing the WinSMASH reconstruction program. The trajectory algorithm computed a speed *at impact* of 73.6 km/h (45.7 mph) as the damage algorithm computed an overall velocity change of 67.4 km/h (41.9 mph) with a matching negative longitudinal component. At this point, the Ford rebounded 1.5 meters (4.9 feet) off the tree and came to rest in close proximity to the point of impact (in the center median) facing northwest.

**Figure 2.** West view of struck W-beam guardrail.

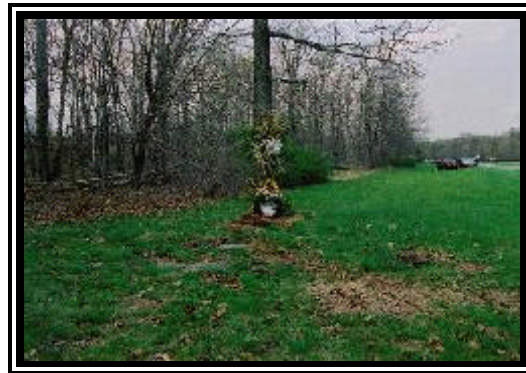
**Figure 3.** Northwest view of impacted tree.

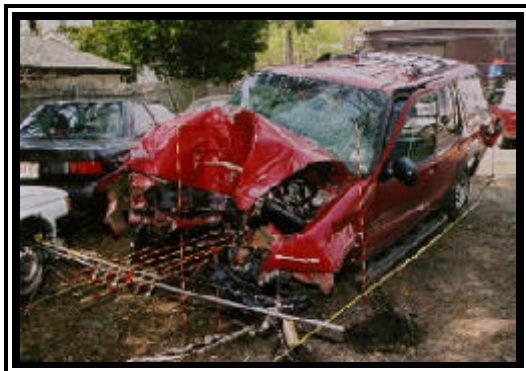
The 2000 Ford Explorer XLS 4x4 sustained severe frontal damage as a result of the impact with the large diameter tree (**Figure 4**). The direct contact damage began 4.0 cm (1.6 in) right of the end plane centerline and extended left 40.0 cm (15.7 in). The impact deformed the full frontal width resulting in a combined direct and induced damage length (Field L) of 49.0 cm (19.3 in). Six crush measurements were documented at the level of the reinforcement bar (*bumper fascia separation*): C1= 18.5 cm (7.3 in), C2= 68.0 cm (26.8 in), C3= 83.0 cm (32.7 in), C4= 81.0 cm (31.9 in), C5= 72.0 cm (28.3 in), C6= 13.5 cm (5.3 in). The Collision Deformation Classification (CDC) for this impact to the Ford was 12-FCEN-4 with a principal direction of force of 0 degrees. The hood was deformed up and rearward from engagement against the tree. The bumper corners were pulled inward by the narrow contact damage. Induced contact damage produced longitudinal shifting of the A-pillars which buckled the roof and side rails. The windshield was fractured from (exterior) impact forces and (interior) right instrument panel occupant loading. Extensive passenger loading of the right instrument panel area also resulted in an 8.0 cm (3.1 in) x 50.0 cm (19.7 in) slit to the windshield, contributing to passenger compartment integrity loss. The right rear tempered glazing was disintegrated by cargo shift during the crash. Reduction in the left wheelbase measured 21.0 cm (8.3 in) as the right wheelbase was elongated 11.0

**Figure 4. Frontal damage to the 2000 Ford Explorer XLS 4x4.**

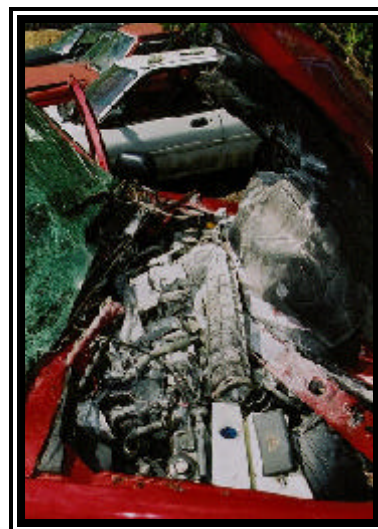
**Figure 5. Fire damage to the engine compartment.**

cm (4.3 in). The left front axle fractured and resulted in complete separation of the left front wheel/tire. This damage was not attributed to the W-beam guardrail impact given consistent rotating tire marks documented at the scene; but related to the severe frontal crash forces. Although the fuel tank was deformed by undercarriage movement during the crash, snagging occurred during post-crash vehicle extrication activities which resulted in minor fuel leakage. Minor fire damage was also noted in the engine compartment area (**Figure 5**).

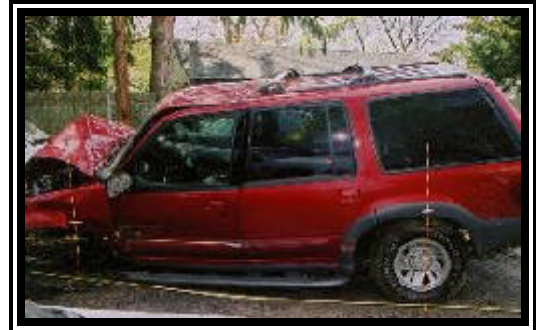
Direct contact damage was also identified at the front left area and left side surface attributed to the W-beam guardrail impact. The direct contact damage began at the front left bumper corner and extended 11.0 cm (4.3 in) inboard. This contact pattern also extended 392.0 cm (154.3 in) rearward along the left side surface (**Figure 6**); at and below the level of the frame. Contact separation documented along the guardrail during the SCI scene inspection necessitated assignment of two separate events for this damage pattern. Induced contact damage above the level of the frame jammed the left front door opening and produced outward buckling of the upper window frame. The CDC's for the guardrail impacts to the Ford were 12-FLEE-9 and 12-LZES-1, respectively.

**Figure 6. Left side surface damage to the 2000 Ford Explorer XLS 4x4.**

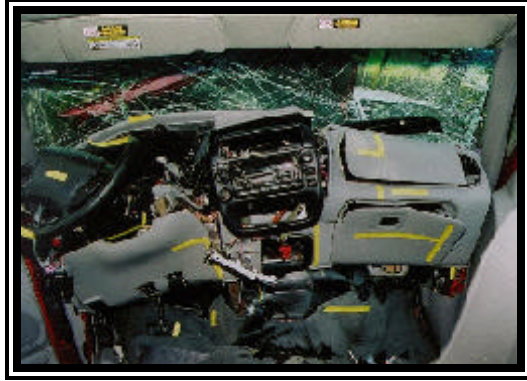
Interior damage to the Ford Explorer was severe and attributed to component intrusions and occupant contact (**Figures 7 & 8**). The left knee bolster was heavily deformed and scuffed. The steering column was displaced approximately 12.0 cm (4.7 in) upward and 17.0 cm (6.7 in) to the left from driver loading. Steering wheel rim deformation measured 12.0 cm (4.7 in) along the top portion as shear capsule movement measured 3.0 cm (1.2 in). The accelerator pedal fractured with the brake pedal displaced to the left. The rear view mirror separated from the windshield undamaged. The right knee bolster and glove compartment door were deformed and scuffed. Tissue, blood, scratch marks and indentations were identified on the front right passenger air bag module cover flap. Blood spattering was noted along the right roof side rail and B-pillar. Cargo movement in the vehicle resulted in extensive deformation to the second row seat back along with minor abrading and scuff marks to the rear aspect of the front right seat back. Longitudinal intrusions into the front left occupant space involved 27.0 cm (10.6 in) of toepan intrusion and 10.0 cm (3.9 in) of instrument panel intrusion with 8.0 cm (3.1 in) of vertical floor intrusion. Longitudinal intrusions into the front right occupant space involved 33.0 cm (13.0 in) of toepan intrusion, 5.0 cm (2.0 in) of instrument panel intrusion and 5.0 cm (2.0 in) of cargo intrusion.

**Figure 7. Interior damage to the 2000 Ford Explorer XLS 4x4.**

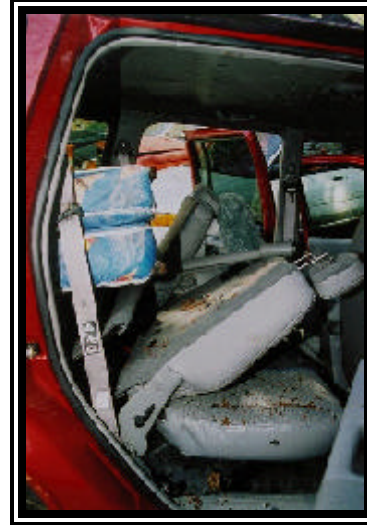
**Figure 8. Second row seat back deformation from cargo movement within the vehicle.**

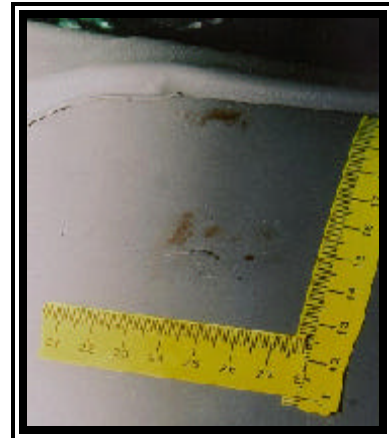
The 2000 Ford Explorer XLS 4x4 was equipped with redesigned frontal air bags for the driver and front right passenger positions which did not deploy as a result of the crash. The driver air bag was housed in the center of the steering wheel with a horizontally oriented flap tear seam (H-configuration). Contact evidence to the driver air bag module cover flap consisted of small scuff marks and indentations. The front right passenger air bag was housed in the right mid-instrument panel area with a single cover flap design hinged at the top aspect. The cover flap was rectangular in shape and measured 37.0 cm (14.6 in) in width and 17.4 cm (6.9 in) in height. Contact evidence to the passenger air bag module cover flap consisted of skin tissue, scratch marks and indentations.

**Figure 9.** Contact evidence to the non-deployed front right passenger air bag module cover flap.
