On-scene Investigation / Vehicle to Vehicle
Dynamic Science, Inc. / Case Number: DS02003
Wheeled Coach Moduvan ambulance on a 1997 Ford E350 series chassis
Washington
February, 2002

1. Report No. DS02003		2. Government Accession No.		3. Recipient Catalog No.	
4. Title and Subtitle In-Depth Accident Investigation				5. Report Date	
				6. Performing Organization Report No.

Dynamic Science, Inc.
Accident Investigation
Case Number: DS02003

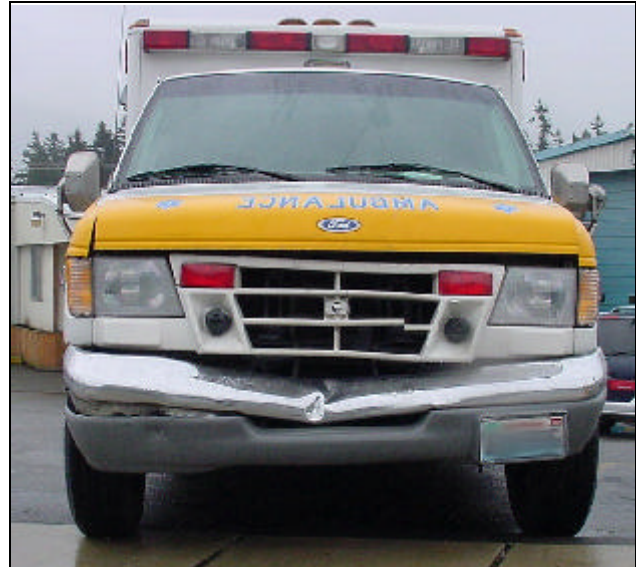
The driver of the other vehicle slowed and the case vehicle could not stop in time and the front of the case vehicle (12FZEW1) struck the rear of the other vehicle.

Figure 2. Front, case vehicle

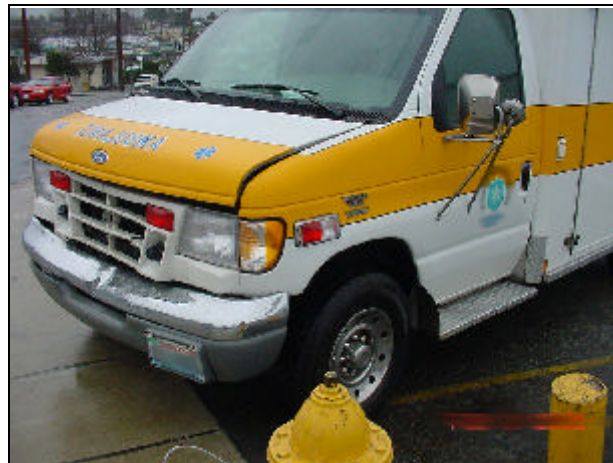
Description:	Wheeled Coach Moduvan ambulance on a 1997 Ford E-350 single rear wheel cutaway chassis	
VIN:	1FDJE30F0VHAxxxxxxx	
Odometer:	308,578 km (191,747 miles)	
Engine:	7.3 L, V8 diesel	
Reported Defects:	None	
Cargo:	Assorted medical equipment and supplies. Unknown weight.	
Damage Description:	Minor frontal damage to bumper and grille.	
CDC:	12FZEW1 (photos only)	
Delta V ¹ :	Total	Unknown
	Longitudinal	Unknown
	Latitudinal	Unknown
	Energy	Unknown

Figure 7. Front right, case vehicle

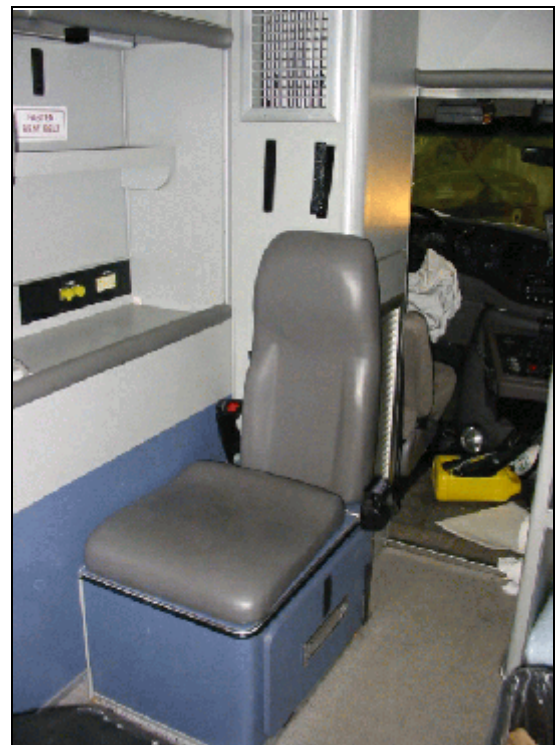
The front, rear-facing patient care seat was equipped with a manual belt. The seat back was padded and covered with a vinyl material. It was attached to the side of the compartment using Velcro straps. At the time of the inspection, the seat back was found on the floor on the right side of the compartment.

Figure 11. Front, rear-facing patient care seat

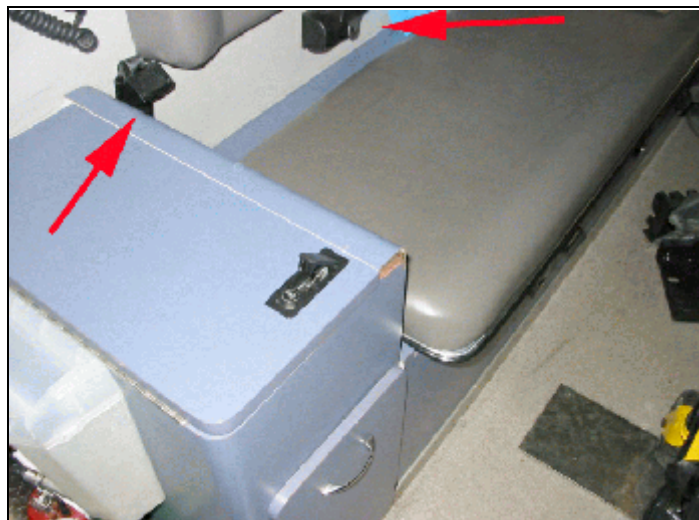
The rear of the ambulance was occupied by an unrestrained 28-year-old male (188 cm/74 in, 82 kg/180 lbs) Patient Care Provider (PCP) and a 73-year-old female patient. The PCP was seated on the right side squad bench facing the patient. A lap belt was available, but was not being used at the time of the crash. The patient was strapped to the Rugged brand ambulance cot in the center of the vehicle with her head toward the front of the vehicle.

Figure 13. Lap belt and buckle at PCP seated position

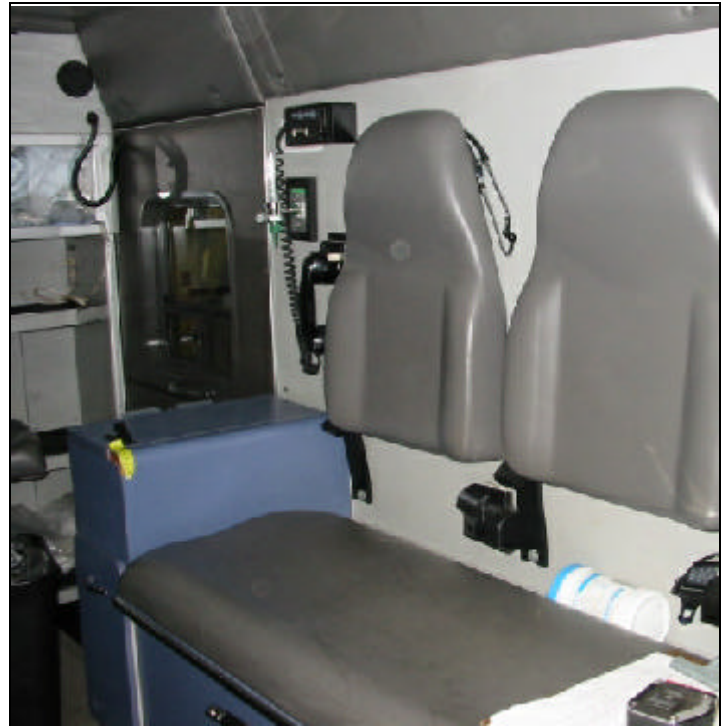
The 28-year-old right rear occupant (188 cm/74 in, 82 kg/180 lbs) was seated in a normal, upright fashion facing the center of the vehicle on the vinyl covered squad bench seat. He was not using the available lap belt. He was attending the 78-year-old female patient. This occupant reacted to the initial braking by pitching somewhat to his right. At impact, he pitched out of his seat to the right—possibly catching the cabinet corner with his right hip. He was projected forward and onto the floor—sliding forward into the left side of the door panel—causing it to shift and displacing the Velcro-attached seat back. It is believed that he came to rest near the passage between the ambulance body and the ambulance cab. He complained of pain to his neck and back, but was otherwise unhurt.

Figure 15. Fresh area of peeled away laminate

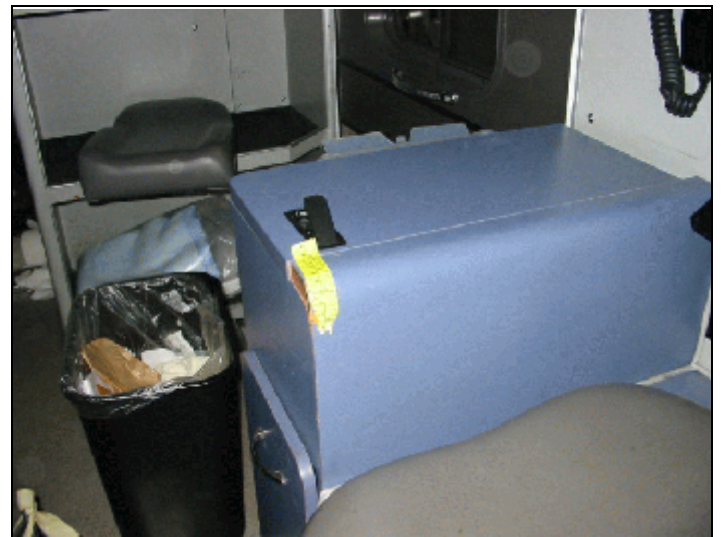
Figure 16. Close up to possibly right hip contact

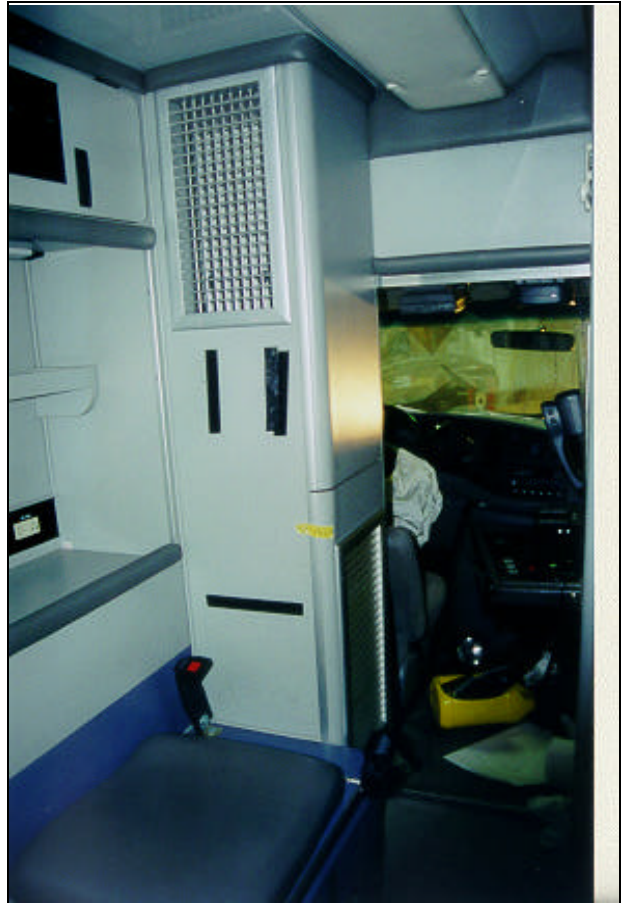
Figure 17. Possible contact to door portal—panel shifted

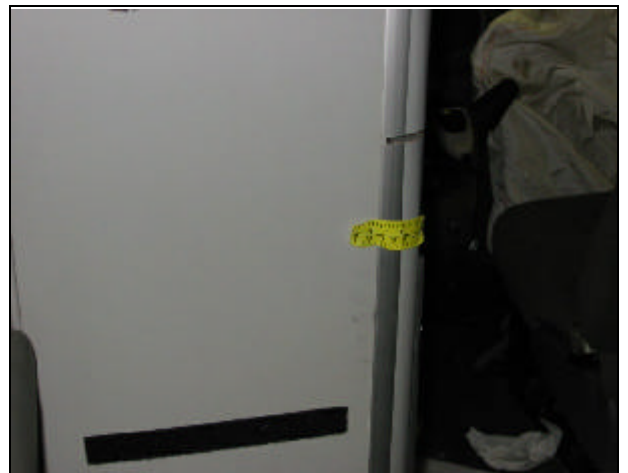
Figure 18. Close up of shifted panel
