ON-SITE CHILD SAFETY SEAT INVESTIGATION

CASE NUMBER - IN-06-026

VEHICLE - 1996 CHEVROLET LUMINA LS

CRASH DATE - August 2006

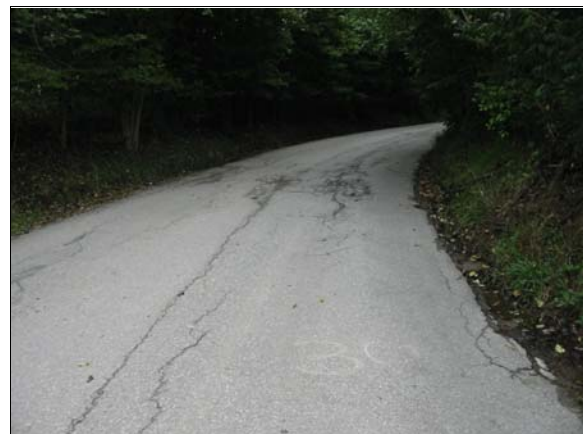
Figure 1: Approach of case vehicle westbound, approximately 30 meters (98 feet) from impact area

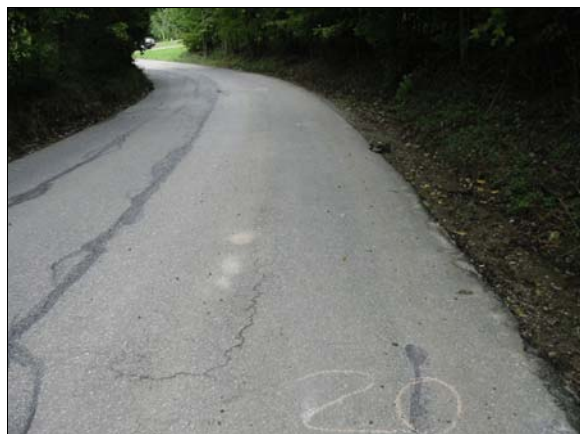
Figure 2: Approach of Ford eastbound approximately 20 meters (66 feet) from impact area

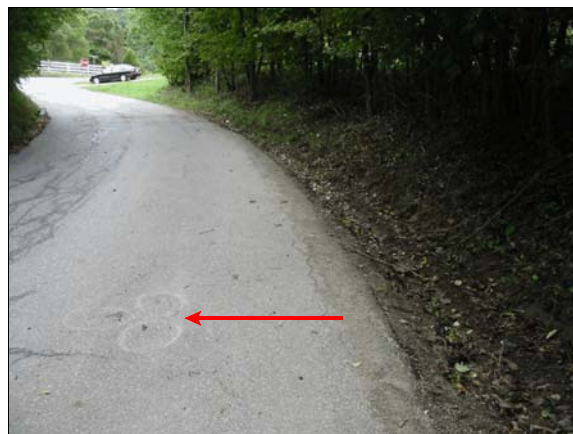
Figure 3: Area of impact viewed from Ford's approach, arrow shows impact gouges in the roadway

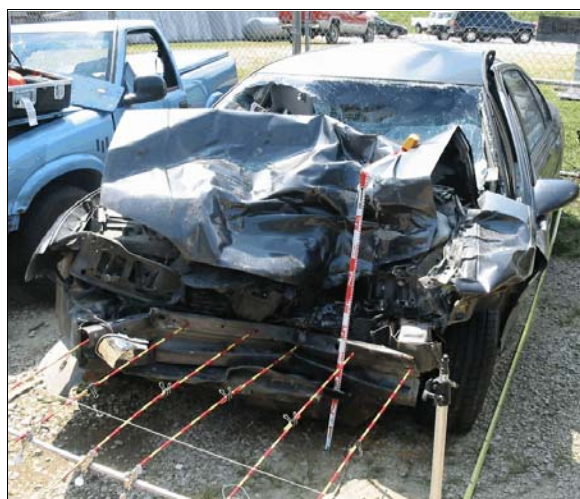
Figure 4: Overview of damage to front of case vehicle from impact with front of Ford, tape measure graduated in tenths of meter, each increment on rods is 5 cm (2 in)

Crash: The front of the case vehicle (**Figure 4**) impacted the front left of the Ford (**Figure 5**), causing the case vehicle's driver and front right passenger air bags to deploy. The Ford's driver and front right passenger air bags also deployed as a result of the crash.

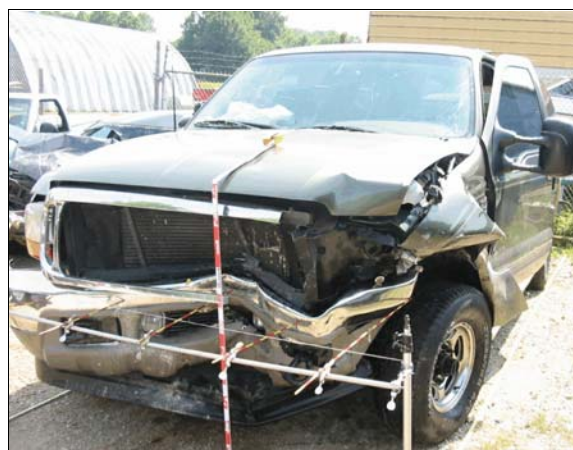
Figure 5: Overview of damage to front of Ford from impact with front of case vehicle

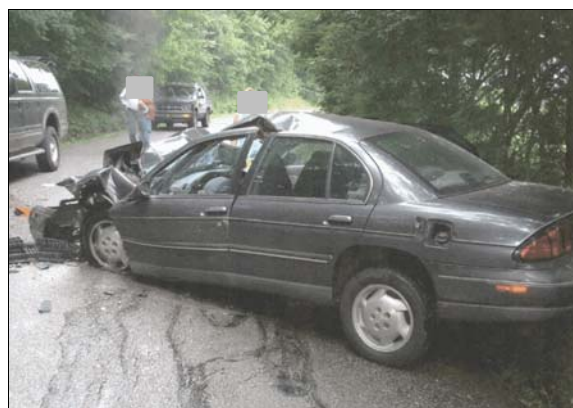
Figure 6: Sheriff's department on-scene photo showing case vehicle's final rest position, Ford at final rest on left in foreground, view is to west

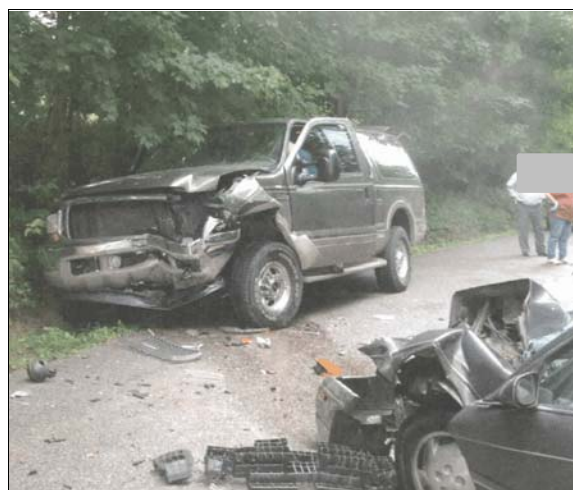
Figure 7: Sheriff's department on-scene photo showing Ford's final rest position, view is to southwest

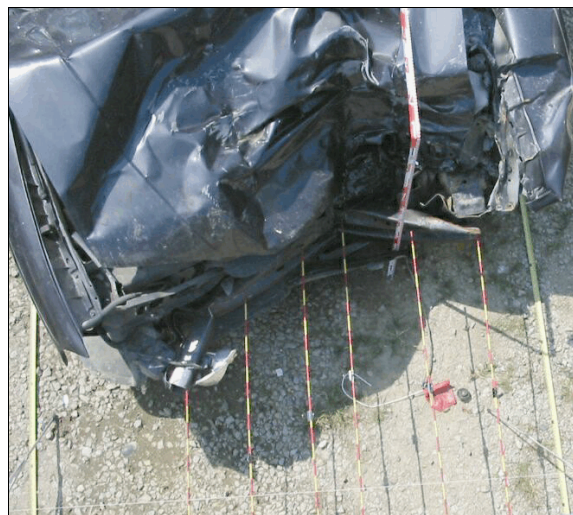
Exterior Damage: The case vehicle's impact with the Ford involved the front plane. The front bumper, bumper fascia, hood, grille, radiator, left headlamp/turn signal assembly and front of the left fender were directly damaged and crushed rearward. Direct damage began at the left front bumper corner and extended approximately 88 centimeters (34.6 inches) across the front bumper. The front bumper fascia was not present at the vehicle inspection, so direct damage was determined based on damage to the bumper bar and hood. Crush measurements were taken to the bumper bar, and the residual maximum crush was measured as 88 centimeters (34.6 inches) occurring at C₃ (**Figure 8** below). The table below shows the case vehicle's front crush profile.

Figure 8: Top view of crush to front of case vehicle

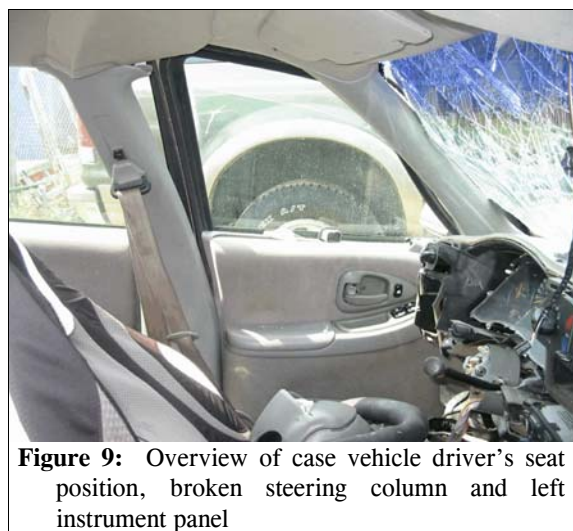
Vehicle Interior: Inspection of the case vehicle’s interior (Figure 9 and Figure 10 below) revealed evidence the driver heavily loaded the steering wheel and knee bolster. The steering wheel rim was significantly deformed forward (Figure 11 below) and the steering wheel had broken off the steering column tilt hinge. The driver’s knee bolster and instrument panel were also broken out. Blood stains were found on the upper left quadrant of the driver’s air bag. Finally, the left edge of the right front seat back was deformed forward and the seat back twisted clockwise as a result of contact by the back right passenger. Intrusions occurred at the left toe pan, which was intruded longitudinally 21 centimeters (8.3 inches) and the left A-pillar, which intruded longitudinally 7 centimeters (2.8 inches).

Figure 9: Overview of case vehicle driver’s seat position, broken steering column and left instrument panel

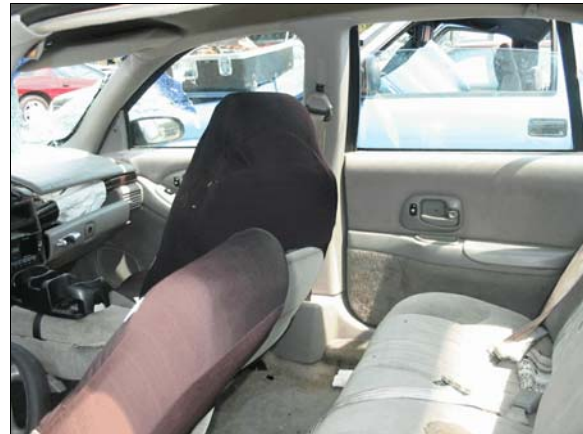
Figure 10: Overview of case vehicle's back right seat position and deformation of front right seat back

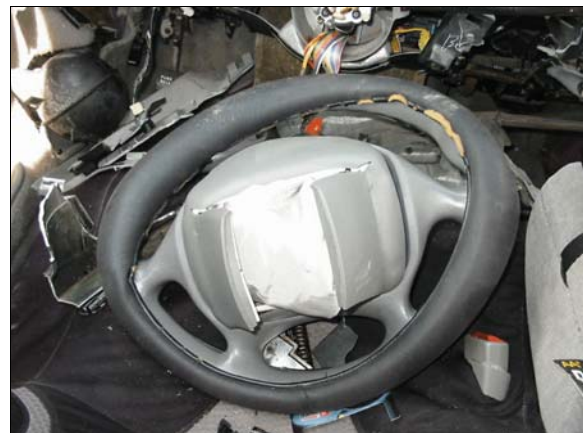
The case vehicle's driver air bag was located in the steering wheel hub. An inspection of the air bag module cover flaps (**Figure 11**) and the air bag fabric revealed that the cover flaps opened at the designated tear points and there was no evidence of damage during the deployment to the air bag or the cover flaps. The driver's air bag (**Figure 12**) was designed without any tethers or vent ports. The deployed driver's air bag was round with a diameter of 63 centimeters (24.8 inches). An inspection of the driver's air bag revealed blood stains from the driver on the air bag's top left quadrant.

Figure 11: Case vehicle steering wheel deformation and air bag module cover flaps

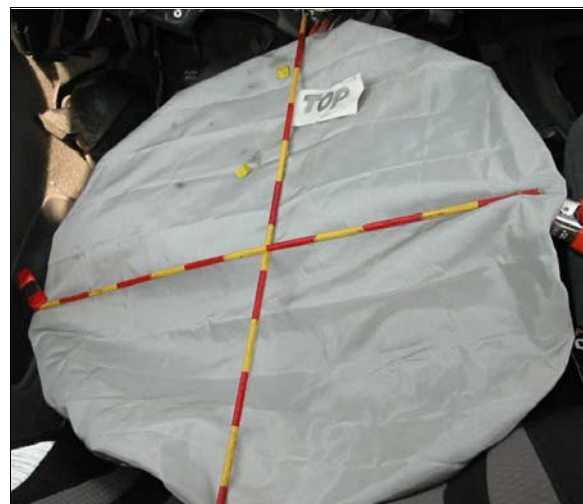
Figure 12: Case vehicle driver's air bag

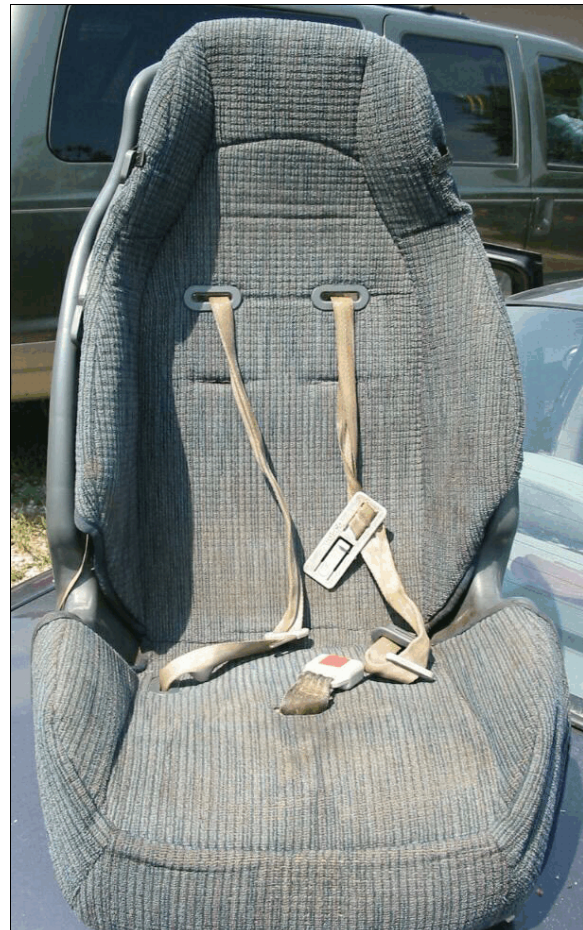
Figure 13: Overview of front of child safety seat

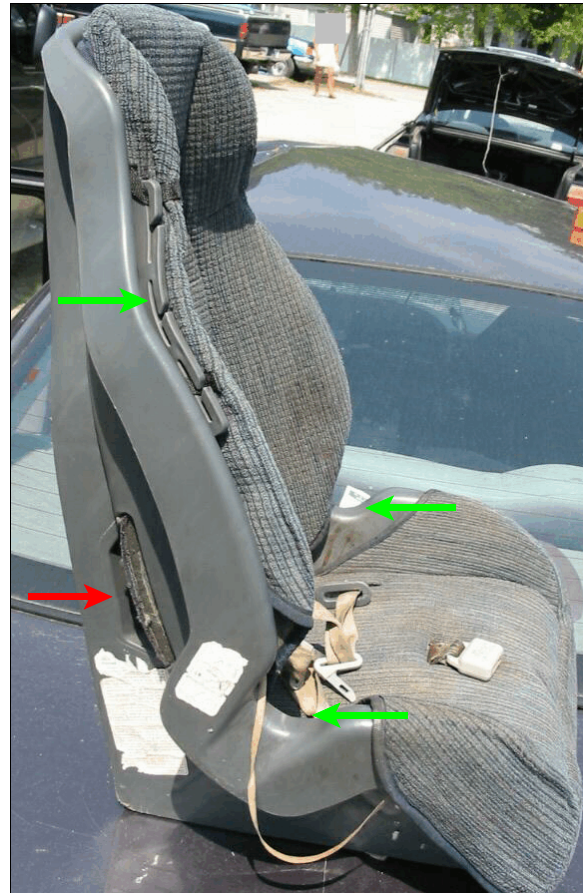
Figure 14: Child safety seat, red arrow shows belt path, green arrows shows shoulder belt slots and lap belt path for use as a belt positioning booster

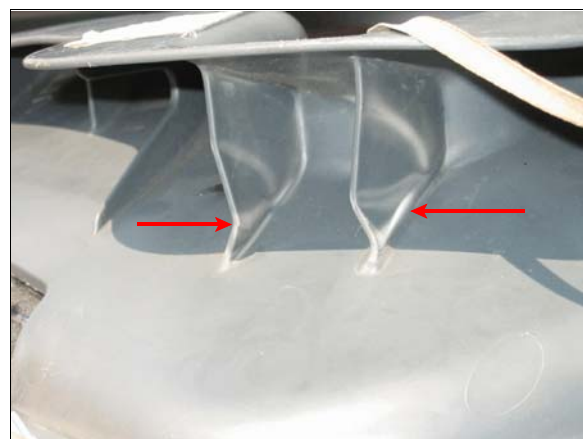
Inspection of the child safety seat showed areas under the lap belt paths where the plastic frame supports had been stressed under load during the crash (**Figure 15** below). There were also lap belt webbing abrasions in the plastic of both belt paths. In addition, there were significant abrasions on the case vehicle's lap belt webbing and latch plate belt guide. No evidence was observed that indicated usage of the child safety seat's five-point harness. The evidence indicated that the child was restrained only by the lap portion of the case vehicle's three-point, lap-and-shoulder safety belt. The investigating sheriff's deputy indicated that the shoulder portion of the safety belt was found behind the child safety seat. The on-scene sheriff's department photographs support the investigating deputy's statement. They show the child safety seat in the back right seat

Figure 15: Arrows show deformation of supports under right lap belt path due to loading from lap belt, similar load pattern was found on supports under left belt path

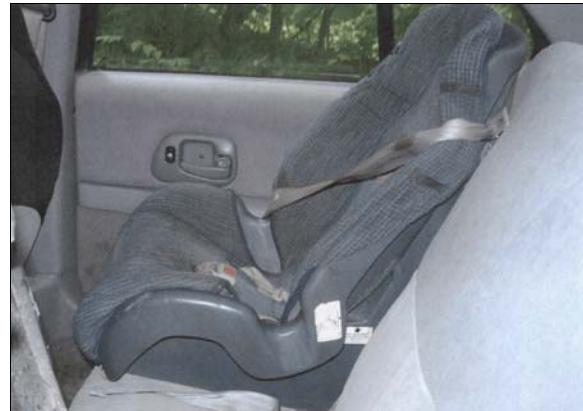
position following the removal of the child (Figure 16). The photographs show the safety belt unbuckled with the lap belt diagonally across the child safety seat's seat back and the shoulder belt behind the child safety seat's seat back. In summary, the evidence indicates that the child was not restrained by the child safety seat's five point harness. The child seat was being used as a belt positioning booster seat and the child was improperly restrained by only the lap portion of the lap-and-shoulder belt. The shoulder portion of the safety belt was positioned behind the child safety seat at the time of the crash.

Figure 16: Sheriff's department on-scene photo of child safety seat in case vehicle's back right seat position

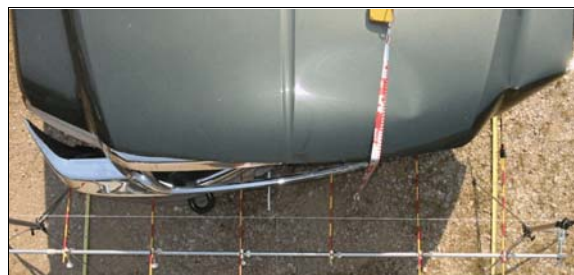
Exterior Damage: The Ford's impact with the case vehicle involved the front plane. The front bumper, hood, grille, radiator, left headlamp/turn signal assembly and the left fender were directly damaged and crushed rearward. Direct damage began at the left front bumper corner and extended approximately 91 centimeters (35.8 inches) across the front bumper. Crush measurements were taken at the bumper. The residual maximum crush was measured as 53 centimeters (20.9 inches) occurring at C₁ (**Figure 17**). The table below shows the Ford's front crush profile.

Figure 17: Top view of crush to front of Ford

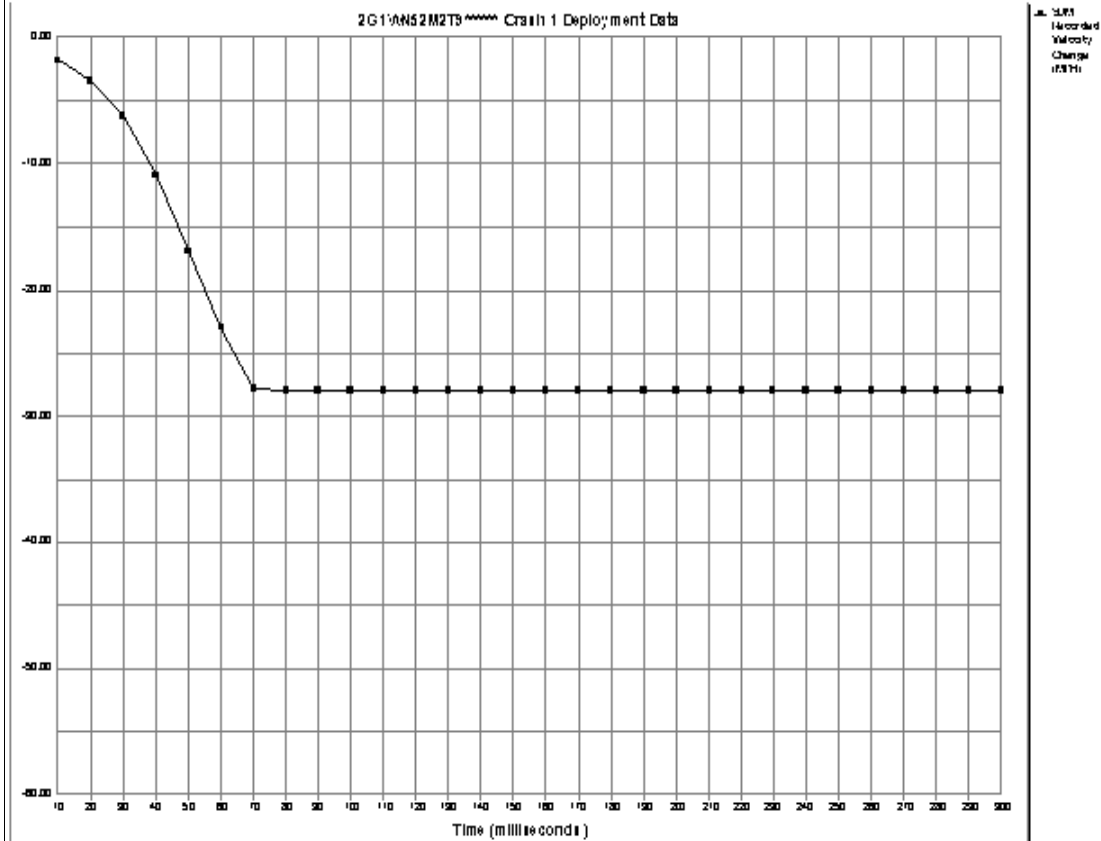
Figure 19: Case vehicle's system status at deployment and longitudinal velocity change data

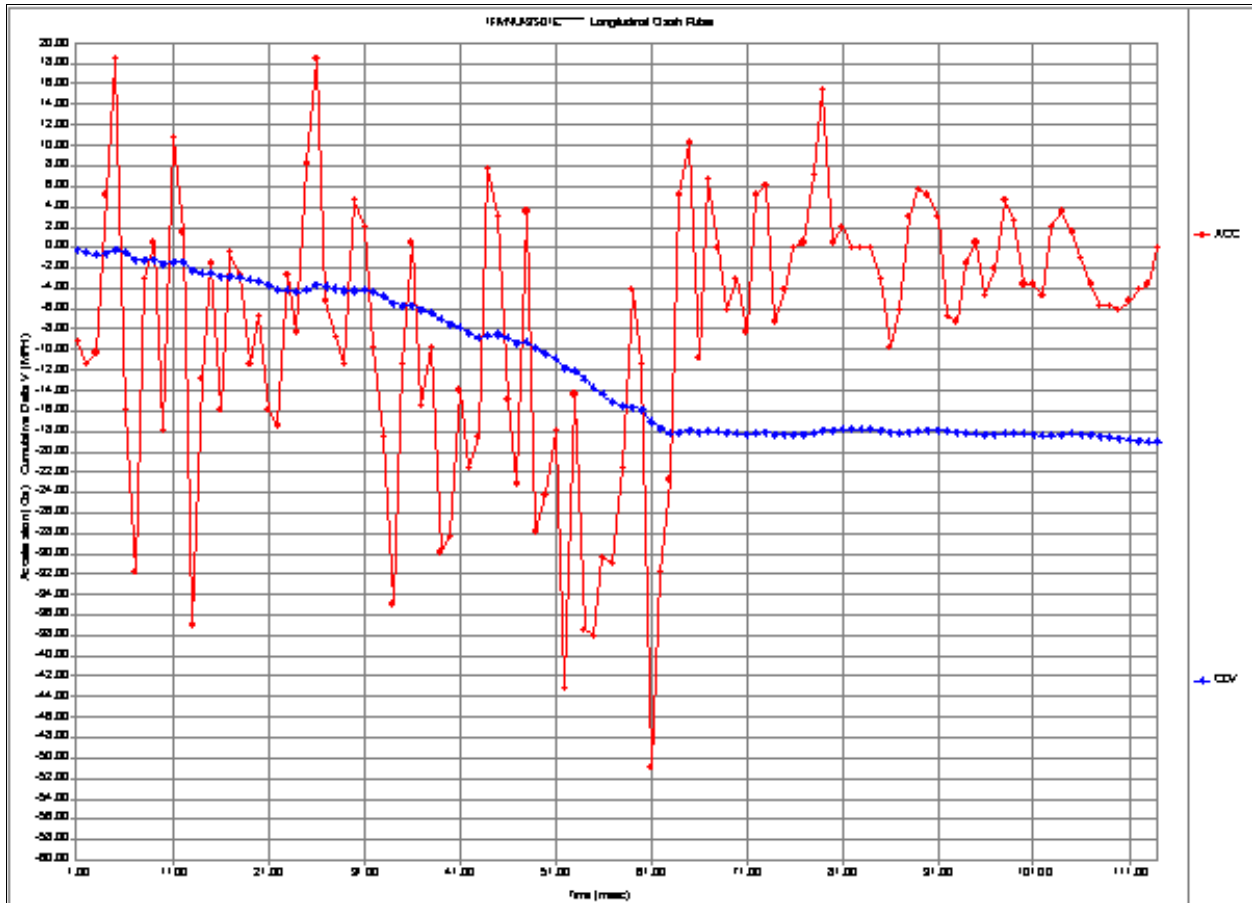
Figure 23: Ford's deployment longitudinal crash pulse
