ON-SITE POTENTIAL SAFETY-RELATED DEFECT INVESTIGATION

CASE NUMBER - IN07035
LOCATION - INDIANA
VEHICLE - 1993 FORD E350 SUPER CLUB WAGON
CRASH DATE - October 2007

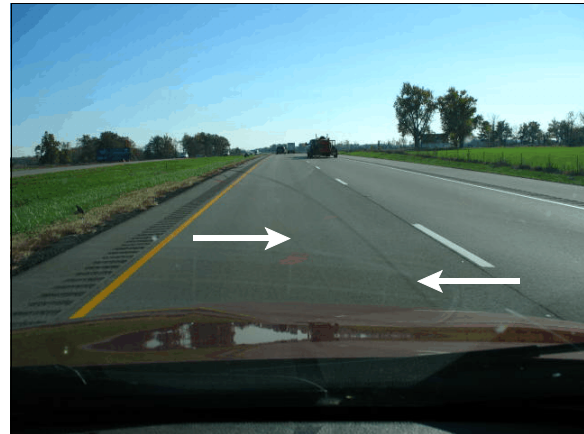
Pre-Crash: The Ford was traveling south in the inside southbound lane (**Figure 1**). Based on an interview with a witness, who was traveling directly behind the Ford, the Ford’s driver and the witness were in the process of passing a tractor semi-trailer. The witness stated that she had been behind the Ford for 8 to 16 kilometers (5 to 10 miles). She stated that her vehicle and the Ford were traveling approximately 122 to 124 km.p.h. (76 to 77 m.p.h.) as they were closing on the tractor semi-trailer. She said they had passed several other vehicles prior to attempting to pass the tractor semi-trailer.

Figure 1: Approach of Ford southbound in inside lane; right arrow shows Ford’s right rear yaw mark, left arrow shows right front yaw mark

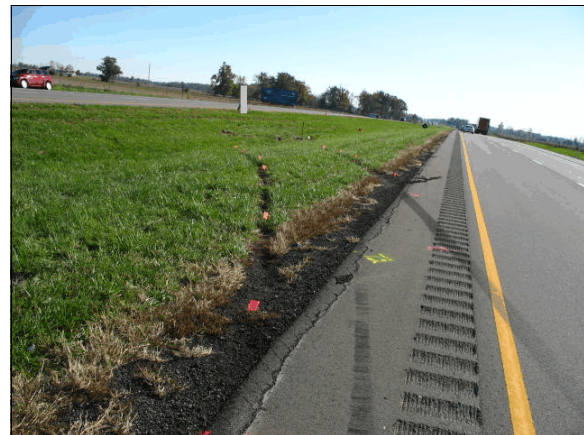
Figure 2: Ford’s yaw marks departing inside shoulder of southbound lanes into median, yaw marks from right to left are right rear, left rear and right front

the Ford entered the median (**Figure 2** above). The roadway was devoid of marks indicative of a flat tire, such as an irregular tire mark containing broad intermittent transfers. As the Ford approached the bottom of the median (**Figure 3** above), it tripped and rolled over, passenger side leading, along a diagonal path through the median. The Ford then entered the northbound lanes, landed on its passenger side and slid to the outside shoulder of the northbound lanes facing east (**Figure 4**). Based on the scene evidence, the Ford rolled over across a total distance of approximately 48 meters (157 feet). An undetermined number of the Ford's 16 passengers were ejected from the vehicle during the rollover. The police crash report indicated that the ejection/entrapment status of 10 of the passengers was unknown. The police measurements located the final rest position of 2 ejected passengers, and the police crash report indicated that the third row left passenger was partially ejected. The evidence indicated that the ejections occurred through the side windows. The inspection of the Ford revealed that all the doors were jammed closed due to damage, and the side glazing in all the windows as well as the backlights was broken out during the rollover. This contractor was not able to determine the specific number of times the Ford rolled over. However, based on the damage to the Ford and the rollover distance, this contractor estimated that the Ford rolled over 17 quarter turns (i.e., four and one quarter rolls).

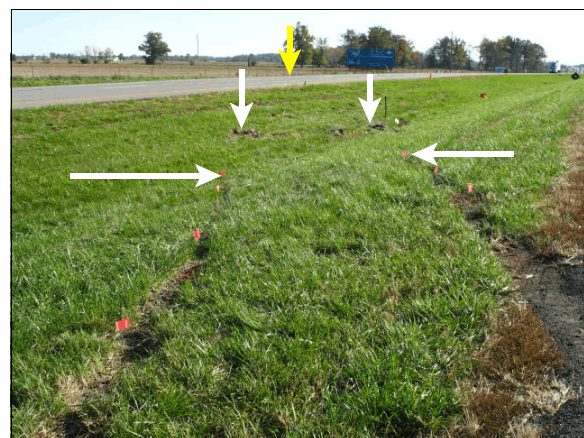
Figure 3: Arrows in foreground show Ford’s trip point, middle arrows show first ground impact, arrow in background shows area of final rest on outside shoulder of northbound lanes

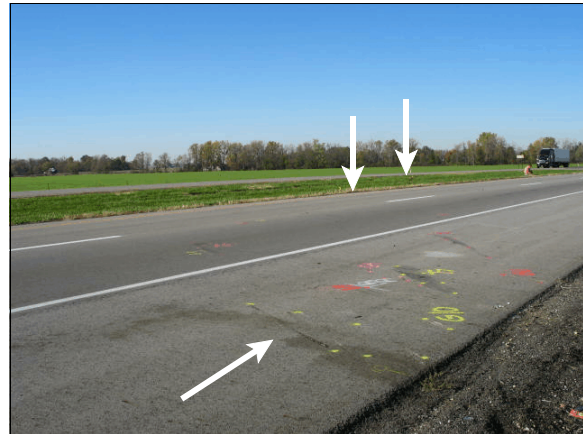
Figure 4: View northwest to Ford's location of final rest on outside shoulder of northbound lanes (left arrow); center arrow shows area of scratches and gouges on inside shoulder, right arrow shows area where Ford departed southbound lanes and entered median

Post-Crash: The Ford came to final rest on its passenger side facing east with the back portion of the vehicle on the outside shoulder of the northbound lanes and the front portion of the vehicle on the grass (**Figures 4** and **5**). Rescue personnel cut all the driver side pillars as well as the inside window frames of the back doors and bent the roof structure over to the passenger side in order to extricate the remaining passengers. The total number of passenger's that were ejected and their final rest locations are not known. There was insufficient information contained in the police crash report to make this determination and there was no scene evidence regarding the rest positions of any ejected occupants.

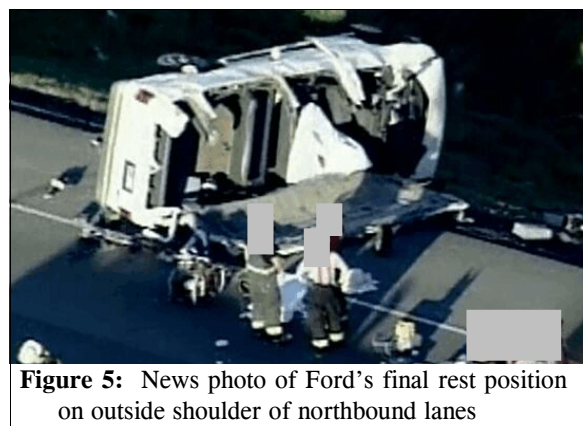
Figure 5: News photo of Ford's final rest position on outside shoulder of northbound lanes

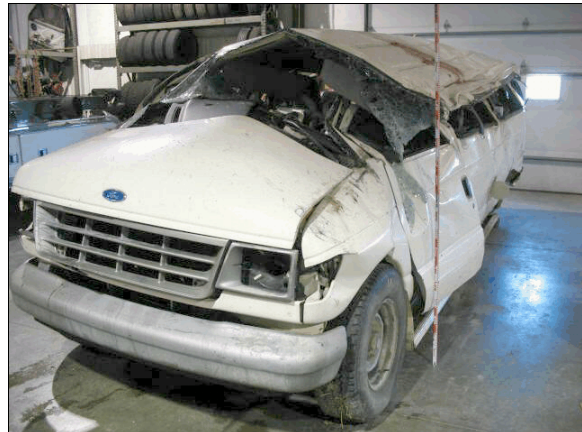
Exterior Damage: The entirety of the Ford sustained direct and induced damage as a result of the rollover. The top, left side and right side sustained the primary contact direct damage, with the top plane sustaining the most severe damage (**Figures 6 and 7**). There was no direct damage to the front or back planes of the Ford indicating that the rollover was side-to-side. The direct damage on the top plane began 51 centimeters (20.1 inches) forward of the left front axle and extended 511 centimeters (201.2 inches) rearward along the top plane. The full width of the roof also sustained direct damage, which was measured as 165 centimeters (65 inches). The maximum residual lateral crush occurred at the left A-pillar (**Figure 8**) and was determined to be approximately 46 centimeters (18 inches). The maximum residual vertical crush occurred to the roof side rail over the driver's seat. Due to alteration of the roof crush when rescue personnel cut the driver's side pillars and bent the roof to the passenger side, a specific vertical crush value could not be measured. The Ford's left and right side wheelbase dimensions were unchanged due to the crash.

Figure 6: Overview of damage to Ford's top and left side; vertical scale in tenths of meter

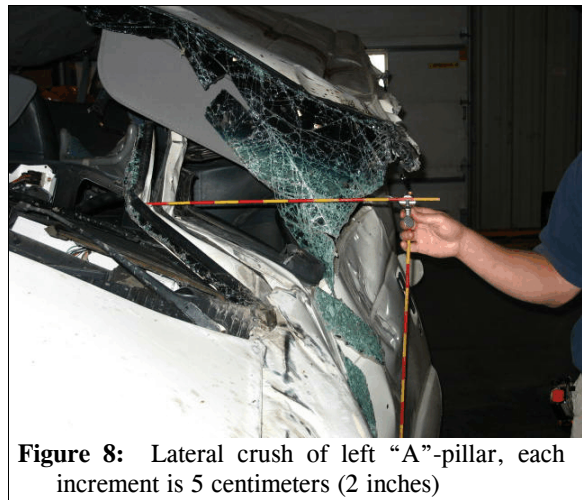
Figure 8: Lateral crush of left "A"-pillar, each increment is 5 centimeters (2 inches)

Vehicle Interior: It was only possible to conduct a visual inspection of the Ford's interior and obtain photographs through the windows. The Ford was under a police impound order and the tow facility representative instructed this contractor that the Ford could not be touched or manipulated. The observations indicated that the Ford had sustained numerous intrusions into all of the seat rows by the roof, roof side rail, adjacent window frames and pillars. The most severe intrusion appeared to be the lateral displacement of the left A-pillar into the driver's occupant space. The A-pillar was determined to have intruded approximately 46 centimeters (18 inches).

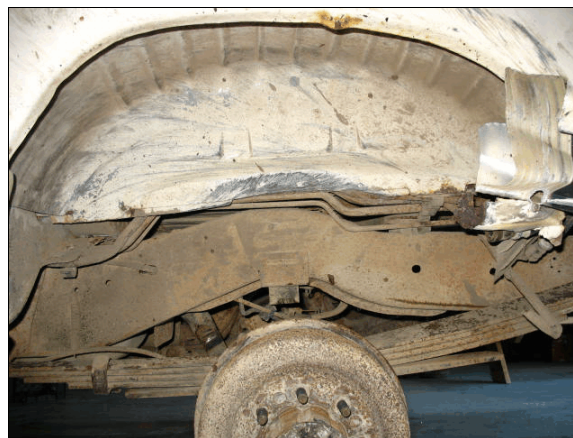
Inspection of the left rear wheel well revealed evidence that the left rear tire tread had separated from the tire carcass as the Ford was traveling down the roadway and slapped against the inside of the wheel well. Numerous black marks and abrasions were observed on the inside of the wheel well (**Figure 9**). The heaviest area of interaction was on the bottom of the wheel well directly above the left rear axle (**Figure 10**).

Figure 9: Black tire tread marks and abrasions on inside of Ford's left rear wheel well

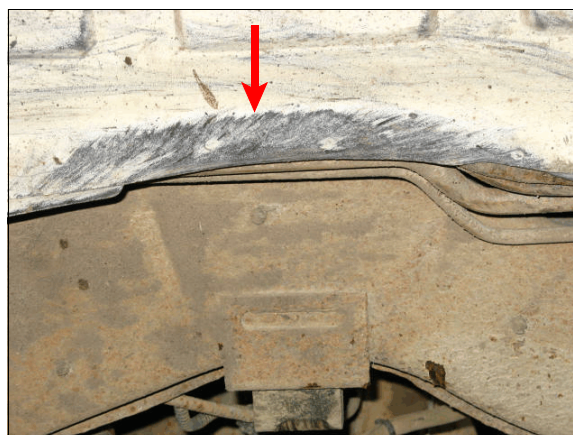
Figure 10: Close view of Figure 9; arrow shows heavy black marks and abrasions from left rear tire tread

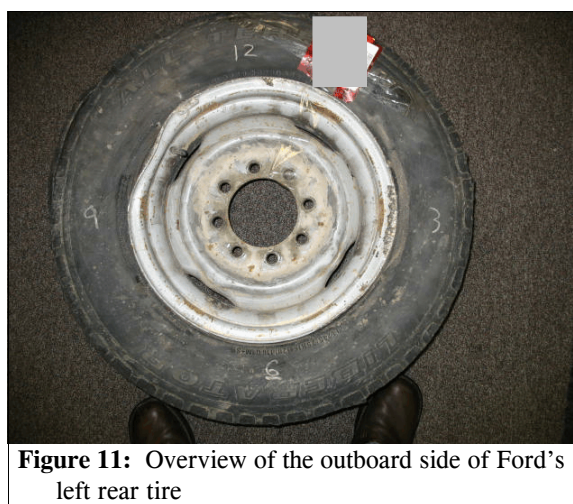
The inspection of the left rear tire took place at the state police post where it had been impounded. The Tire Identification Number (TIN) side of the tire (i.e., outboard side) was numbered with the clock sectors 12, 3, 6, and 9 (**Figure 11**). The 12 o'clock position was placed at the TIN. The same numbers were also written on the other side of the tire opposite each corresponding o'clock position (**Figure 12**) to identify reference points for comparing areas on one side of the tire to the other side. The tire was identified as a Liberator All Terrain (**Figure 12** below), size LT245/75R16. The TIN was DOT BF11N9JJ4601 (**Figure 13**). The information on the tire sidewall indicated that the load range was E and the tread was composed of two polyester plies and two steel plies. The sidewall was designed with two polyester plies. The tire tread was totally separated from the tire carcass. The tread was in a single piece (**Figure 14**) and its length was measured as 244 centimeters (96.1 inches). The tread depth was measured as 9 millimeters (11/32 inch) at the center of the tread and 7 millimeters (9/32 inch) at the outside of of

Figure 11: Overview of the outboard side of Ford's left rear tire

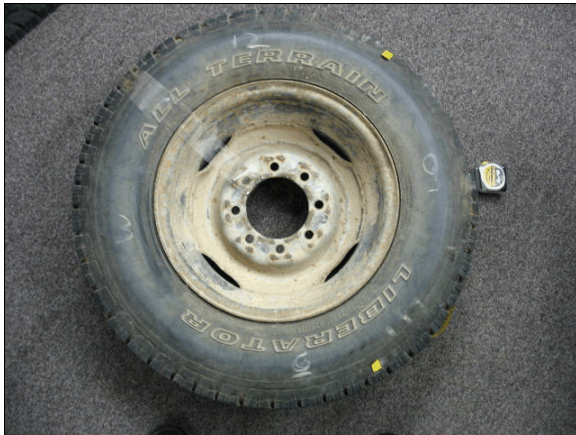
the tread. The tire carcass had a tear in it that was 78 centimeters (30.7) in length (**Figure 15**) as measured around the circumference of the tire. One end of the tear was located near the edge of the tread on the inboard side 16 centimeters (6.3 inches) to the right of 6 o'clock and extended diagonally across the carcass to the edge of the tread on the outboard side. Neither sidewall of the tire was heavily abraded or damaged (**Figures 11 and 12**) indicating that the tire was not flat while rolling on the roadway. The rim flange on the outboard side had a dent 17 centimeters (6.7 inches) in length located at the approximate 10 o'clock position (**Figures 11 and 16**). The dent on the flange was formed by a force directed toward the center of rotation of the wheel. There were abrasions on the edge of the flange and a wheel weight in this area. A second rim flange dent, also on the outboard side, was located at the 3 o'clock position (**Figures 11 and 17**). It was 13 centimeters (5.1 inches) in length and bituminous material was imbedded in the outside of the flange in this area. This dent was formed by a force directed parallel to the axle. The rim on the inboard side was not deformed and the tire sidewall was not damaged (**Figure 12**).

Figure 12: Overview of inboard side of left rear tire; o'clock positions correspond to same numbers on other side of tire

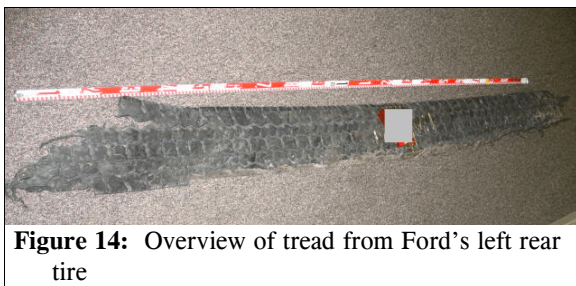
Figure 14: Overview of tread from Ford's left rear tire

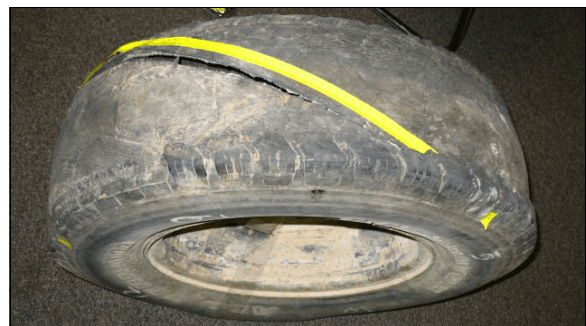
Figure 15: Tear in carcass of Ford's left rear tire

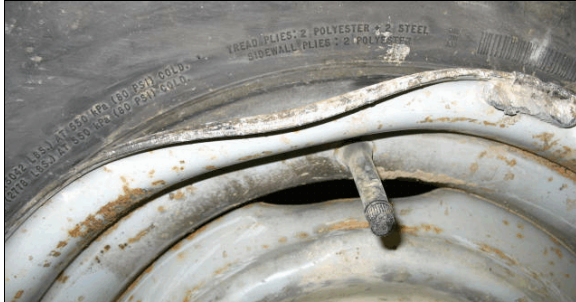
Figure 16: Dent in rim flange on outboard side of Ford's left rear wheel, dent formed by force directed toward center of rotation

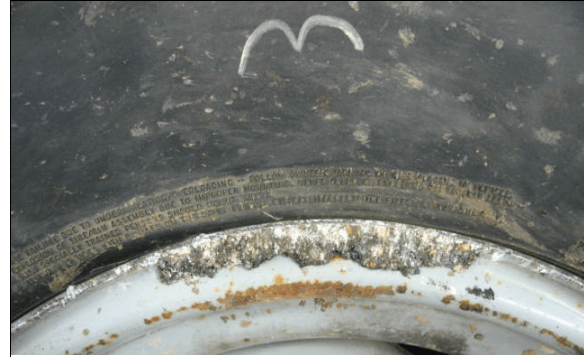
Figure 17: Dent in rim flange on outboard side of Ford's left rear wheel with bituminous jammed in flange; dent formed by force directed parallel to axle

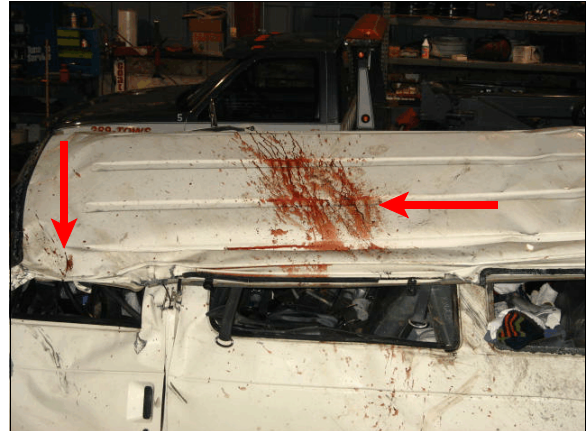
Figure 19: Right arrow shows large deposit of hair and blood on roof behind left front door; left arrow shows blood smear on roof above left front door

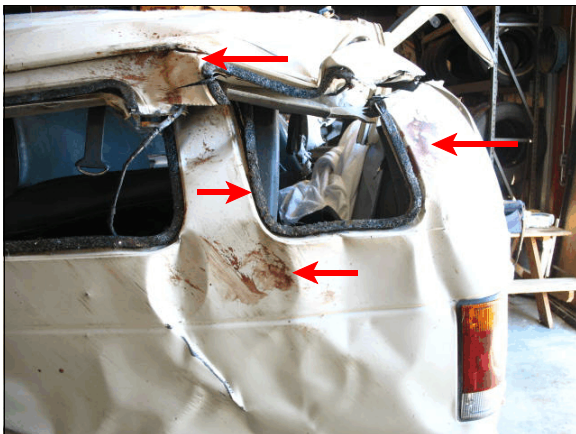
Figure 20: Right arrow shows blood smear on window frame and side of vehicle; left arrows show blood, hair, and tissue on window frame and side of vehicle

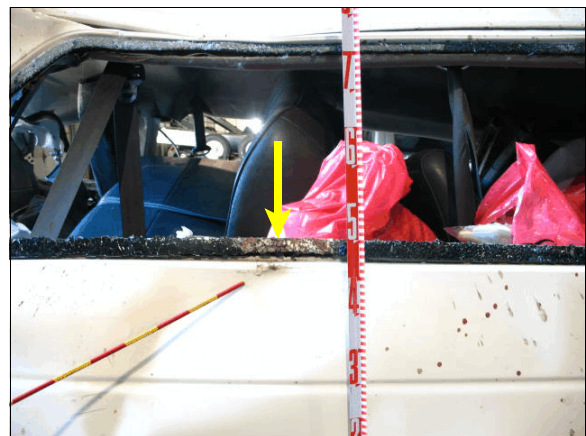
Figure 21: Pointer shows hair deposit on side of vehicle below right side window adjacent to seat rows 3 and 4; arrow shows blood and hair deposit on window frame; vertical scale in 10th of meter
