**CALSPAN ON-SITE HYBRID VEHICLE CRASH INVESTIGATION
SCI CASE NO: CA08024**

**VEHICLE: 2000 HONDA INSIGHT
LOCATION: PENNSYLVANIA
CRASH DATE: MAY, 2008**

14. Sponsoring Agency Code		
15. Supplementary Note An investigation of an intersection crash involving a hybrid 2000 Honda Insight.					
16. Abstract This investigation focused on the crash dynamics and crash severity surrounding the intersection crash of a 2000 Honda Insight and a 2007 Subaru Impreza. The Honda Insight was a gasoline-electric hybrid vehicle powered by a 1.0 liter, in-line three-cylinder internal combustion engine and a 54 kilowatt electric motor. The vehicle's electrical power was supplied by a 144 volt DC nickel-metal hydride battery located behind the rear seat. The Honda was equipped with redesigned front air bags for the driver and front right passenger that did not deploy as a result of the impact. There was no damage to the hybrid battery compartment. This crash occurred at the four-leg intersection of a five-lane north/south road and a three-lane east/west road. The intersection was controlled by overhead traffic signals. The crash occurred when the 72 year old restrained male driver of the northbound Ho

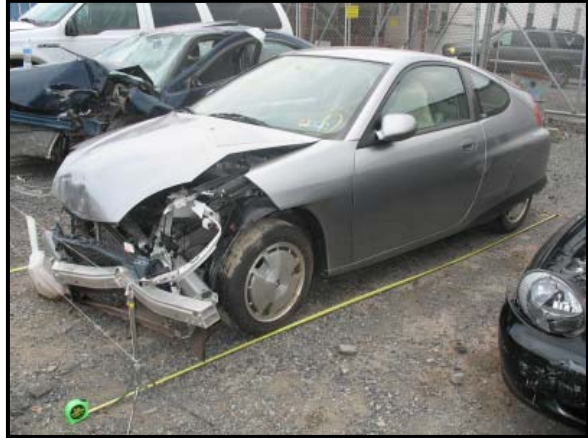
Figure 1: Front view of the Honda.

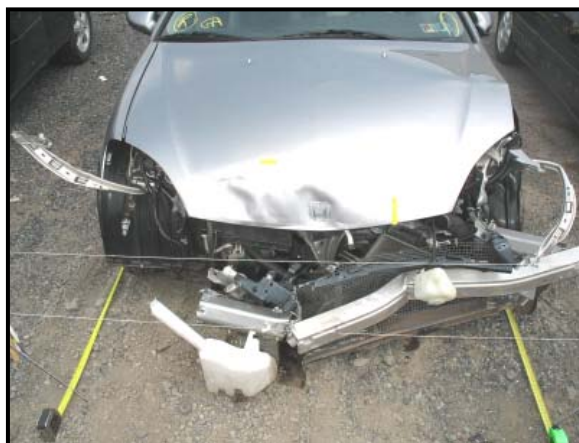
The front plane of the Honda sustained a combined width of direct contact and induced damage that extended across the vehicle's entire 147 cm (58 in) end width. The direct contact damage began at the right front corner and extended laterally across the front plane 95 cm (37.5 in). The direct damage ended 20 cm (8 in) left of center as measured on the hood face. Refer to **Figure 4**. The direct contact extended 18 cm (7 in) longitudinally onto the hood. The bumper fascia could not be inspected as it had separated during the impact and was not with the vehicle. The bumper reinforcement beam consisted of a 63 mm x 76 mm (2.5 in x 3 in) aluminum box beam that was 109 cm (43 in) in length. It was observed that the beam was fractured 13 cm (5 in) right of center and deformed in an inverted V-pattern. The entire reinforcement beam and its mounting structure had separated from the vehicle at its mounting point. This mounting structure was a design unique to the Insight. The reinforcement beam was attached to the vehicle's sub-frame by two aluminum stand-offs. Each stand-off was a formed hexagonal structure measuring 9 cm (3.5 in) in diameter and 29 cm (11.3 in) long. The stand-offs were attached to the sub-frame by a hexagon bolt pattern. The angular impact force caused a shearing deformation of the aluminum at the bolted connection. **Figure 5** is an overall view of the structure of the bumper reinforcement. **Figure 6** is a close-up view of the right stand-off. There was no crush of the stand-offs and no measureable crush at the sub-frame mounts. There was no measureable change in either wheelbase dimension. Both doors were operational. The windshield was not fractured and all the side glazing was intact. The Collision Deformation Classification (CDC) was determined to be 01-FZEW1.

Figure 4: View of the frontal damage.

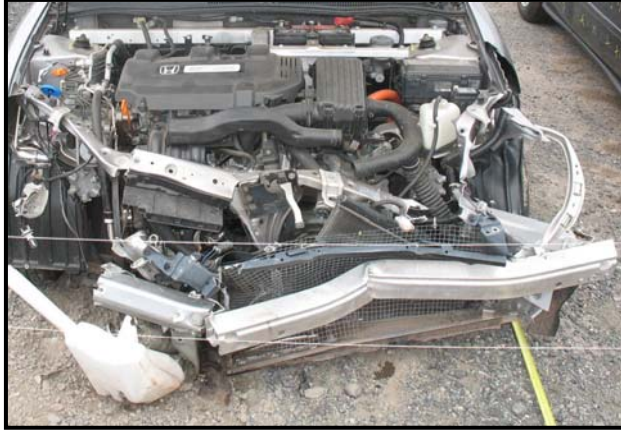
The front plane of the Subaru impacted the right frontal area of the Honda in an 11/1 o'clock impact configuration. The force of the angular impact deformed the bumper reinforcement beam and sheared the Honda's frontal structure that supported the beam from its mounting points. [Refer to the *Exterior Damage* section of this report for greater detail on the front structure and its damage.] The offset impact force caused the vehicle to rotate counterclockwise and redirected the Honda to the southwest. The Honda came to rest facing southwest partially blocking the southbound traffic lane. The Subaru was deflected to its right by the impact and separated with a southerly trajectory. The Subaru came to rest facing south on the west leg of the intersection. **Figure 8** at the end of this report is a schematic of the crash.

Figure 5: View of the bumper reinforcement structure.

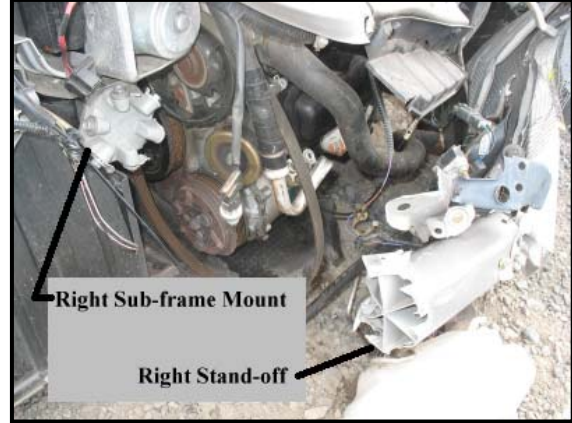
Figure 6: Close-up view of the right stand-off and sub-frame mount.

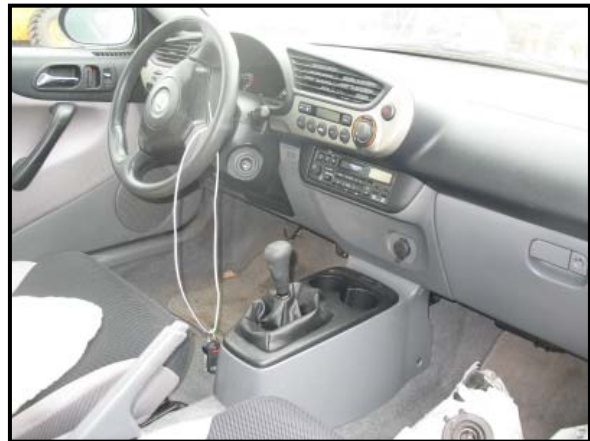
There was no interior damage or intrusion within the occupant compartment of the Honda. No points of occupant contact were present. **Figure 7** is an interior view of the Honda.

Figure 7: Interior view of the Honda.

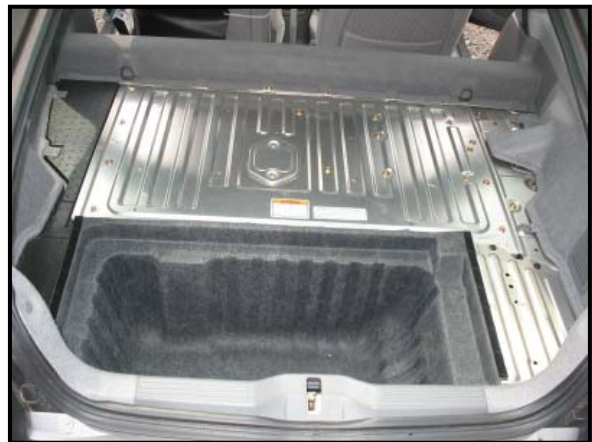
The battery storage compartment in the Honda Insight was located aft of the front seats above the rear axle. The compartment measured approximately 53 cm x 91 cm x 23 cm (21 in x 36 in x 9 in), length x width x height, respectively. The compartment was sealed by an aluminum cover that was bolted in place. There was no damage to the compartment. A storage well was located rearward of the battery compartment. The spare tire was housed below the storage well, under the level of the battery compartment. **Figures 8 – 11** are a series of images of the Insight's cargo area and battery compartment.

Figure 9: View of the battery compartment location.

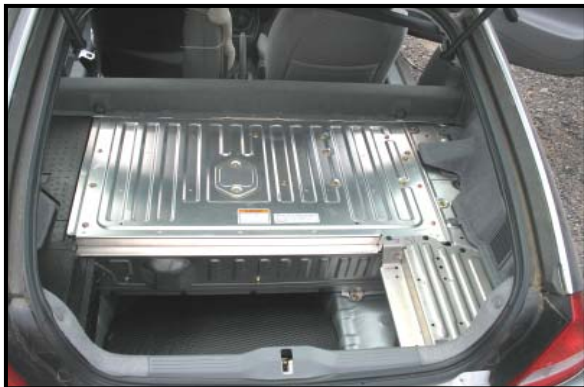
Figure 10: Battery compartment and storage well.

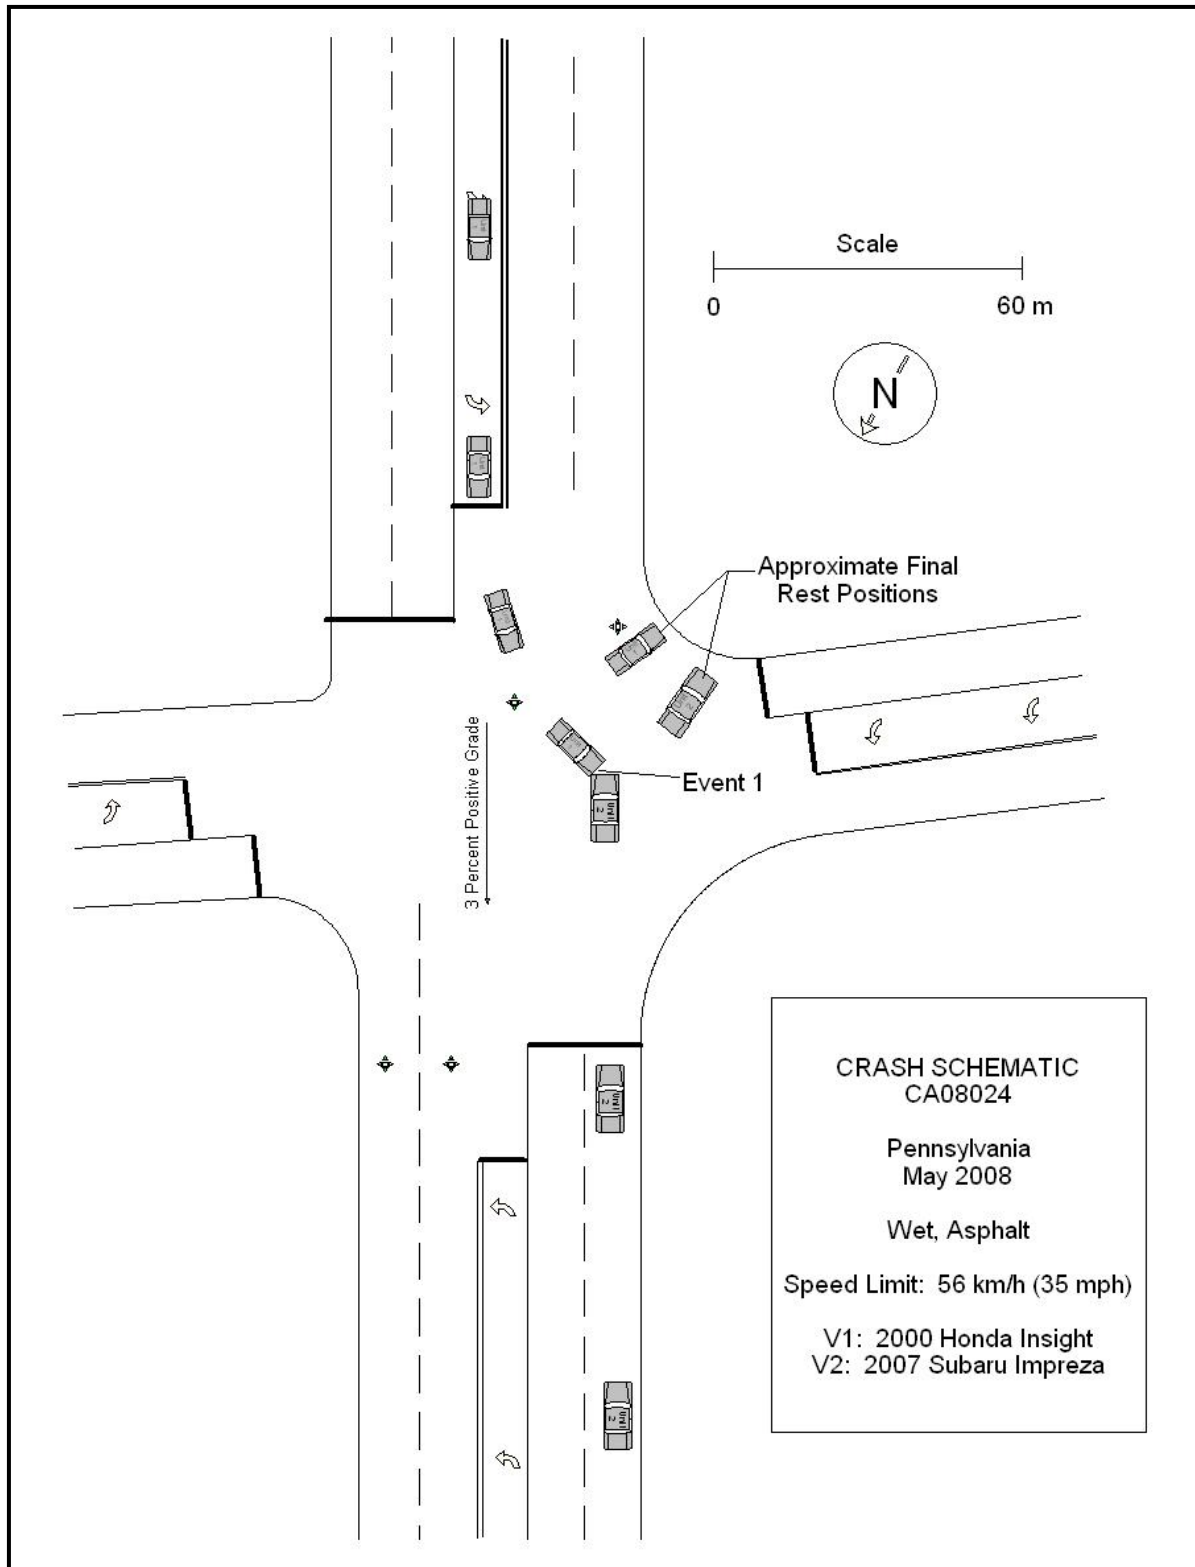
Figure 12: Crash schematic.
