On-Site Ambulance Investigation
Dynamic Science, Inc. (DSI), Case Number DS09001
2005 Ford E350 Econoline Type II Ambulance
California
December 2008

1. Report No. DS09001		2. Government Accession No.		3. Recipient Catalog No.	
4. Title and Subtitle On-Site Ambulance Investigation				5. Report Date August 10, 2009

This on-site investigation focused on the crash dynamics and injuries sustained in a crash involving a 2005 Ford E350 Econoline van that was configured as Type II¹ ambulance (**Figure 1**). This single vehicle crash occurred in December 2008 at 1059 hours in California. The subject vehicle was being driven by a restrained 19-year-old male. Two unrestrained Emergency Medical Technicians (EMTs) and a 56-year-old female patient were positioned in the rear of the ambulance. The Ford was traveling westbound at an unknown speed. There were other vehicles in front of the Ford. The Ford was transporting the patient from a nursing facility to a local hospital for a medical appointment. The Ford was not traveling with the lights and siren. While negotiating a left curve, the Ford departed the right side of the roadway. According to the investigating officer, there were no indicati

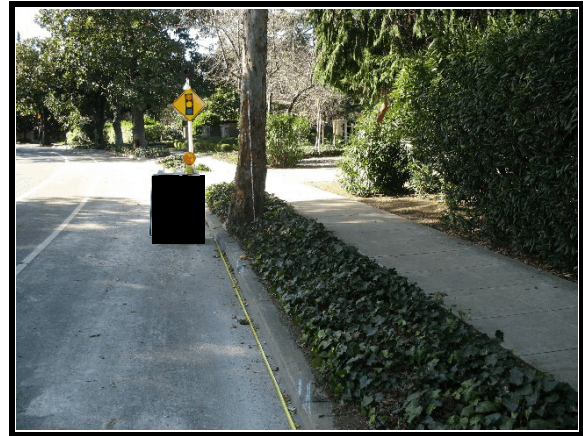
As the Ford entered the curved aspect of the roadway, it continued in a straight line. There were no indications that the driver attempted to brake or steer the vehicle. The Ford traveled over the north curb edge and continued forward until striking the tree with its front right bumper corner (**Figure 4**). The damage to the tree extended vertically from the ground upward 193 cm (76 in). The impact severity was moderate and resulted in the deployment of the frontal air bag system in the Ford. The Barrier algorithm of the WinSMASH program computed a Total Delta-V of 14 km/h (8.7 mph), based on the front bumper damage profile. The results were low because most of the damage was outboard of the right frame rail and was not included in the crush profile per the measurement

Figure 4. Area of impact with tree

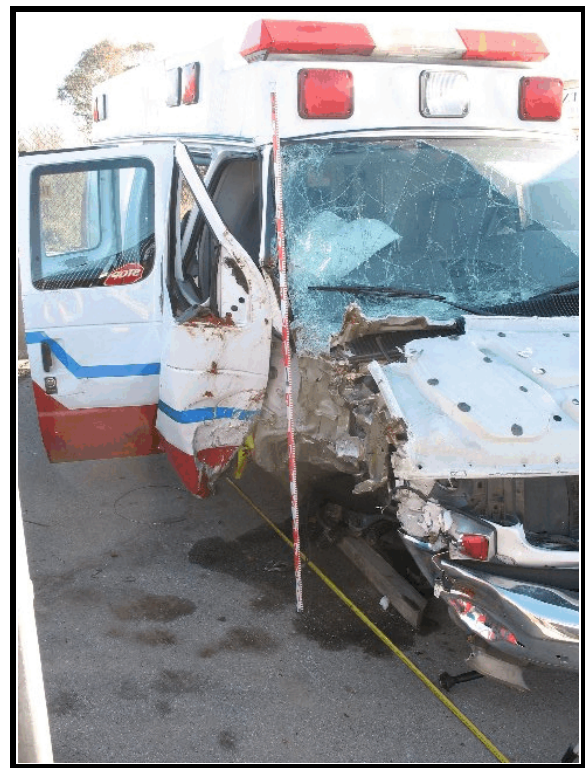
The Ford sustained moderate front end damage as a result of the impact with the tree (**Figure 5**). The direct damage began at the front right bumper corner and extended laterally 35 cm (13.7 in) along the plastic fascia on frontal plane. The damage extended longitudinally down the right side and terminated at the right A-pillar. The A-pillar was deformed and the right front door was jammed and bowed outward. The windshield was cracked and holed. The bumper fascia and hood fascia were separated from the vehicle. The front right wheel was fractured from the front axle. The rim sustained a 16 cm (6.3 in) wide by 9 cm (3.5 in) deep deformation. There was a 9 cm (3.5 in) by 10 cm (3.9 in) tear in the outboard sidewall. The right side wheel base was shortened by 94 cm (37 in), based on the location of the front axle. Six crush measurements were documented at the bumper level as follows: C1 = 41 cm (16.1 in), C2 = 0 cm, C3 = 0 cm, C4 = 0 cm, C5 = 0 cm, C6 = 0 cm. The Collision Deformation Classification (CDC) for the impact with the tree was 12FREE6.

Figure 5. Right front/side damage

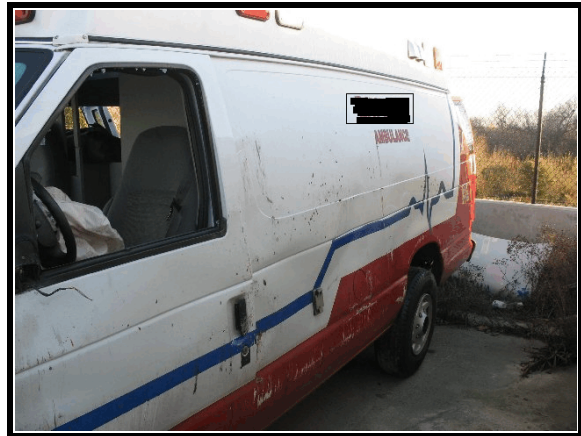
The Ford sustained minor left side damage as a result of the left side leading one-quarter turn rollover (**Figure 6**). The damage began 12 cm (4.7 in) forward of the left A-pillar and extended 412 cm (162.2 in) rearward along the left side plane. The direct damage measured 112 cm (44 in) vertically and there was a maximum crush of 4 cm (1.6 in) that was located on the left door 12 cm (4.7 in) forward of the B-pillar. The CDC for the rollover was 00LDAO2.

Figure 6. Left side rollover damage

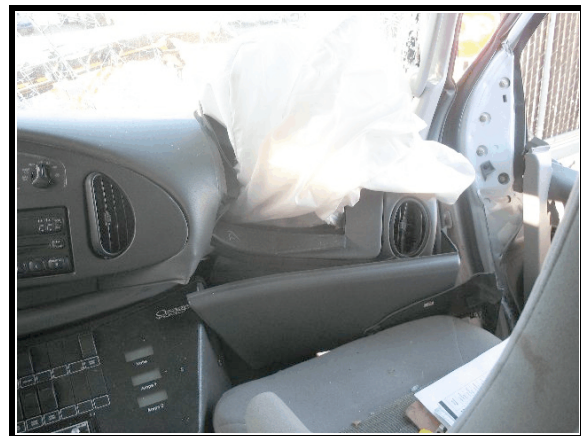
The Ford sustained moderate interior damage as a result of passenger compartment intrusion, occupant contacts, and first responder activity in the vehicle. The right and middle instrument panel, lower A-pillar, and toe pan sustained longitudinal intrusion (**Figure 7**). The center console sustained lateral intrusion. The driver's knee bolster was deformed and the plastic fascia was displaced. A storage table on the right side of the ambulance was deformed, possibly by the EMT seated on the squad bench. There was blood located on the left side cabinetry that probably came from the right ear injury to the second EMT. The base of the rear-facing seat was deformed, probably by the patient.

Figure 7. Right interior intrusion

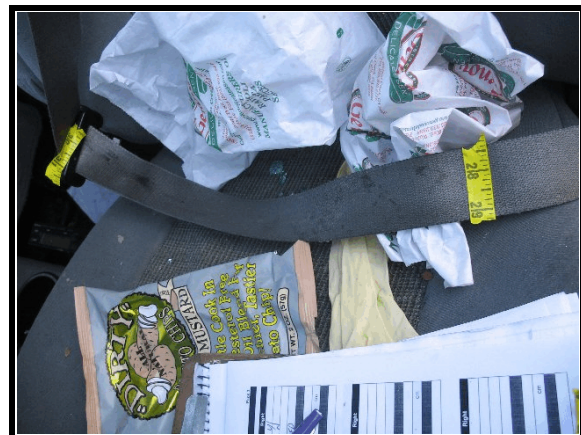
The 2005 Ford Econoline was configured with 3-point manual lap and shoulder belts for the two front row seating positions. The belts were configured with sliding latch plates, Emergency Locking Retractors (ELRs), and shoulder belt anchorages which were in the full-down position. The front belts were equipped with buckle pretensioners. The driver's pretensioner actuated during the impact with the tree. The buckle position was compared to an exemplar vehicle and the stalk was shortened by 2 cm (0.8 in). An area of the driver's belt webbing was scuffed and worn; the area was located 59 cm (23.2 in) from the anchor and measured 36 cm (14.2 in) in length (**Figure 8**).

Figure 8. Marks located on driver's belt webbing

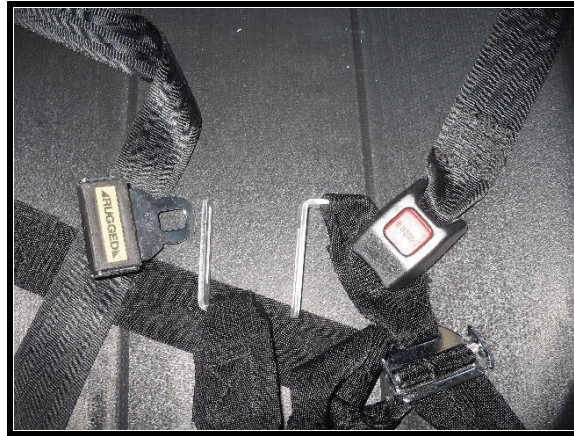
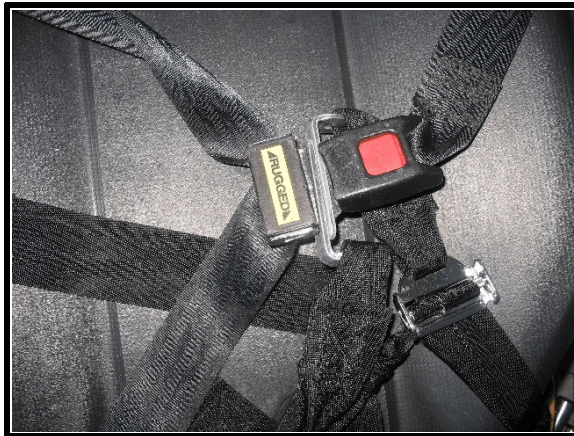
The Stryker Model 6080 MX Pro ambulance cot was configured with two lap belts and one 4-point shoulder restraint. The shoulder restrained was designed to be used in conjunction with the forward lap belt (**Figures 9-10**). There was no evidence that the shoulder restraint was used during this crash. There was a 12 cm (4.7 in) section of loading located on the right belt webbing (forward lap belt) that was located 13 cm (5.1 in) from the latch.

Figure 9. Forward lap belt and shoulder restraint, unassembled

Figure 10. Forward lap belt and shoulder harness, assembled

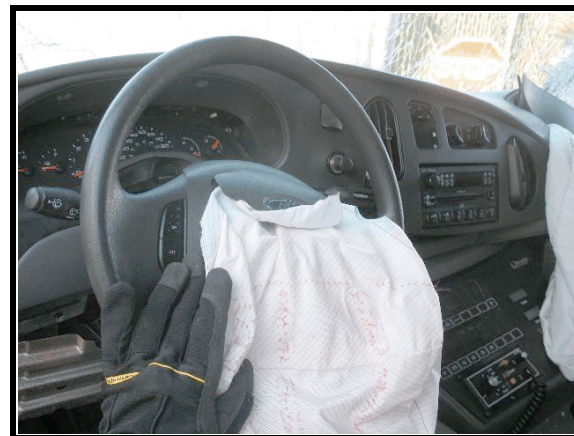
The driver's air bag deployed from the center of the steering wheel hub through symmetrical T-configuration module cover flaps (**Figure 11**). The top flap measured 8 cm (3.1 in) high by 15 cm (5.9 in) wide. The bottom flaps measured 6 cm (2.4 in) high by 7 cm (2.8 in) wide. The air bag measured 48 cm (18.9 in) in diameter in its deflated state. The air bag was configured with two circular vent ports at the 11 and 1 o'clock positions. There was no evidence of damage or contact to the air bag.

Figure 11. Driver's air bag

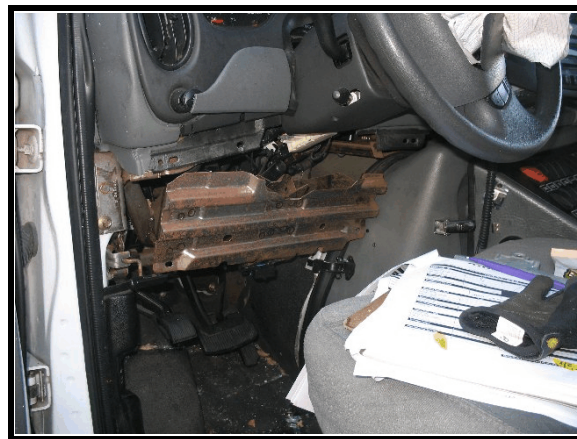
The driver of the Ford was seated in an unknown posture and was restrained by the lap and shoulder belt. The driver stated to the police that he was traveling at or near the speed limit and was following other vehicles on the roadway. It is presumed that his right foot was on the accelerator and his left on the floor board. There were no avoidance maneuvers prior to the impact. At impact, the driver's air bag deployed and the seat belt pretensioner actuated. The driver was displaced in a forward direction and he loaded the shoulder belt and his knees impacted and deformed the knee bolster (**Figure 12**). His face contacted the deployed air bag, causing a small lip laceration.

Figure 12. Deformed knee bolster

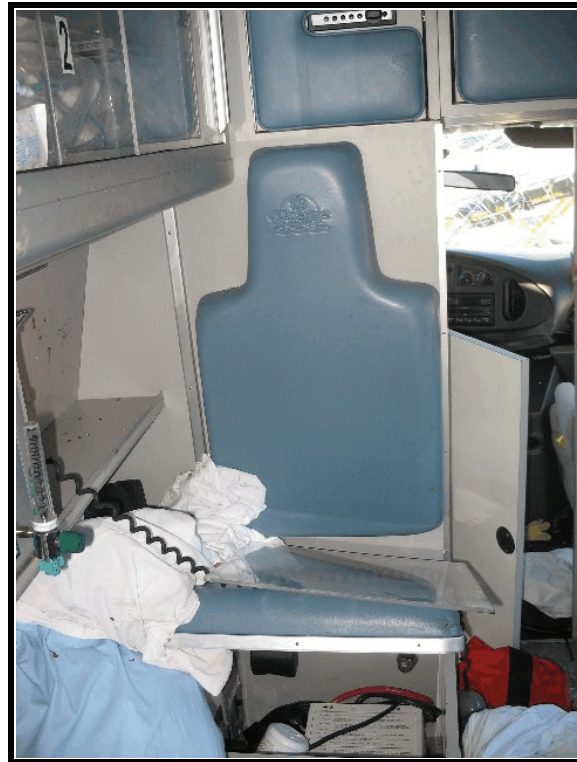
The 23-year-old male second row left occupant was seated in a rear-facing seat. He was not wearing the manual lap belt. He had no warning that a crash was imminent. Prior to impact, he was assisting the second EMT in obtaining a blood pressure reading. At impact, he was displaced rearward into the seat back (**Figure 13**). There were no indications of damage to the seat back. As the vehicle rotated clockwise, this occupant was displaced to his right and he contacted the left interior surface of the ambulance with the right side of his head, likely causing the ear laceration. As the vehicle tripped and rolled on to its left side, this occupant came to rest against the left interior surface. Occupant 03 reported that he contacted this occupant during the rollover. This occupant was able to exit the vehicle through the back door under his own power. He was transported to a local hospital where he was treated and released.

Figure 13. Rear-facing seat behind driver

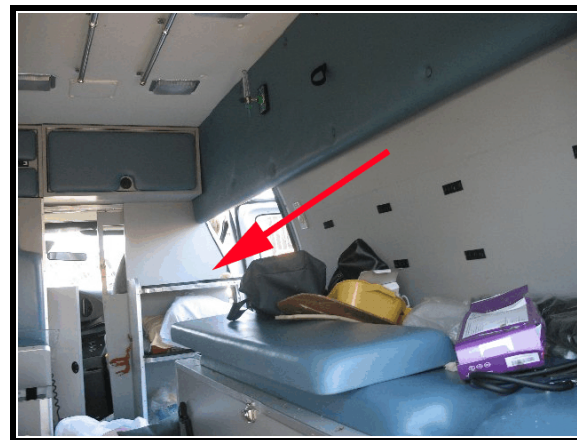
The 18-year-old male third row right occupant was seated in a left side-facing seat (**Figure 14**). He was not wearing the manual lap belt. He had no warning that a crash was imminent. Prior to impact, he was assisting the first EMT in obtaining a blood pressure reading. At impact, he was displaced toward the front of the vehicle with his right side leading into a metal/wood table attached to the right bulkhead. The table was slightly deformed. As the vehicle tripped and rolled on to its left side, this occupant was displaced to the left and contacted Occupant 02 with his left shoulder, causing a left clavicle fracture. This occupant also sustained a forehead laceration from an unknown source. He came to rest on the left side of the ambulance and reported that he lost consciousness for a short period of time. He was able to exit the vehicle through the back door under his own power and was transported to a local hospital where he was treated and released.

Figure 14. Overview of occupant 03 seated position and possible contact to table

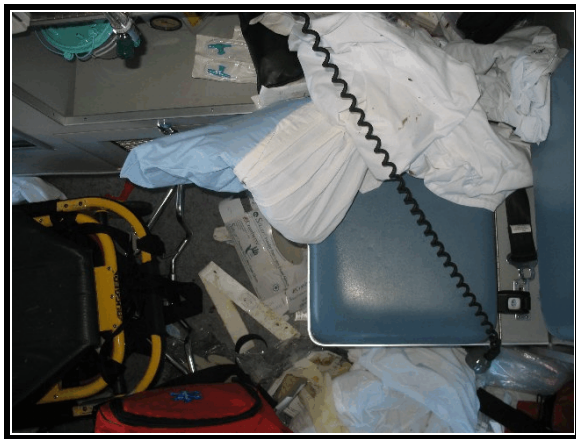
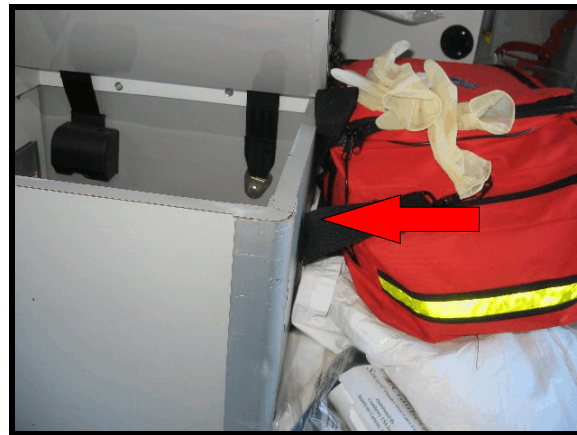
There were indications of loading to the forward lap belt. She sustained contusions and abrasions due to contacts with the restraints. She probably contacted the base of the rear-facing seat and possibly Occupant 2's knees/lower legs with her head (**Figures 16-17**). The EMT in the rear-facing seat did not report any leg injuries. The vehicle came to rest on its left side and it has been reported the cot remained attached to the vehicle. This occupant probably contacted the left interior surface as the vehicle rolled over. The patient was removed from the ambulance cot by EMS personnel, placed on a backboard, and removed from the vehicle. She was transported to a local hospital with serious head injuries and hospitalized for two days before passing away.

Figure 16. Top-down view of seat and forward end of cot

Figure 17. Deformation to upper right corner of seat support
