Remote Investigation/Vehicle to Vehicle to Vehicle/ Front to Right-front to Right-side
Dynamic Science, Inc. / Case Number:DS9801
1998 Chevrolet Lumina
Washington
January, 1998

1. Report No. DS9801		2. Government Accession No.		3. Recipient Catalog No.	
4. Title and Subtitle Remote Accident Investigation Seattle Washington				5. Report Date June 1998

Dynamic Science, Inc.
Crash Investigation
Case Number: DS9801

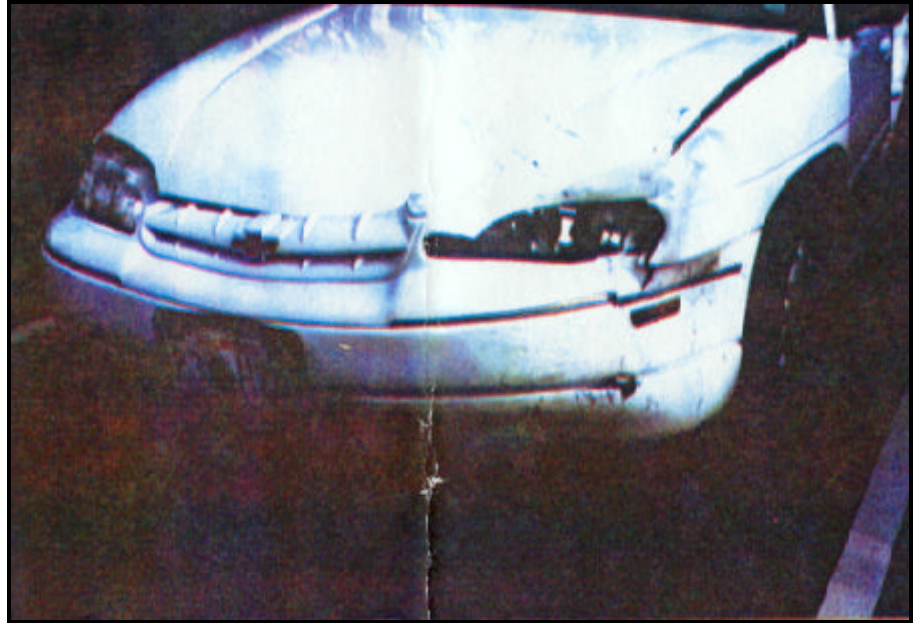
Description:	1998 Chevrolet Lumina	
VIN:	2G1WL52M3W1*****	
Odometer:	4519 km (2808 miles)	
Engine:	6 cyl 3.1L	
Reported Defects:	None	
Cargo:	None known	
Damage Description:	Damage to front-left of vehicle from initial impact. Components included bumper, grille, hood, lamp assemblies, etc. Damage to left-rear door from secondary impact.	
CDC:	11-FLEW-1	
Delta V (ROLDMISS Routine):	Total	10.2 km/h (6.3 mph)
	Longitudinal	-9.6 km/h (-5.9 mph)
	Lateral	3.5 km/h (2.2 mph)
	Energy	6,613. Joules (4881 ft lbs.)

Figure 1. Vehicle 1, front view.

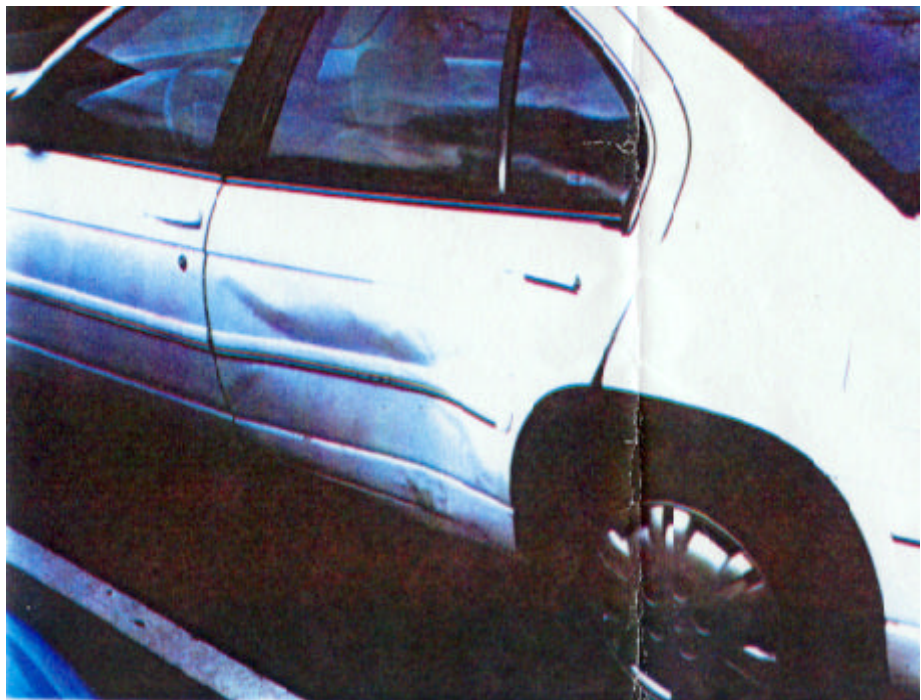
Figure 2. Vehicle 1, left side view.

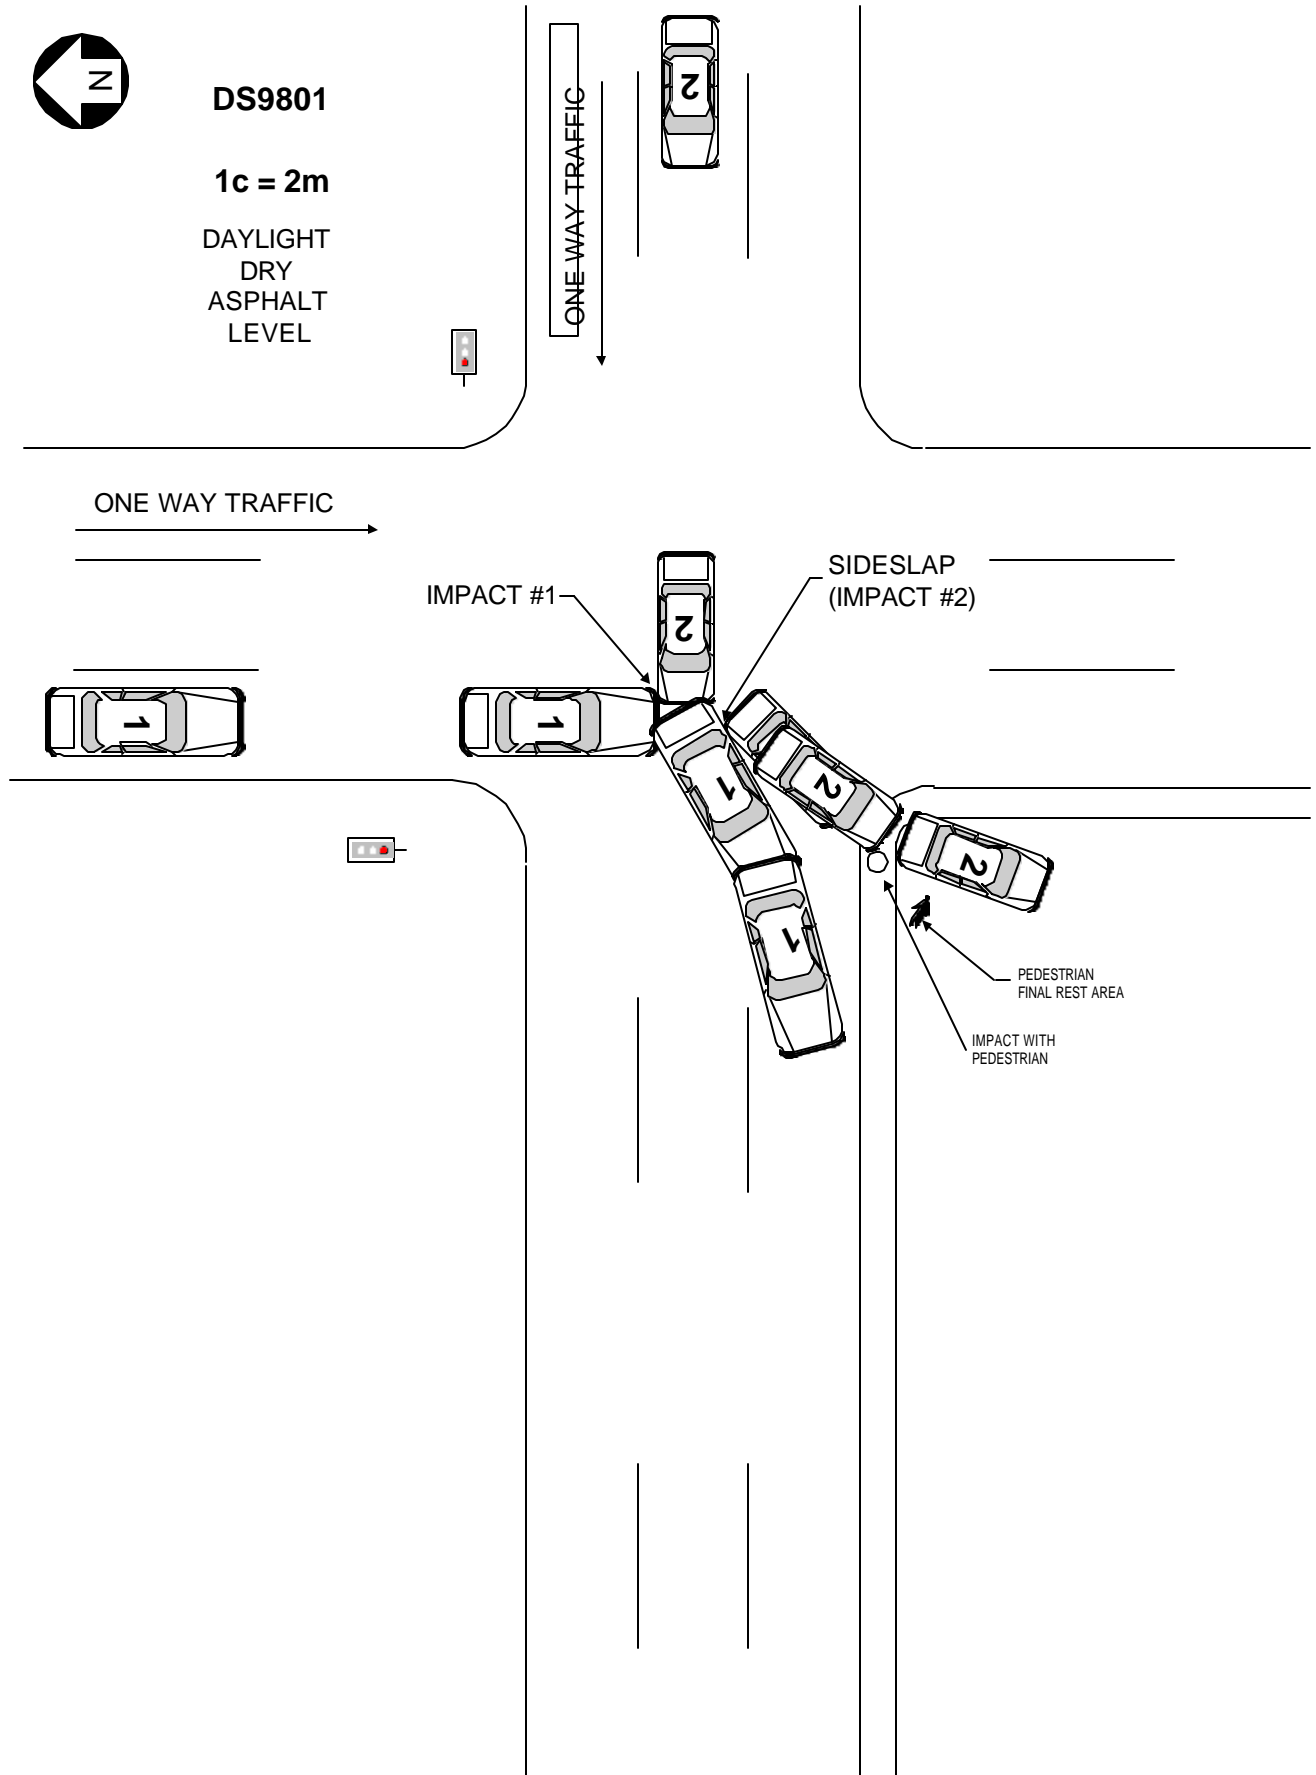
Diagram

Witnesses stated that the driver of Vehicle 2 failed to stop at a red traffic light and entered the intersection from the north. The front of Vehicle 2 struck the front-left of Vehicle 1 in a right-angle impact configuration. After the initial collision, Vehicle 1 rotated clockwise and Vehicle 2 rotated counterclockwise and the left-rear door of Vehicle 1 sideslapped the right-rear of Vehicle 2. Following the second impact, Vehicle 2 traveled off the south edge of the street and struck the pedestrian, knocked her to the ground and came to rest.
