Remote, Redesigned Air Bag Special Study
FOR NHTSA'S INTERNAL USE ONLY
Dynamic Science, Inc., Case Number (DS99023)
1998 GMC Suburban
California
July 1998

1. Report No. DS99023		2. Government Accession No.		3. Recipient Catalog No.	
4. Title and Subtitle				5. Report Date January 12, 2000	
				6. Performing Organization Report No.

Summary

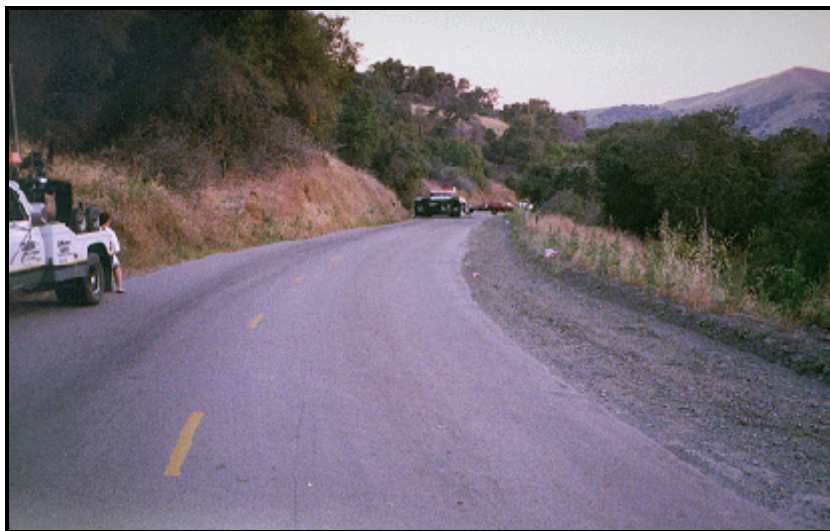
Figure 1. Approach to impact with rock embankment.

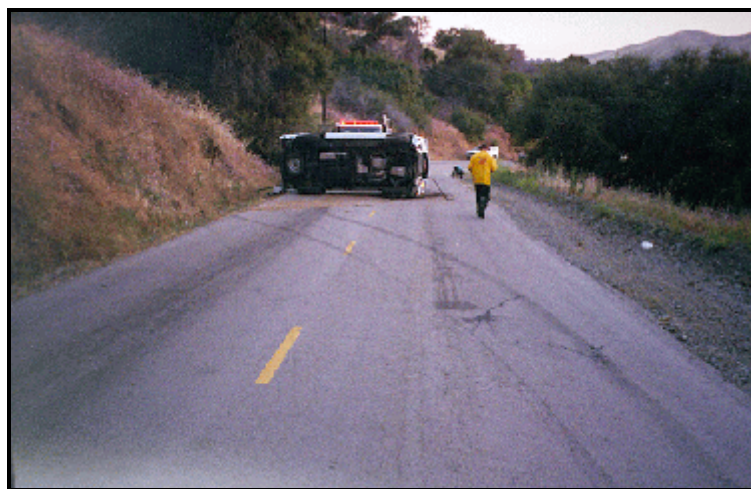
Figure 2. Impact area and final rest (south).

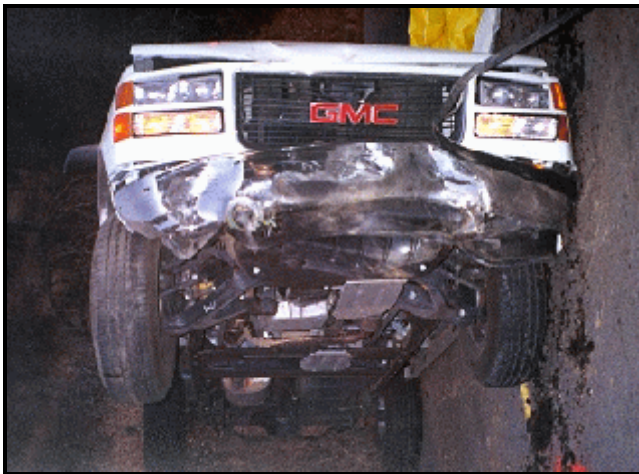
Table 3. Crush Measurements

Plane of Impact	Field L cm/in.	C1 cm/in.	C2 cm/in.	C3 cm/in.	C4 cm/in.	C5 cm/in.	C6 cm/in.
Bumper	188	unk	unk	unk	unk	unk	unk
	74	0	0	0	0	0	0

Figure 3. Exterior, case vehicle - impact #1 to front

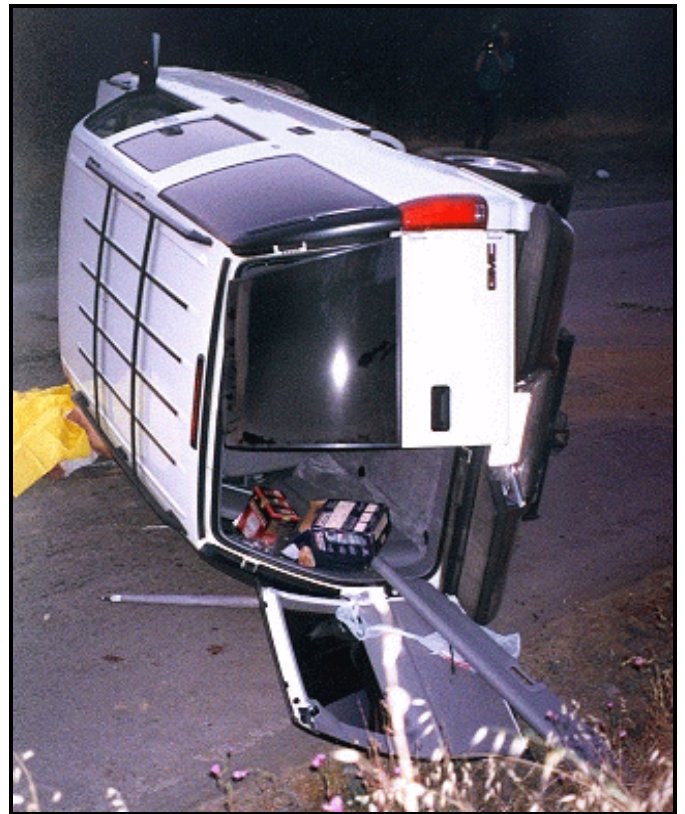
Figure 4. Exterior, case vehicle. Show rollover contact to entire left side.

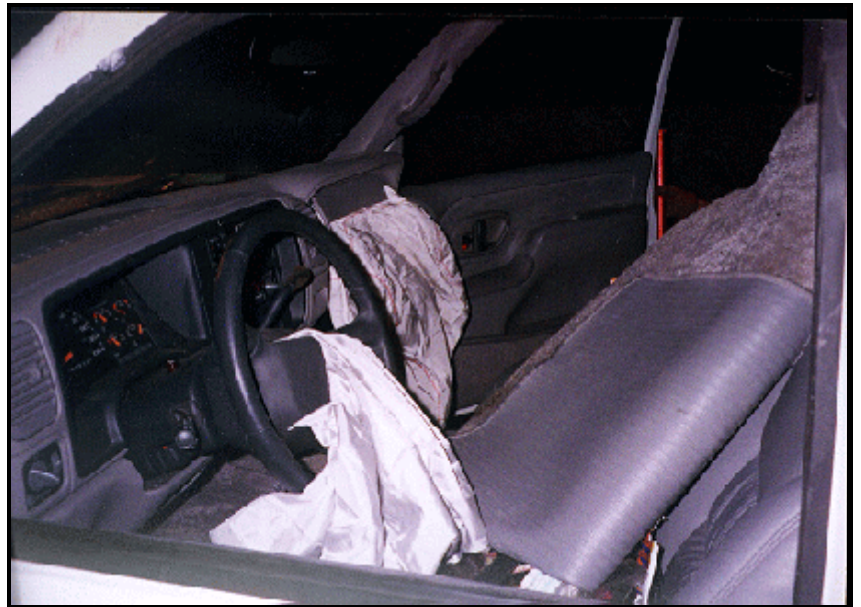
The front left air bag was housed in the steering wheel hub and was concealed by symmetrical I-configuration cover flaps which do not appear to have been damaged in the crash. The front right air bag was housed in the mid-instrument panel position and was concealed by dual rectangular cover flaps which did not appear to have been damaged in the crash.

Figure 5. Interior, case vehicle

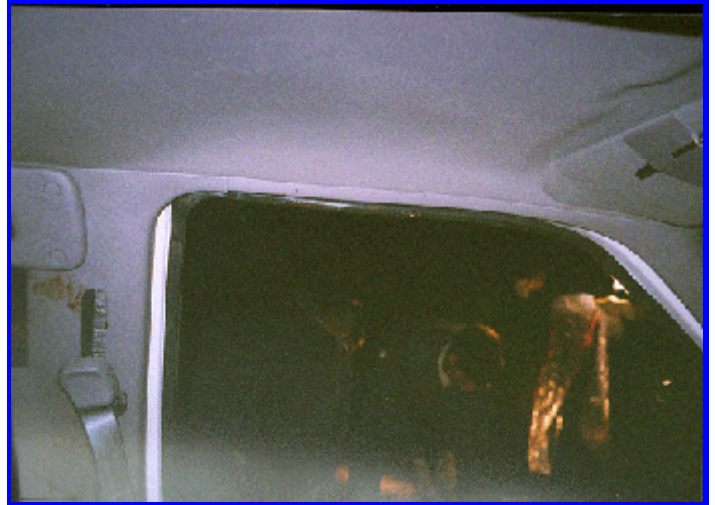
The interior of the GMC Suburban was not inspected; however, police photos show that the driver's head contacted the exterior surface of the top frame of the driver's side window. The left front window was found in the down position and was not damaged. The case vehicle was equipped with front bucket seats. There was no indication of any intrusion. It appears that one of the rear doors may have opened during the rollover.

Figure 6. Interior surface of roof rail

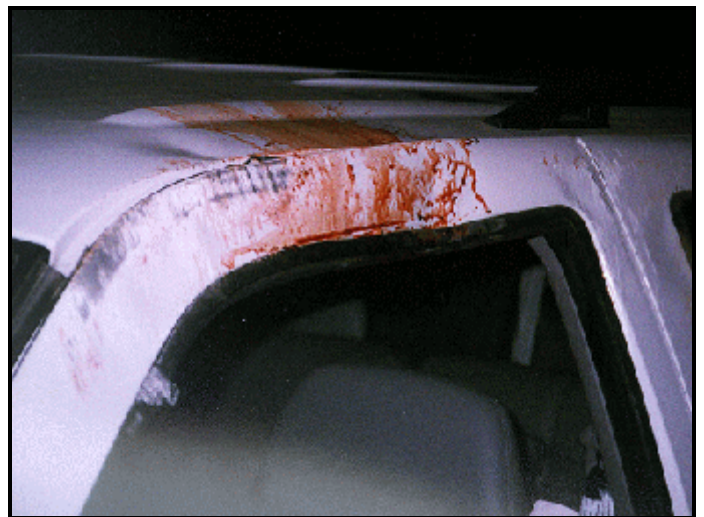
Figure 7. Exterior view of roof rail/side glass rail
