REMOTE AIR BAG DEPLOYMENT REPORT

CASE NUMBER - IN99-026

VEHICLE - 1998 FORD MUSTANG

CRASH DATE - April 1998

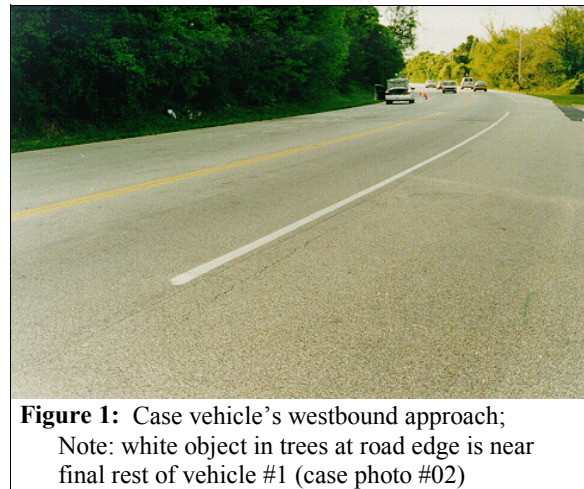
The case vehicle was traveling west in the westbound lane of a two lane undivided roadway and vehicle #1 was traveling east in the eastbound lane of the same roadway. The crash occurred near a Tee intersection where the roadway temporarily expands to include four lanes, to accommodate turning traffic (**Figure 1**). It was dark but lighted and raining. The bituminous roadway was level, wet and without defects, and curved left for westbound traffic. The posted speed limit for both travel directions was 80 km.p.h. (50 m.p.h.). Traffic controls consisted of a double solid yellow centerline, single solid white edge lines each side, a single solid white lane line for westbound traffic, a single solid white lane line that changed to a single broken white lane line for eastbound traffic. The case vehicle drifted across the centerline. It is not known if the case vehicle driver attempted any avoidance actions.

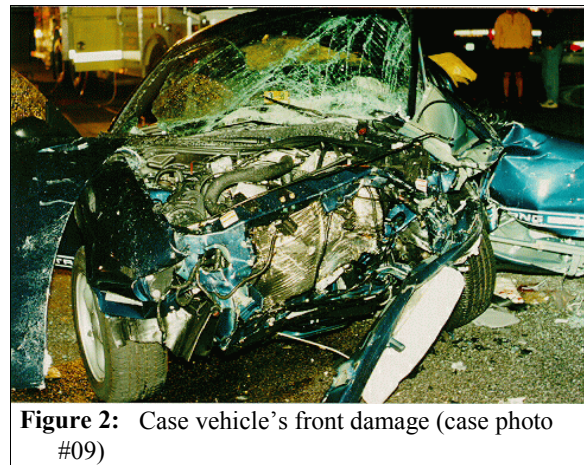
The crash occurred in the inside eastbound lane. The case vehicle's front (**Figure 2**) impacted the front left of vehicle #1, causing the case vehicle's driver and front right passenger air bags to deploy. The case vehicle rotated approximately 150 degrees counterclockwise and came to rest in the eastbound travel lane facing south. Vehicle #1 rotated approximately 90 degrees counterclockwise and came to rest off the south pavement edge, facing north-northeast.

The case vehicle sustained direct contact damage across the entire front end width. The front bumper fascia was torn off and the bumper itself was crushed rearward and to the left. The front frame was pushed back with the bumper. The grille and headlamp assemblies were shattered. The front engine compartment frame and brackets were shoved rearward. The radiator was pushed into the engine and the engine into the cowl. The hood was crushed into the lower windshield and hung by its right rear bracket, dangling over the side of the right front fender. The left front fender was crumpled rearward into the cowl. The front right fender was moved rearward, with its middle humped at the wheel well. The left front tire and wheel assembly was crushed back into the lower left A-pillar (**Figure 3**), causing the upper A-pillar and left roof rail to peak in an inverted "V" over the driver's seat. This caused the splintered windshield to be pulled upwards and created a top-to-bottom glazing separation near the right A-pillar. As well, the rearward crush of the left lower and upper A-pillars bent the left front door's forward edge inwards and sprung the door latch away from the left lower B-pillar, causing the door to come open. The left front door glazing was shattered (kernalized). The backlight glazing was also shattered, but this was probably due to extrication activities.

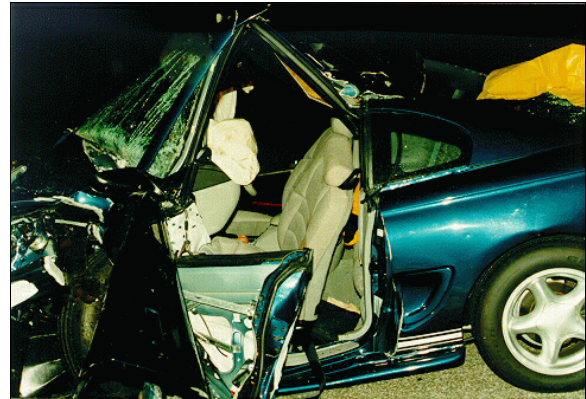
There was severe intrusion to the case vehicle's driver seat area. Intruding components included: the lower and upper portions of the left A-pillar, windshield, front left roof header, left side of instrument panel, toe pan and foot well, and the steering column and wheel (**Figure 4**). The driver's seat was tilted to the left (**Figure 3**), indicating deformation of the floor, and the seat cushion was deformed due to intrusion (**Figure 5**, below). The steering wheel was deformed and the area where the steering column joins the instrument panel was disturbed, suggesting substantial loading of the steering column.

Figure 3: Intruding components of case vehicle into driver space; Note: left front tire post-crash location at lower A-pillar (case photo #12)

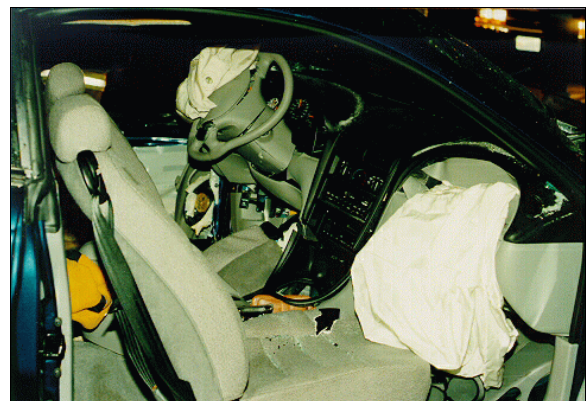
Figure 4: Interior view of case vehicle; Note: damage to steering column and wheel rim (case photo #18)

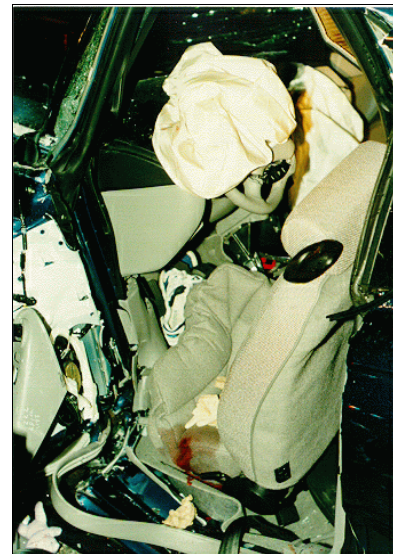
Figure 5: Case vehicle's intruded driver seating area; Note: leading edge of seat (case photo #17)

In view of the case vehicle's high delta V (nearly 80 km.p.h. [50 m.p.h.]) and the heavy intrusion to the driver's seat area, including severe deformation of the steering assembly, left instrument panel, foot well and driver's seat (**Figure 5**), this contractor is of the opinion that the autopsy report is less than complete. There were no reported bone fractures below the head and no inspection of the spinal cord.

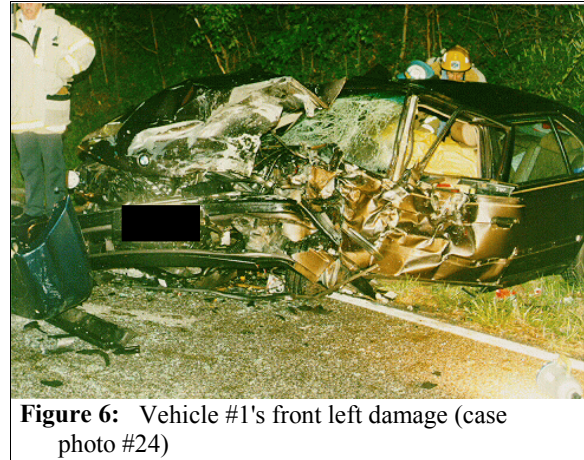
Vehicle #1 was a rear wheel drive, 1988 BMW 735i, five-passenger, four-door sedan (VIN: WBAGB4310J1-----), equipped with a 3.5 liter, I-6, gasoline engine and a four-speed automatic transmission with a console-mounted shift lever. Four-wheel anti-lock brakes were not an option for this vehicle. Wheelbase for vehicle #1 was 283 centimeters (111.5 inches). No odometer reading was reported. Vehicle #1 was towed from the scene due to disabling damage (**Figure 6**). Damage included: direct contact to the left side of the front bumper and fascia that pushed the left corner rearward and pulled the right corner forward; the grille and front headlamps were shattered; the left front of the hood was pushed at an angle to the middle of the engine compartment and its left rear edge raised to front header height; the windshield glazing was fractured, the left front fender and wheel assembly were shoved into the left lower A-pillar; the upper A-pillar was impacted above the belt line and moved to an almost vertical position; the forward third of the left front door was crushed inwards; and the left front door glazing was shattered (kernalized). The CDC for vehicle #1, estimated from police photographs, is **11-FYAW-7**, with principal direction of force 320 (-40) degrees. The WinSMASH reconstruction program was used to calculate Delta V based on a CDC-only estimated crush profile. These CDC-only calculations provide a borderline reconstruction, but the results appear reasonable. The estimated Total, Longitudinal, and Lateral Delta Vs for vehicle #1 are, respectively: 72 km.p.h. (45 m.p.h.), -62 km.p.h. (-38 m.p.h.), and 36 km.p.h. (22 m.p.h.).

Figure 6: Vehicle #1's front left damage (case photo #24)
