REMOTE CHILD SAFETY SEAT REPORT

CASE NUMBER - IN99-072
LOCATION - Illinois
VEHICLE - 1995 CHEVROLET LUMINA
CRASH DATE - May 1999

1. Report No. IN99-072		2. Government Accession No.		3. Recipient's Catalog No.	
4. Title and Subtitle Remote Safety-Related Investigation Vehicle - 1995 Chevrolet Lumina Location - Illinois			5. Report Date: March 28, 2002

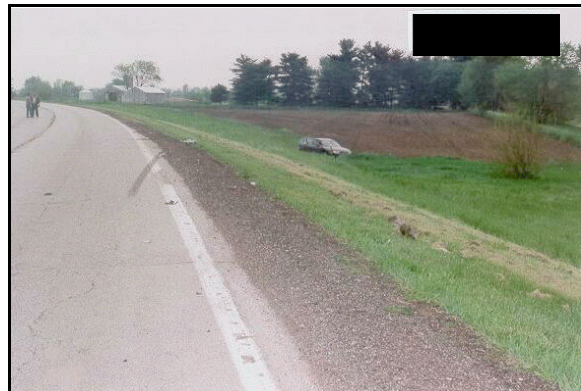
Figure 1: On-scene, case vehicle's northbound approach, point of impact, east road edge departure and final rest (case photo #01)

rotated approximately 170 degrees clockwise while traversing a grassy slope along the roadside and came to rest heading southeast, approximately 49.1 meters [161 feet] northeast from the point of impact (**Figure 1**). The other vehicle continued southward in the northbound lane and came to rest heading south on the east shoulder approximately 133.5 meters [438 feet] south of the point of impact (**Figure 2**).

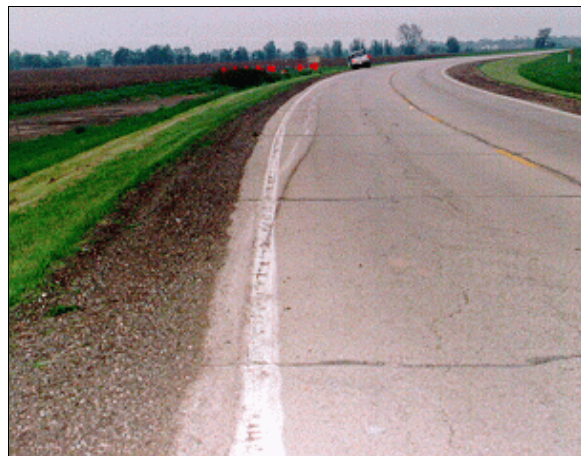
Figure 2: On-scene, look back along case vehicle's northbound approach (looking south) showing the other vehicle's track of gouges and final rest (case photo #07)

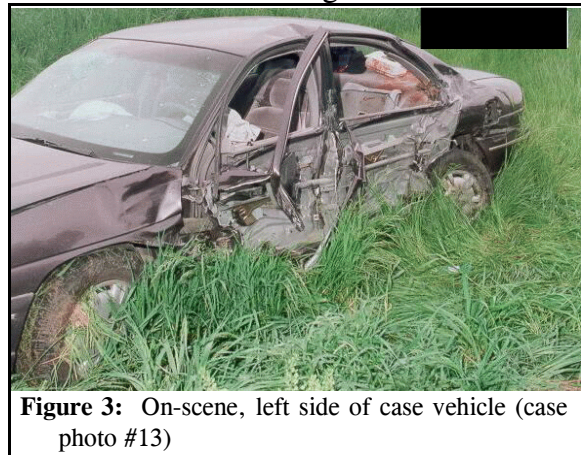
The case vehicle's contact with the other vehicle involved the left side, extending from just forward of the left A-pillar rearward to the left rear bumper corner and vertically from the sill to just above the base of the side windows (**Figure 3**). The driver's door exterior window frame was snagged and pulled outward. The left front and rear door exterior body panels were peeled away and there was direct contact on the upper B- and C-pillars, with some remote bucking on the roof near the B-pillar. The left side window glazing was disintegrated (**Figure 4**) and the windshield had stress cracks on the left, but the back window glazing was not damaged. The case vehicle's left rear tire was deflated and restricted. The available photographs do not show the left side interior surface, but the police inspection report indicates intrusions on the left side of 6 centimeters [2.5 inches] for the driver's door, 10 centimeters [4.0 inches] for the left B-pillar and 8 centimeters [3.0 inches] for the left rear door. The case vehicle was towed due to damage.

Based on the available photographs, the CDC for the case vehicle's single impact was estimated as: **12-LDAW-2 (350)**. No reconstruction program was used on this crash because of the swiping-type nature of the impact. This contractor's visual estimate of the delta V is 14-23 km.p.h. [9-14 m.p.h.], indicating a crash of low severity for the case vehicle.

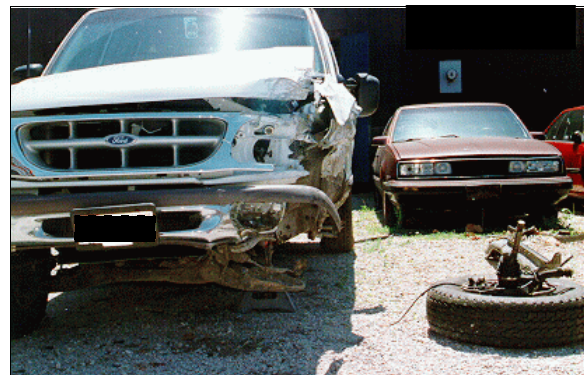
The Ford’s initial contact with the case vehicle involved the front left bumper corner, the left headlight assembly, the leading edge of the left fender and the left corner of the engine hood, with direct contact extending down the left side to the A-pillar (**Figure 5**), with some direct damage on the lower edge of the driver’s door (**Figure 6**). The front left wheel snagged against the case vehicle’s front left door, tearing off the wheel assembly. The leading edge of left front fender was crushed inward and rotated upward and penetrated the case vehicle’s left rear window. The police photographs show hair and other tissue on the crushed fender (**Figures 7 - 9**). The Ford was equipped with dual front air bags that did not deploy.

Figure 5: Other vehicle's front left damage; Note: left front wheel torn off during impact with case vehicle (case photo #30)

Based on the available photographs, the CDC for the Ford was estimated as **12-FLEE-6 (0)**. No reconstruction program was used on this crash because of the sideswiping nature of the impact. This contractor's visual estimate the delta V is 14-23 km.p.h. [9-14 m.p.h.], indicating a crash of low severity.

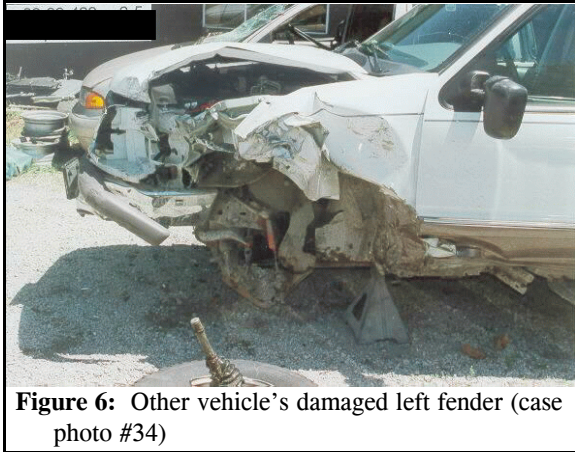
Figure 6: Other vehicle's damaged left fender (case photo #34)

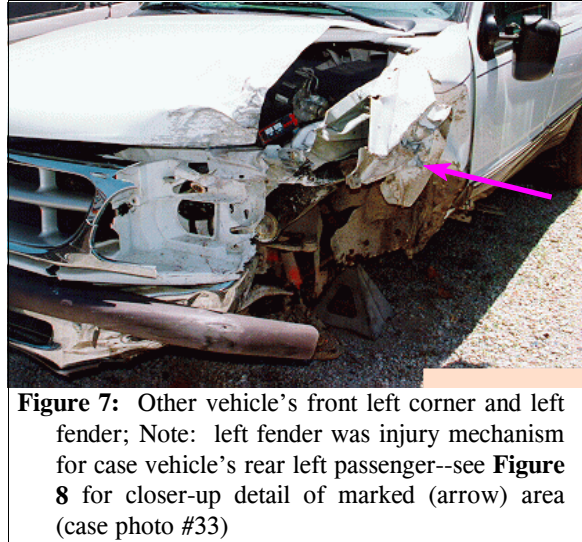
Figure 7: Other vehicle's front left corner and left fender; Note: left fender was injury mechanism for case vehicle's rear left passenger--see **Figure 8** for closer-up detail of marked (arrow) area (case photo #33)

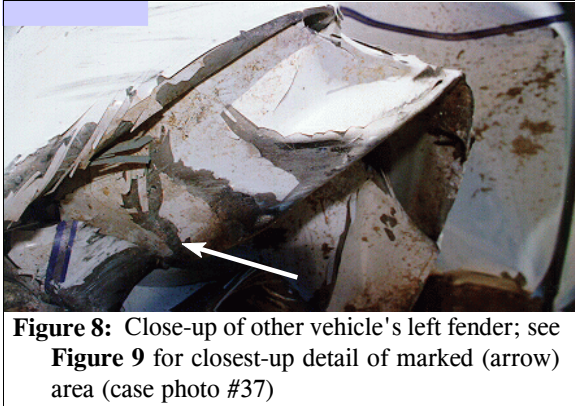
Figure 8: Close-up of other vehicle's left fender; see **Figure 9** for closest-up detail of marked (arrow) area (case photo #37)

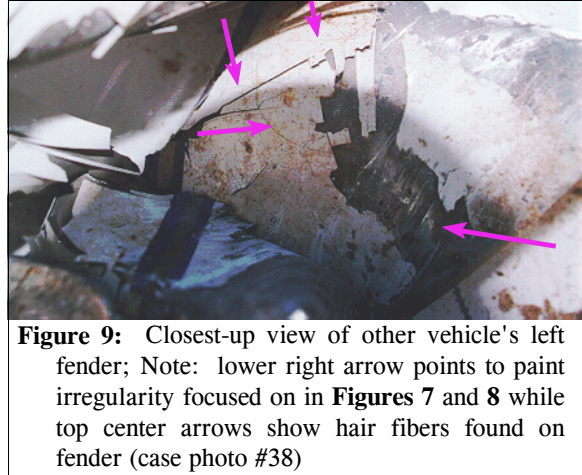
Figure 9: Closest-up view of other vehicle's left fender; Note: lower right arrow points to paint irregularity focused on in **Figures 7** and **8** while top center arrows show hair fibers found on fender (case photo #38)
