# Case Report

CASE # 2003-079-057

Vehicle one, a 1998 Ford Mustang, was traveling north in the number four lane of a six lane, physically divided, concrete, level, dry highway. Vehicle two, a 1995 Chevy Camaro, was traveling north in the number five lane of the same highway. Vehicle three, a 2003 Volvo XC90, was traveling north in the number five lane of the same highway. As vehicle one negotiated a lane change, from number five to number six, its left front plane contacted the right rear plane of vehicle three. Vehicle one spun counter clockwise then it's right rear contacted the right plane of vehicle two as vehicle two veered to the left to attempt to avoid the crash. Vehicle three, after being contacted by vehicle one on its right rear plane then spun clockwise and rolled over about six quarter turns, landing on its roof. Vehicle one was towed with moderate damage.

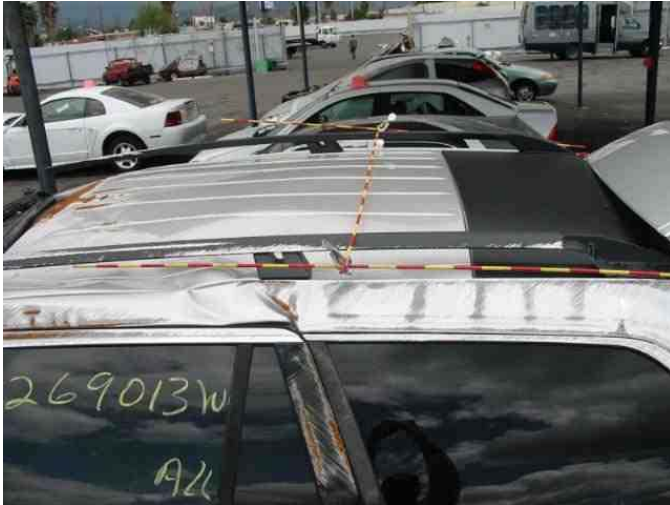
UPPER DAMAGE B PILLER AREA (ID=210206480)

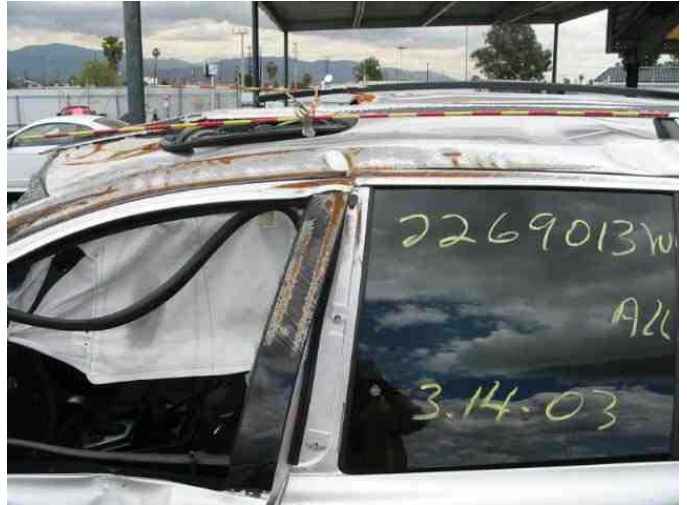
UPPER DAMAGE A TO B PILLER (ID=210206482)

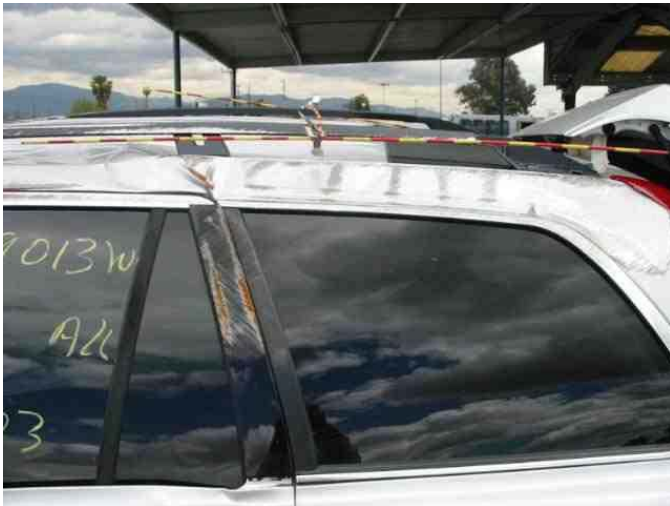
UPPER DAMAGE B TO C PILLER (ID=210206481)

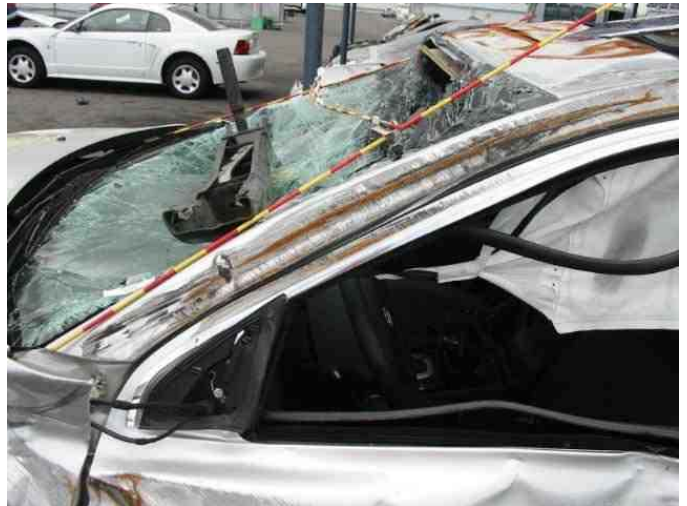
A PILLER DAMAGE (ID=210206483)

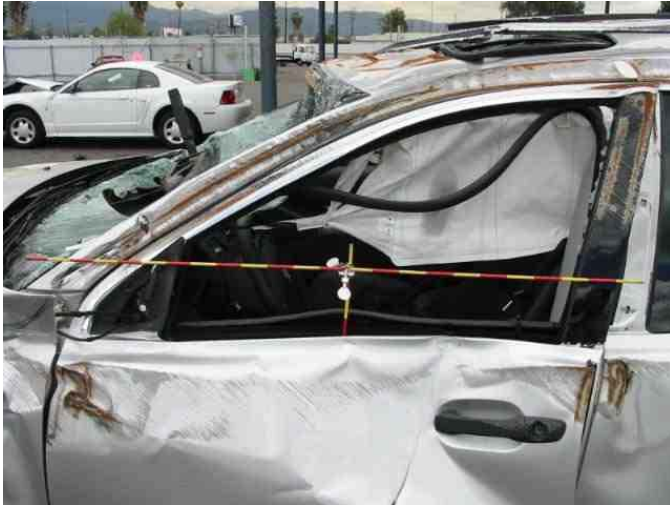
LEFT FRONT DOOR AREA DAMAGE (ID=210206492)

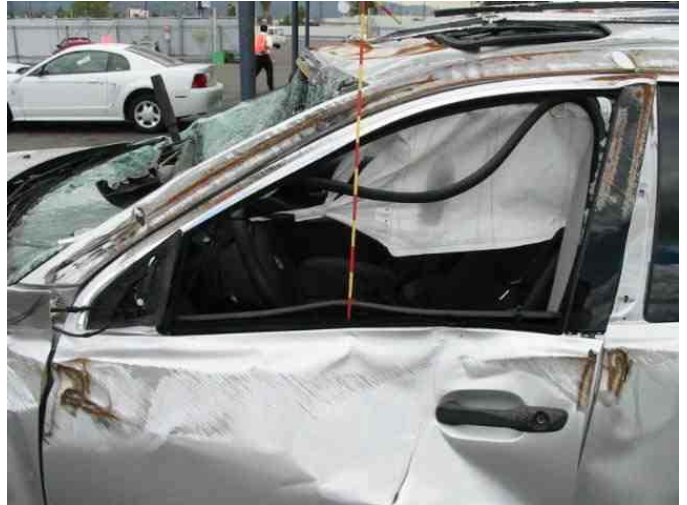
LEFT FRONT DOOR DAMAGE AREA (ID=210206494)  
MID

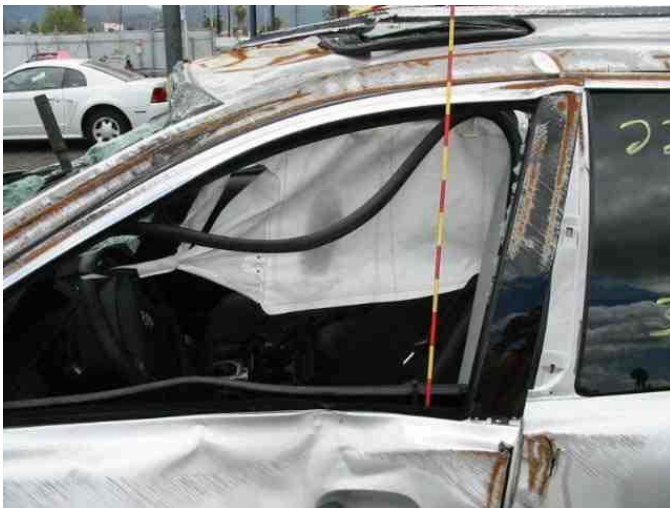
LEFT FRONT DOOR AREA DAMAGE (ID=210206493)  
REAR

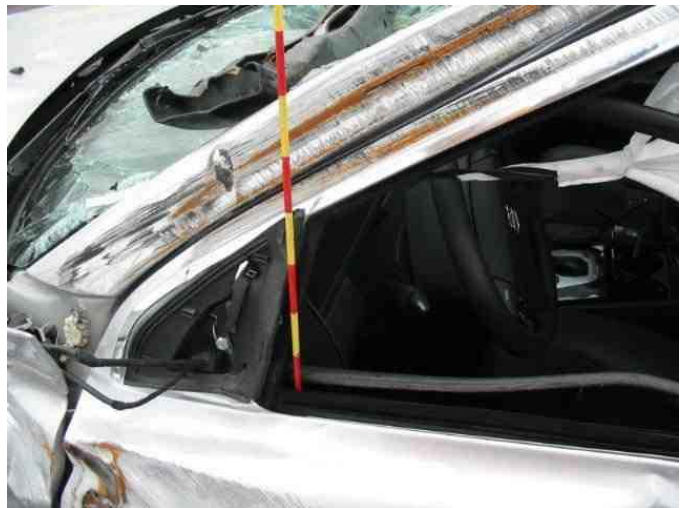
LET FRONT DOOR AREA DAMAGE (ID=210206495)  
FRONT

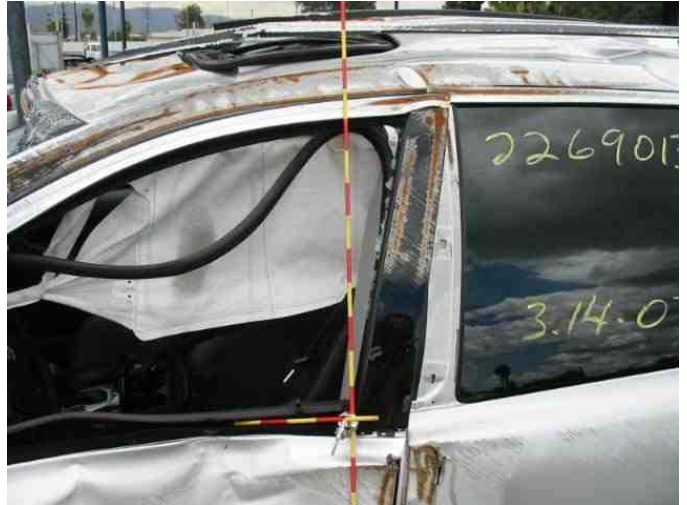
B PILLER DAMAGE

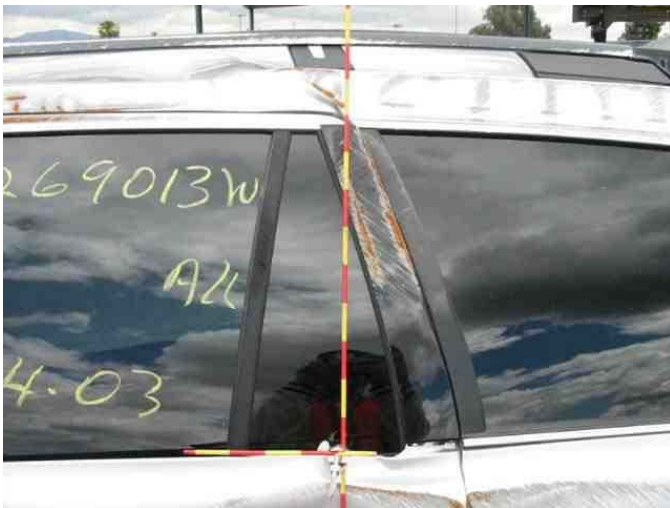
C PILLER DAMAGE

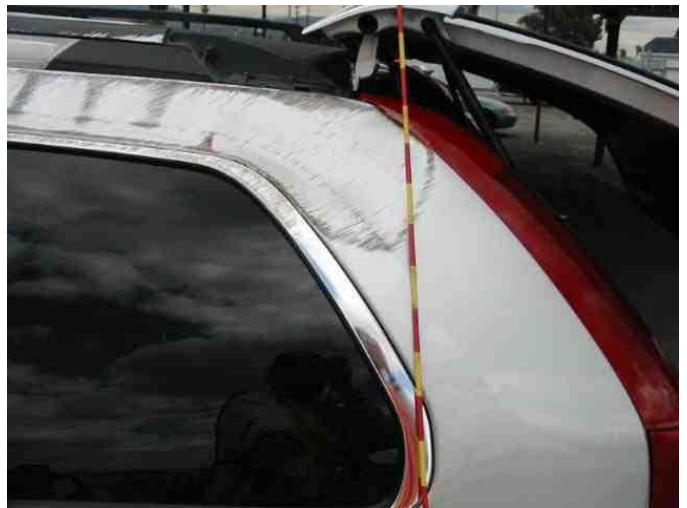
D PILLER DAMAGE

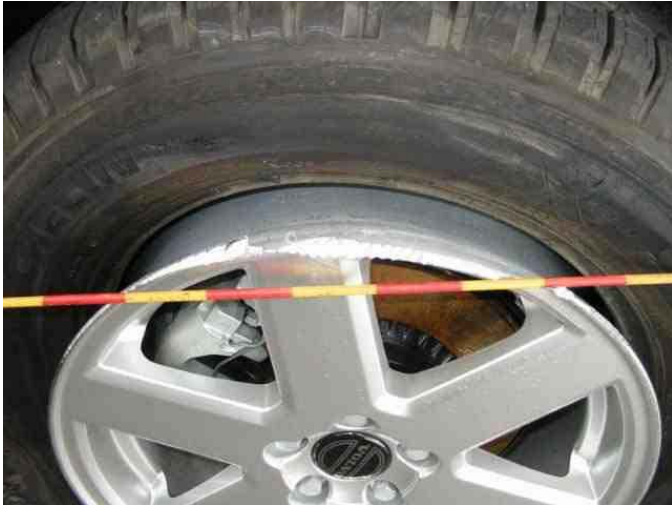
DAMAGE TO LEFT REAR WHEEL (ID=21020666)

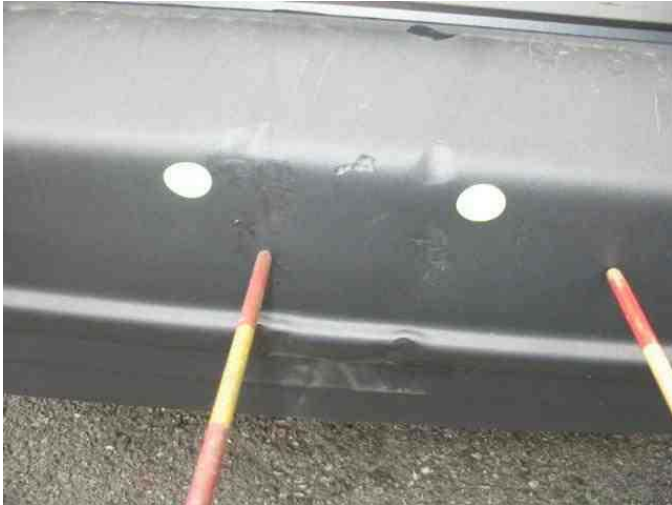
CLOSE UP OF DIRECT DAMAGE (ID=210206434)

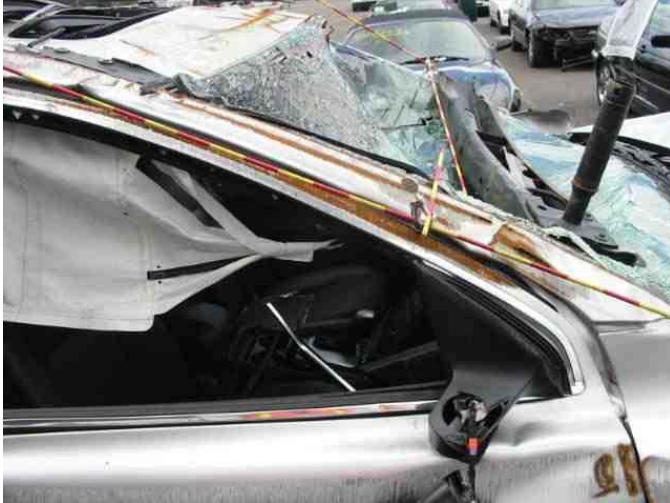
A PILLER DAMAGE

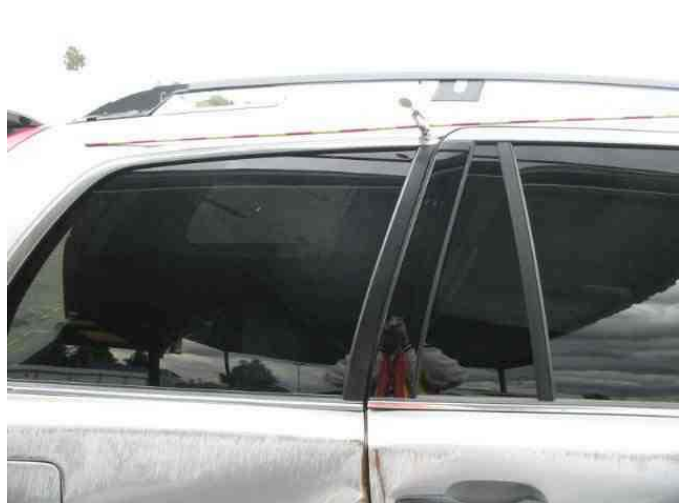
UPPER DAMAGE C TO B PILLER

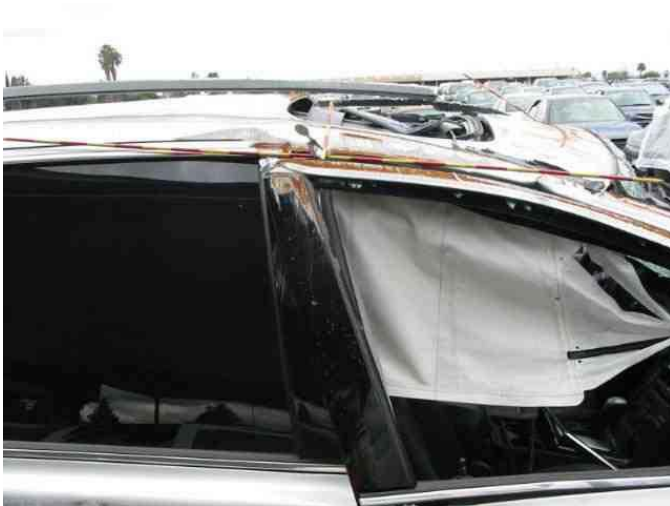
UPPER DAMAGE A TO B PILLER

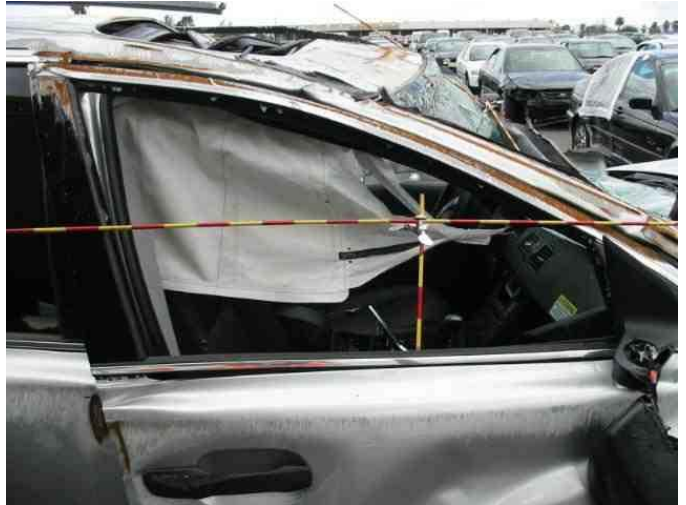
RIGHT FRONT DOOR AREA DAMAGE (ID=210206490)

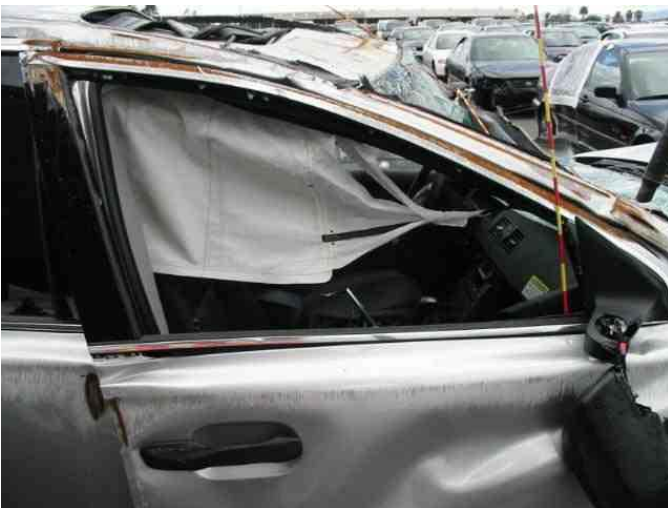
RIGHT FRONT DOOR AREA DAMAGE (ID=210206489)  
FRONT

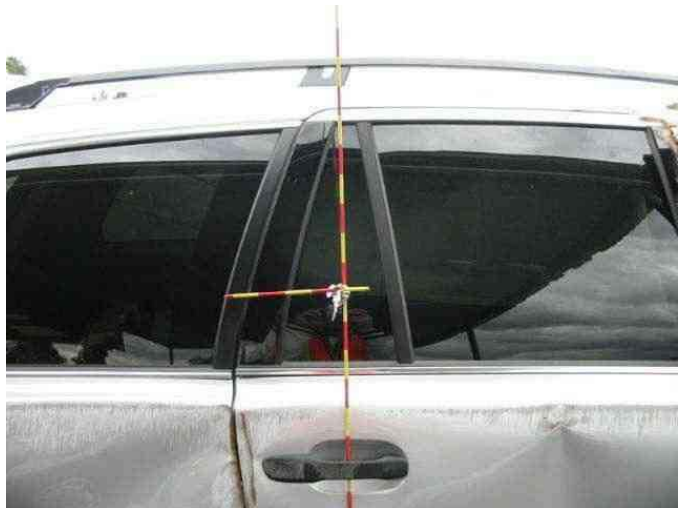
C PILLER DAMAGE (ID=210206507)

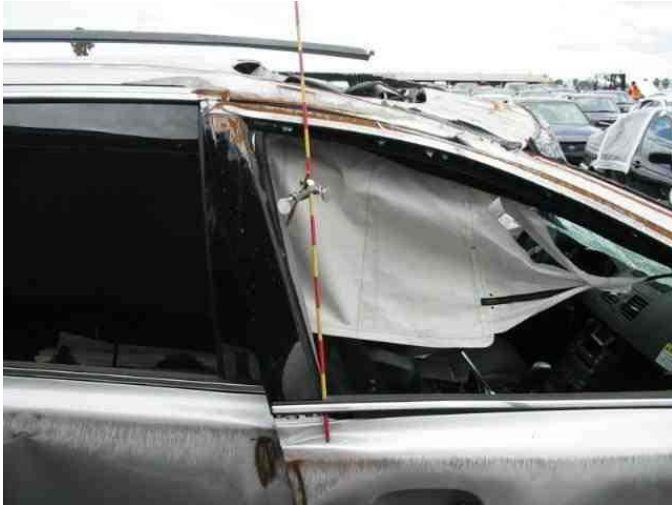
B PILLER DAMAGE

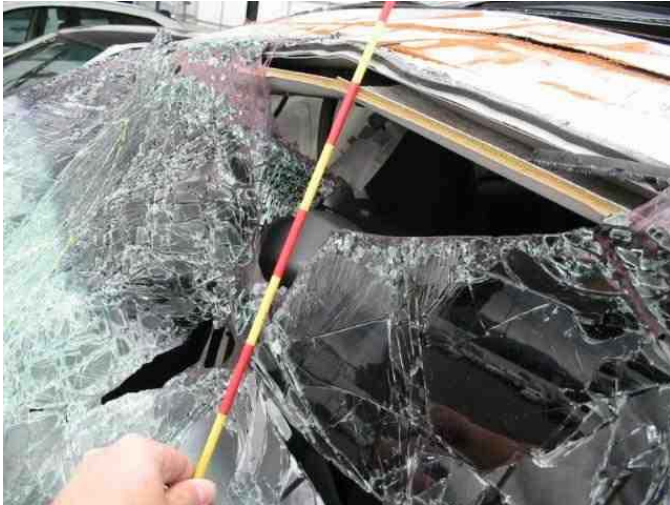
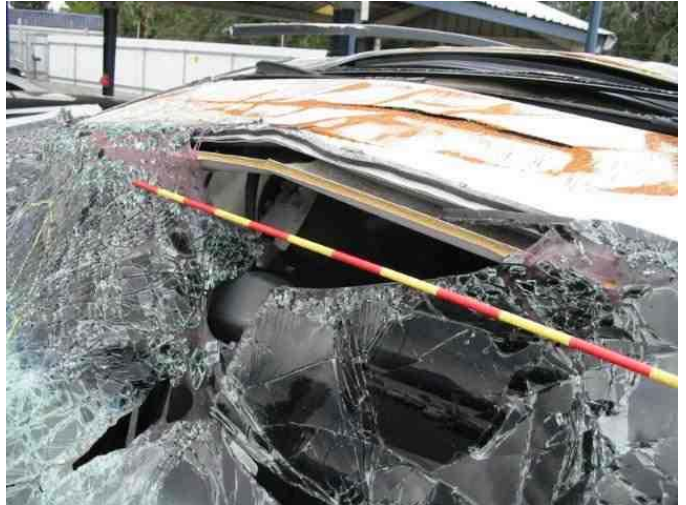
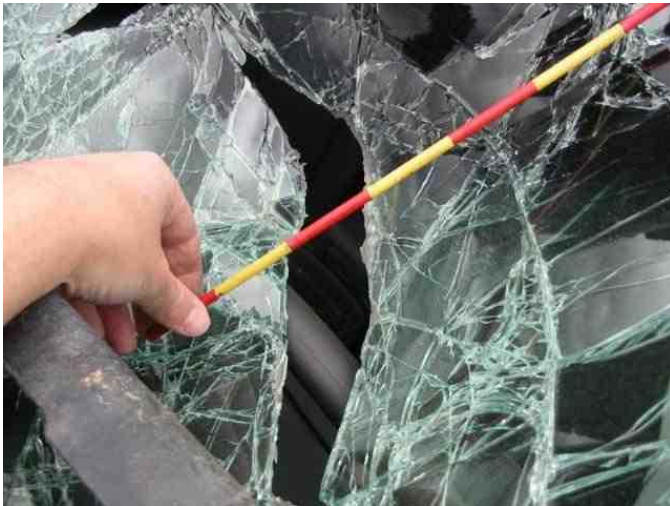
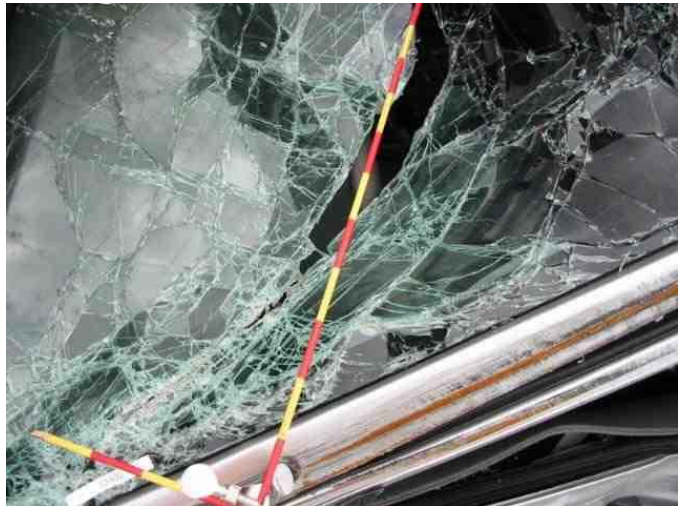
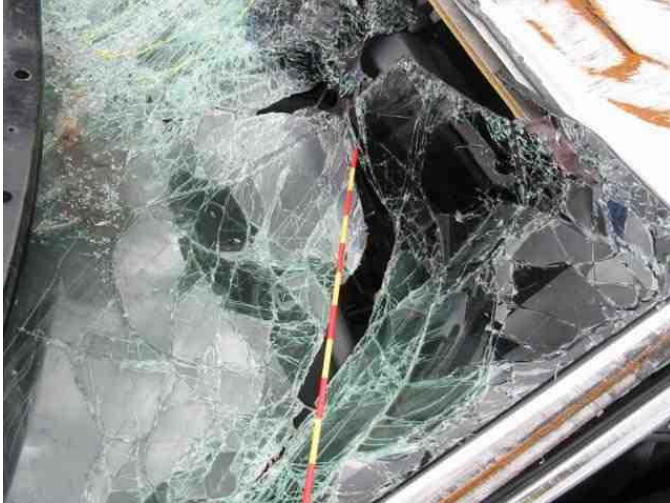
WINDSHIELD DAMAGE

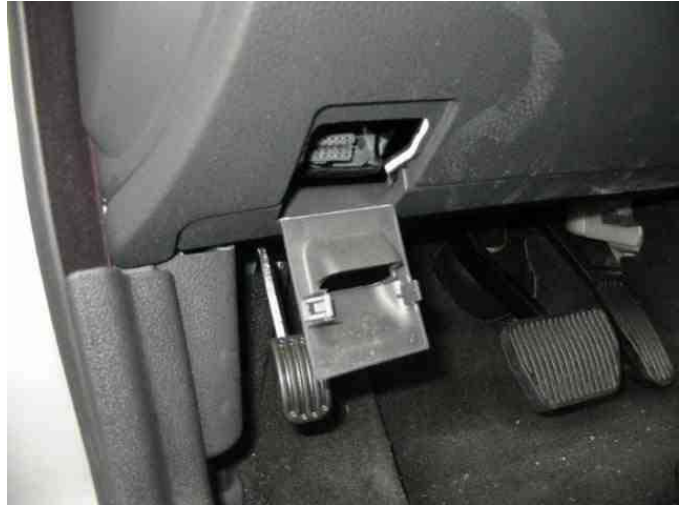
BROKEN FLAP ON LEFT LOWER KNEE BOLSTER (ID=210206640)

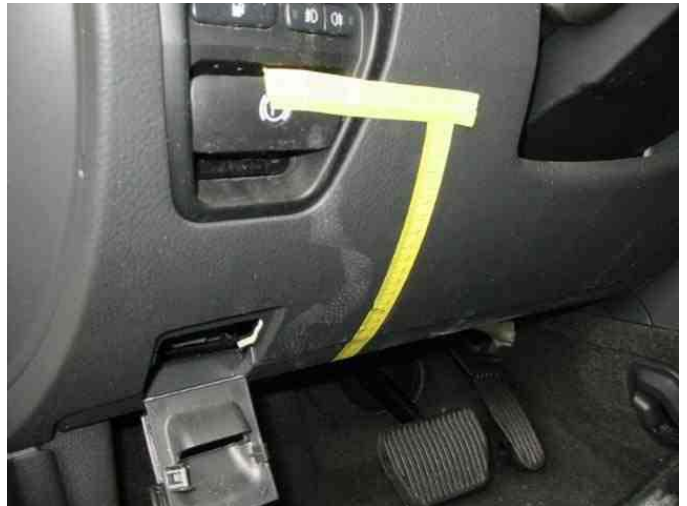
CONTACT ON DRIVERS LEFT SIDE (ID=210206641)

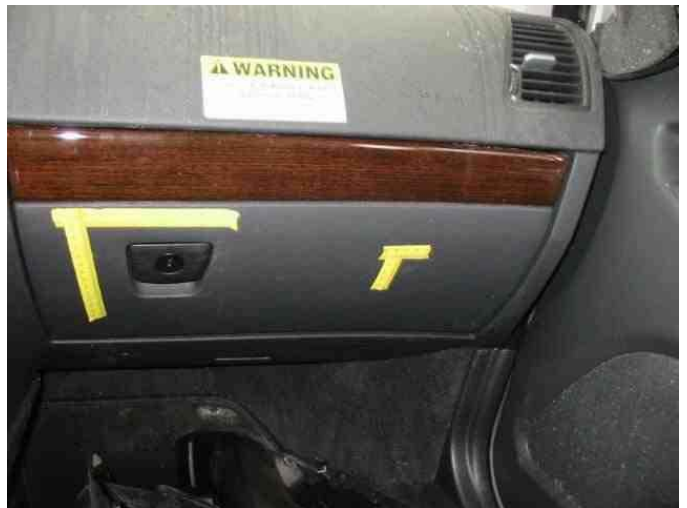
CONTACT ON PASSENGER SIDE (ID=210206653)

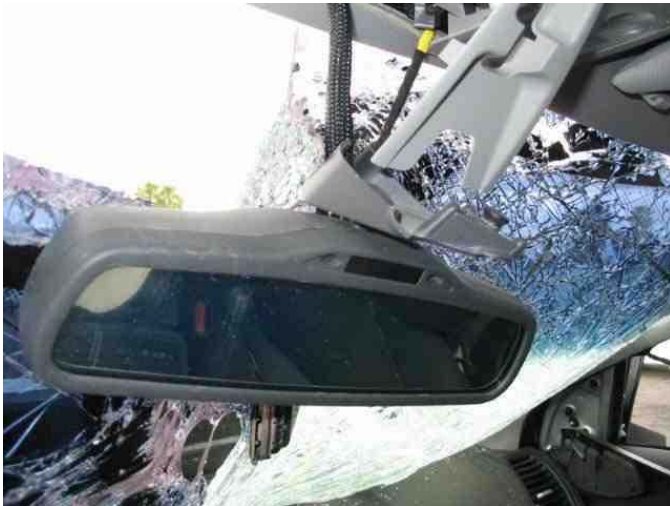
BROKEN REAR VIEW MIRROR

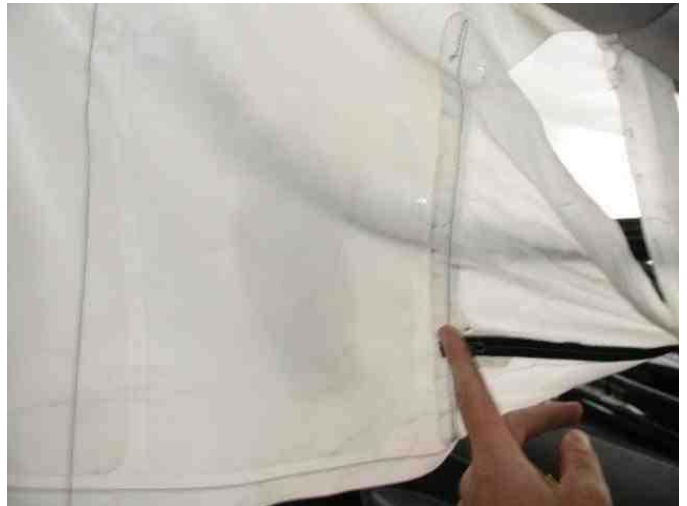
INSIDE OUT VIEW OF CONTACT ON DRIVERS CURTAIN (ID=210206655)
