DOT HS 812 836

**Special Crash Investigations
On-Site Guardrail End
Terminal Investigation
Vehicle: 2008 Ford Explorer
Location: Pennsylvania
Crash Date: November 2016**

SPECIAL CRASH INVESTIGATIONS
ON-SITE GUARDRAIL END TERMINAL IMPACT INVESTIGATION
CASE NO.: CR16030
VEHICLE: 2008 FORD EXPLORER
LOCATION: PENNSYLVANIA
CRASH DATE: NOVEMBER 2016

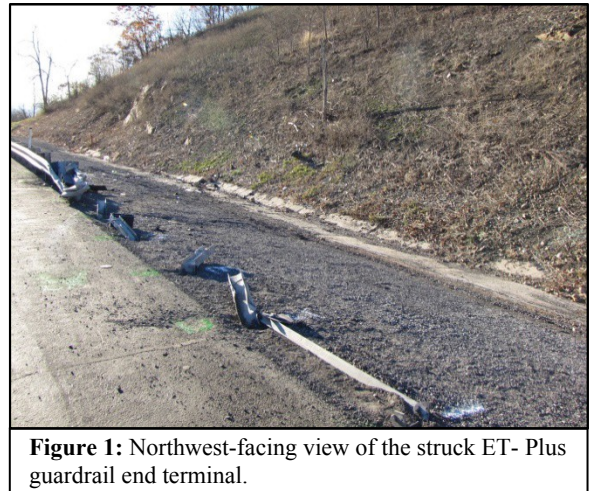
This report documents the on-site investigation of the crash of a 2008 Ford Explorer into a 4-inch ET-Plus guardrail end terminal (**Figure 1**). The Ford was traveling west on a limited-access roadway when it departed the right side of the road and struck the guardrail end treatment. The ET-Plus end terminal was displaced along a portion of the guardrail and deformed the W-beam. Following engagement with the guardrail system, the Ford climbed over the W-beam and rolled over, coming to rest on its left plane. The Ford was driven by an unbelted 55-year-old male, who reported to the police that he had fallen asleep. The police investigation determined the driver was intoxicated.

Figure 1: Northwest-facing view of the struck ET- Plus guardrail end terminal.

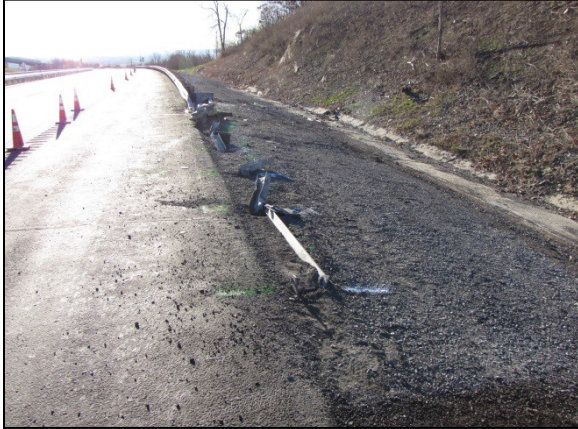
The front right corner of the Ford struck the end terminal located at Post 1 (Event 1, **Figure 3**). The force of the impact resulted in the deployment of the driver's air bag. The right bias of the crash force caused the Ford to rotate clockwise as the vehicle crushed and displaced the end terminal to the west, extruding the W-beam. After the displaced end terminal detached the W-beam from Post 3, the exposed right end of the bumper reinforcement bar engaged the left side of the end terminal and was drawn into the feeder chute. The interference between the W-beam and reinforcement bar in the feeder chute choked the displacement of the end terminal (**Figure 4**).

Figure 3: West-facing trajectory view for the Ford at the point of impact (Event 1).

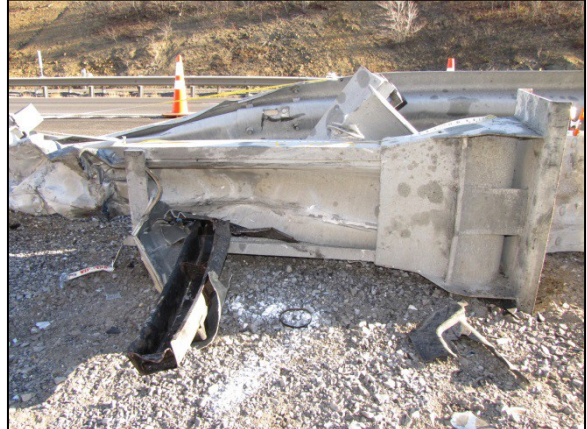
Figure 4: South-facing image depicting the choked end terminal and the bumper reinforcement beam.

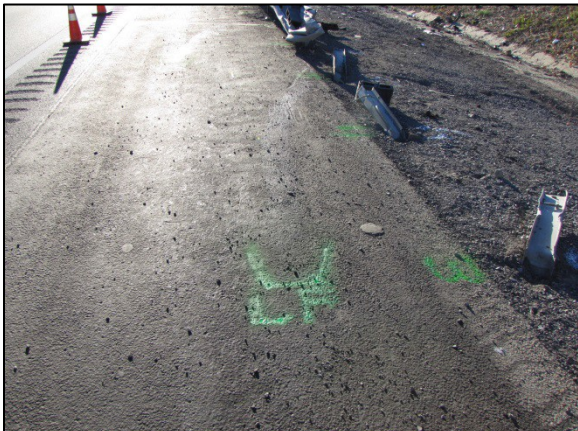
Figure 5: West-facing image depicting the arcing left front tire marks.

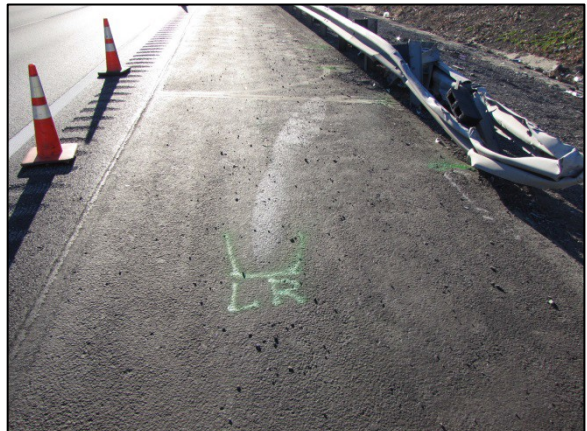
Figure 6: West-facing image depicting the left rear tire mark and deformed W-beam.

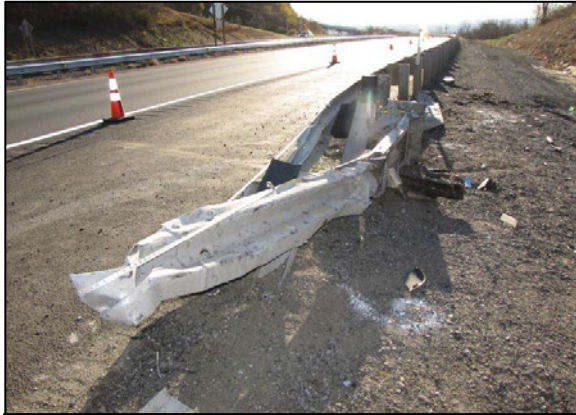
The momentum of the vehicle accelerated the combined mass of the end terminal and the extruded rail, which projected (whipped) the end terminal to the northwest and deformed the W-beam into a U-shaped pattern between Posts 5 and 6 (**Figure 7**). Absent the bumper reinforcement bar, the lower radiator support and engine cradle became exposed and struck the guardrail posts at locations 4 and 5 during the vehicle's displacement, which was evidenced by the U-shaped deformation pattern observed at the vehicle inspection.

Figure 7: West-facing image depicting the U-shaped deformation of the W-beam between Posts 5 and 6.

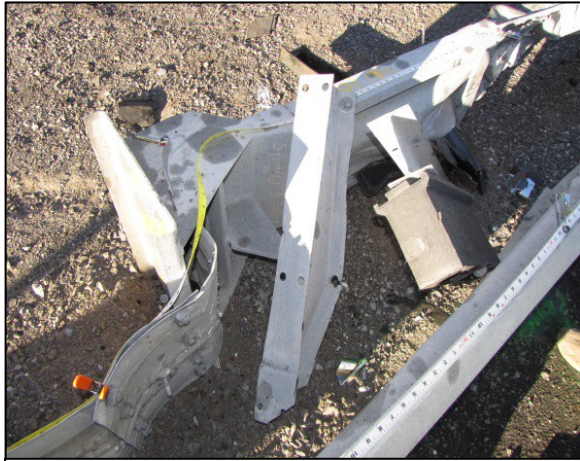
Inspection of the installation determined that the crash resulted in an approximate overall damage length of 12.8 m (42.0 ft) that extended to the area of Post 8. The HBA-designed Post 1 separated from its foundation on impact; however, the hanger bolt between the end terminal and the post did not shear. Post 1 remained attached to the end terminal during the crash sequence. The SYT-designed Post 2 was deformed 80 degrees to the west, bent at ground level, and sheared at the weakening holes. The ground strut between Posts 1 and 2 remained in place. SYT-designed Posts 3, 4, and 5 were deformed approximately 80 to 90 degrees along the vehicle's trajectory at the ground-level weakening holes.

Figure 10 depicts Post 1 and the ET-Plus end terminal at the time of the SCI inspection. **Figure 11** depicts deformed Posts 3 and 4. Composite block-outs and carriage bolts were used at each post. The carriage bolts pulled through and released the W-beam at these locations, with displacement of the block-outs.

Figure 10: Northeast-facing image of Post 1, which remained attached to the displaced end terminal.

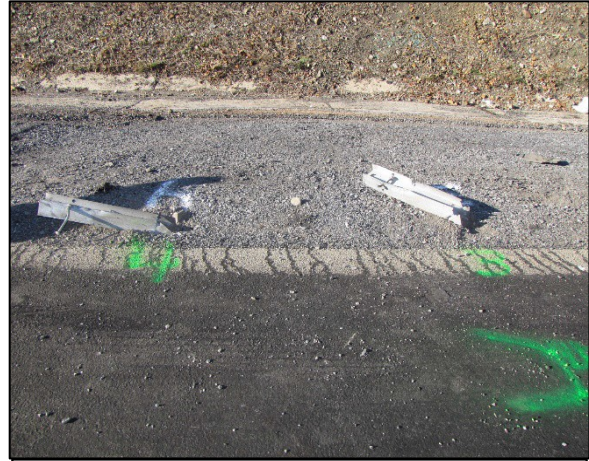
Figure 11: North-facing view of deformed Post 3 (right) and Post 4 (left).

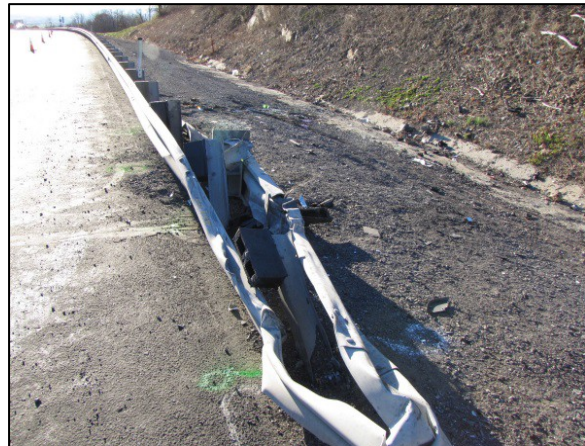
The W-beam deformed into a U-shape at the vertex between Post 5 and 6 (**Figure 12**). Post 6 was deformed approximately 60 degrees to the west, and bent at ground level. Post 7 was deflected approximately 30 degrees. The carriage bolts at both posts pulled through and separated from the W-beam and the composite block-outs remained attached. The carriage bolt at Post 8 had only partially pulled through the W-beam. The deflection at this post was approximately 10 degrees to the west. There was no damage to Post 9 and beyond. The height of the W-beam at an undamaged location between Posts 10 and 11 measured 72 cm (28.5 in).

Figure 12: Northwest-facing view depicting the U-shaped deformed W-beam guardrail.

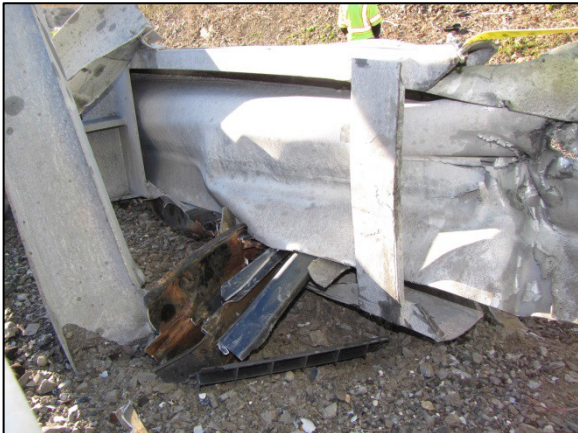
As the end terminal slid along the W-beam, the reinforcement beam was pulled laterally into the feeder chute approximately 36 cm (14 in) (**Figure 13**). The right lateral force (with respect to the vehicle) deformed the left frame rail of the Ford and separated the reinforcement beam from the vehicle. The reinforcement beam's structure crushed and rotated approximately 90 degrees in the feeder chute. The interference created by the presence of the reinforcement beam against the W-beam and feeder chute (**Figure 14**) choked its displacement. In total, 4.3 m (14 ft) of W-beam was extruded.

Figure 13: Northwest-facing image depicting the right (field) side of the end terminal and the end of the reinforcement bar in the feeder chute.

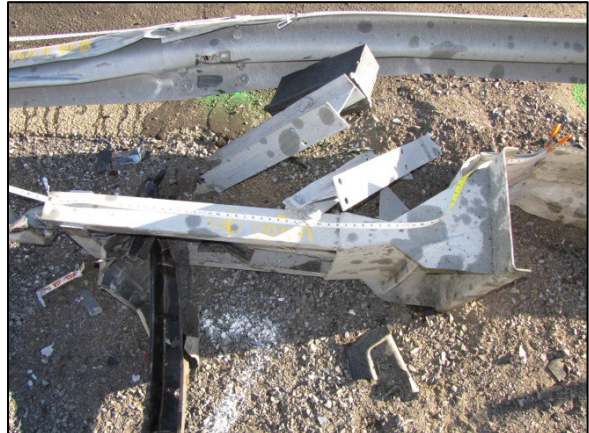
Figure 14: Overhead view depicting the bumper reinforcement bar in the displaced end terminal.

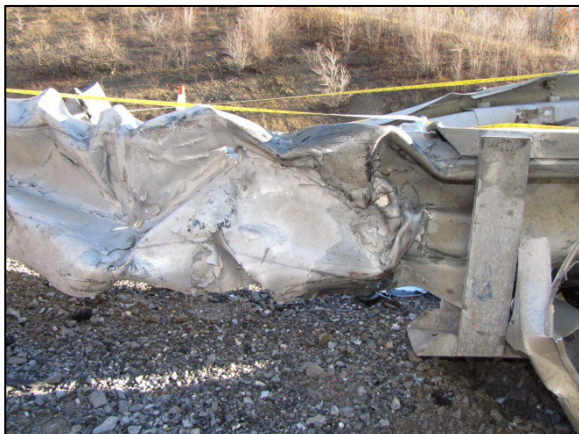
With the end terminal choked, the longitudinal force of the impact transferred to the W-beam. This sudden loading of the W-beam was evidenced by a 0.7 m (2.3 ft) buckled section of the beam located immediately downstream of the end terminal (**Figure 15**). Through the U-shaped bending of the W-beam, the end terminal came to rest on the north side of the guardrail adjacent to Post 7. The extruded W-beam extended beyond Post 9. Inspection of the W-beam revealed that the initial 2.1 m (7 ft) of the extrusion was abraded, flattened and folded onto itself (**Figure 16**). It was determined that this section of the extruded W-beam was struck and flattened by the left plane of the Ford after the vehicle had climbed the guardrail and overturned.

Figure 15: South-facing image of the buckled W-beam downstream of the end terminal.

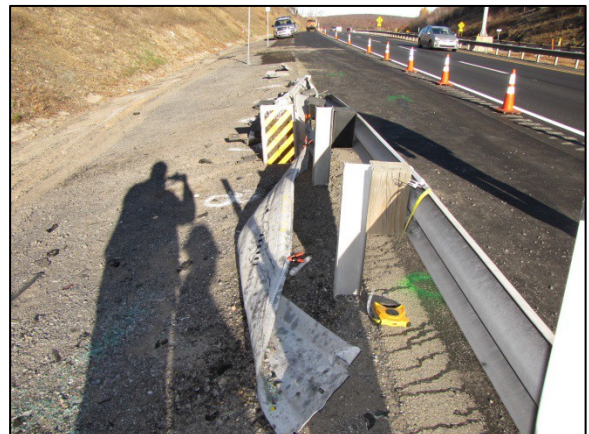
Figure 16: East-facing image of the extruded W-beam flattened by the Ford as it struck the ground near its final rest position.

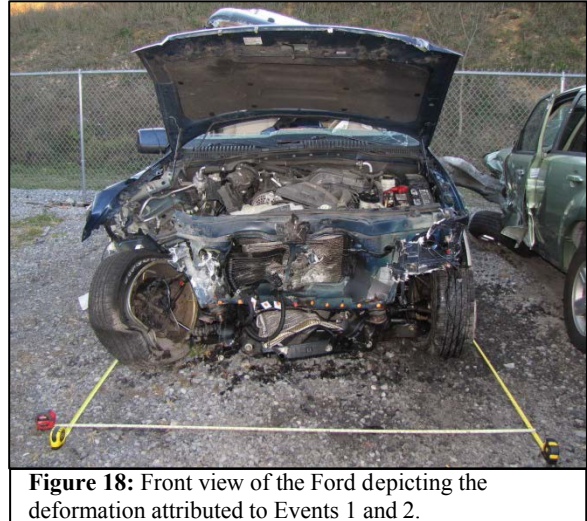
The Ford exhibited damage to its front and left planes consistent with the events of the crash sequence. The front plane/right aspect of the Ford struck the end terminal (**Figure 18**). Through inspection, it was determined that the right frame rail was not damaged or compressed. The force of the Event 1 impact was located to the right of the bumper reinforcement bar and the right frame rail. Due to the overlapping damage as a result of the engagement with multiple components of the guardrail system, the direct contact damage resultant to the end terminal impact could only be estimated. The direct contact attributed to the end terminal impact (Event 1) began an estimated 56 cm (22 in) right of center and extended 23 cm (9 in) to the front right corner. The force of the impact deformed the (relatively) soft structures of the corner and the end terminal engaged the right front wheel assembly. The suspension fractured and the right front wheel rim collapsed. The right bias of the impact caused the Ford to initiate a clockwise rotation. The Collision Deformation Classification (CDC) assigned to the damage pattern was 12FREE3. An analysis of the corner impact configuration was beyond the scope of the WinSMASH program. The EDR-reported maximum longitudinal delta-V was -26.52 km/h (-16.48 mph) at 238 milliseconds.

The right end of the reinforcement bar engaged the left side of the end terminal and a 36 cm (14 in) length of the structure was drawn into the feeder chute. The overall length of the reinforcement bar measured 102 cm (40 in). The interference caused by the reinforcement choked the displacement of the end terminal. The vehicle's continued displacement imparted a lateral force to the left frame through the jammed reinforcement bar. This lateral force deformed the left frame an estimated 25 cm (10 in) to the right and the reinforcement bar was torn from its attachment to the frame.

With the reinforcement beam separated from the frame, the width of the front plane engaged the face of the W-beam and the exposed structure of the lower radiator support struck the guardrail posts (Event 2). The residual crush profile documented along the lower radiator support [Field L = 73 cm (28.7 in)] was as follows: C1 = 0, C2 = 8 cm (3.1 in), C3 = 23 cm (9.1 in), C4 = 14 cm (5.5 in), C5 = 10 cm (3.9 in), C6 = 0. Maximum crush was 28 cm (11.0 in), located on the vehicle's centerline. The CDC assigned as representation of the vehicle's engagement with these guardrail components was 12FDEW2. Due to the overlapping damage, a WinSMASH analysis was not conducted.

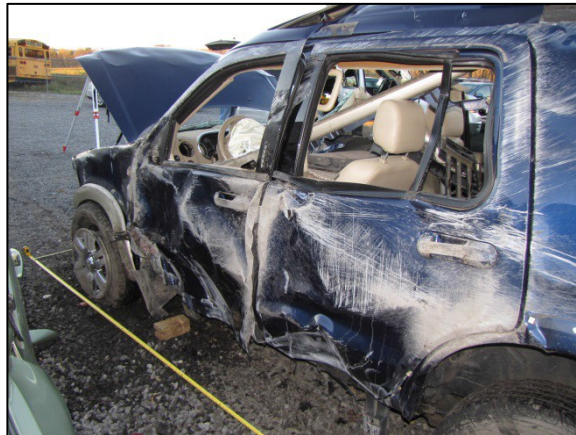
The Ford climbed the guardrail and overturned one quarter-turn to its left (Event 3). The left plane exhibited multiple scratch marks, abrasions and body deformation due to impact with the extruded W-beam and the ground (**Figure 19**). The scratches were oriented in multiple directions indicative of the vehicle's rotation about the vertical axis as it slid to final rest. There was no lateral displacement or vertical crush of the occupant compartment structure. Additionally, the vehicle was dragged along the roadside during its recovery, which contributed to the left plane damage. All the left side glazing and the backlight were disintegrated. The CDC attributed to the rollover damage was 00LDAO3.

Figure 19: Oblique view of the damage to the Ford's left plane.

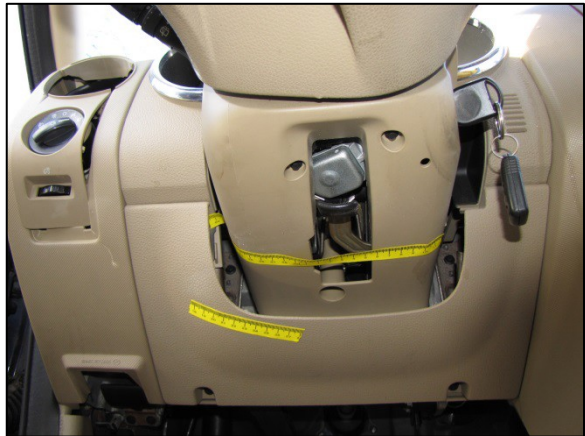
Figure 21: Interior image of the Ford depicting the driver contact to the left instrument panel and knee bolster.

The unbelted driver responded to the crash force with a forward trajectory. His knees contacted the knee bolster and the lower/mid left instrument panel (**Figure 21**). His right knee contact was evidenced by fabric transfers at the protrusion of the bolster for the steering column. The left knee scuffed and fractured the polymer panel left of the bolster at the location of the headlight switch. The switch panel was displaced forward. Located directly above the left knee contact was a HVAC vent louver. This louver was displaced from its mount from a probable left hand/arm contact. A scuff mark was present on the lower aspect of the upper left A-pillar trim panel. Blood was present on the forward aspect of the left front door panel.

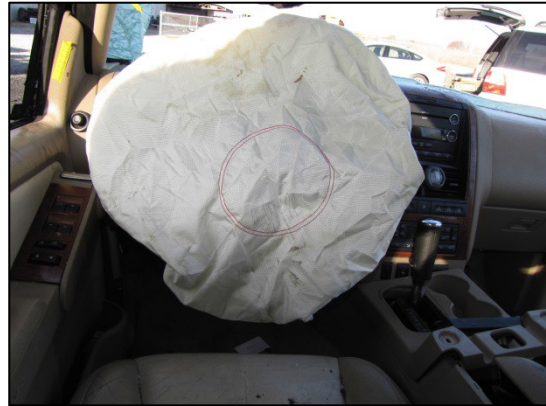
The driver's air bag (**Figure 22**) deployed at impact with the end terminal (Event 1). Stage 1 deployment was commanded at 32 milliseconds, with stage 2 commanded at 42 milliseconds. Blood evidence and post-crash dirt was present in the 12 o'clock sector of the air bag. The front row right occupant position was unoccupied; therefore the front air bag for this position was suppressed. The seat belts were not buckled; therefore, the ACM did not command actuation of the buckle and retractor pretensioners.

Figure 22: Image depicting the deployed drive air bag in the Ford.
