National Transportation Safety Board

Highway Accident Brief

Accident Number: HWY-04-MH-012
Accident Type: Tanker truck overturn and fire
Location: Interstate 895 southbound, near Elkridge, Maryland
Date and Time: January 13, 2004; 2:45 p.m.
Vehicles: 2003 Freightliner tractor cargo tank semitrailer combination unit
2003 Freightliner tractor dry van semitrailer combination unit
1999 International tractor flatbed semitrailer combination unit
1998 Ford Crown Victoria sedan
1987 Chevrolet pickup truck
Owners/Operators: Petro-Chemical Transport, Inc.
Swift Transportation
PGT Trucking, Inc.
Private owner
Private owner
Fatalities/Injuries: 4 fatalities

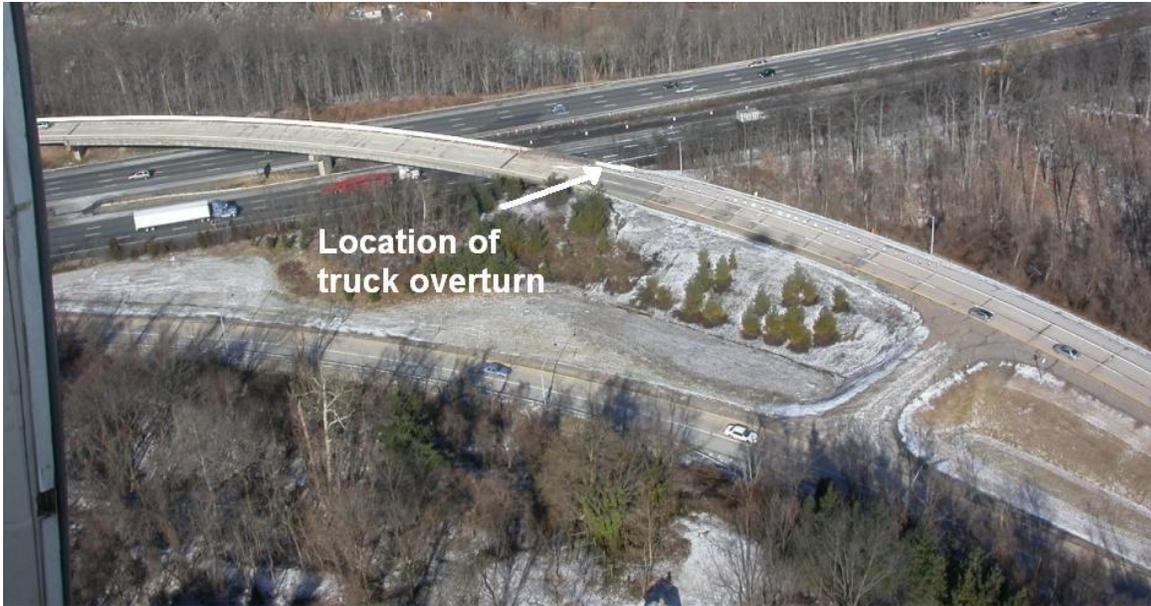
Tire scuff marks indicate that as the tanker approached an overpass (bridge) to Interstate 95 (I-95), it departed from the right traffic lane and went onto the adjacent shoulder.² (See figures 1 and 2.) Scrape and gouge marks on the pavement, roadside barrier, and bridge rail further indicate that as the vehicle traveled along the shoulder, it collided with and mounted these roadside barriers before falling 30 feet over the bridge rail and onto the northbound traffic lanes and median of I-95. The vehicle's speed prior to the accident most likely did not exceed 49 mph based on physical evidence and postaccident tests.

Figure 1. Aerial view of I-895 overpass, showing the accident location. (Courtesy of Maryland Transportation Authority Police Department)

The accident occurred on the left-hand horizontal curve of an elevated direct connection ramp between I-895 and I-95. The ramp was designed to allow southbound traffic on I-895 to access the southbound lanes of I-95 by first passing over both the north- and southbound lanes of I-95 via a bridge. The horizontal curve had a radius of about 954 feet and began approximately 740 feet before the overpass. (See figure 1.) The curve ended approximately 402 feet beyond the overpass.

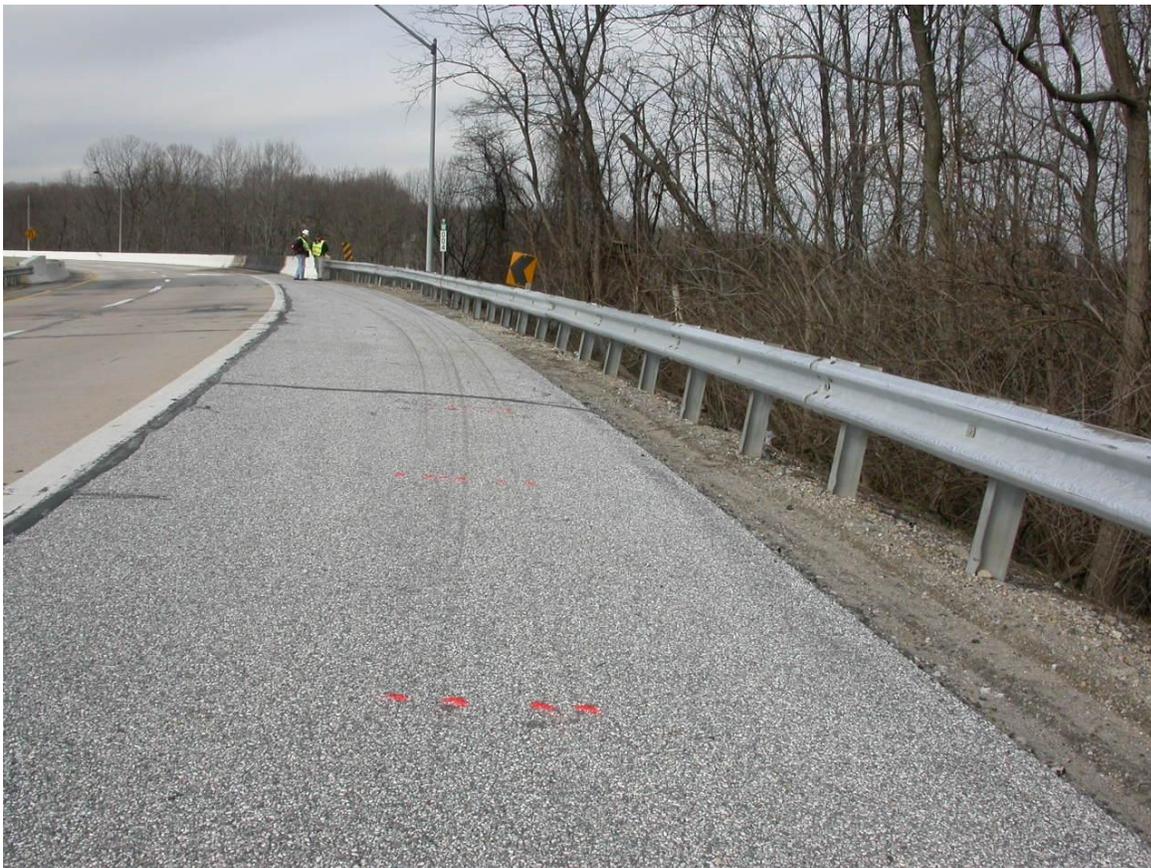
² Scuff marks are caused by tires that are simultaneously rotating while sideslipping. These marks began as thin, heavy lines and progressively increased in width. The darkest portions of the scuff marks were along the outside of the arc created as the vehicle moved from right to left. The marks indicate that the vehicle's brakes were not locked; the driver probably had been attempting to steer back into the travel lanes.

Figure 2. View of tire scuff marks leading to the overpass.

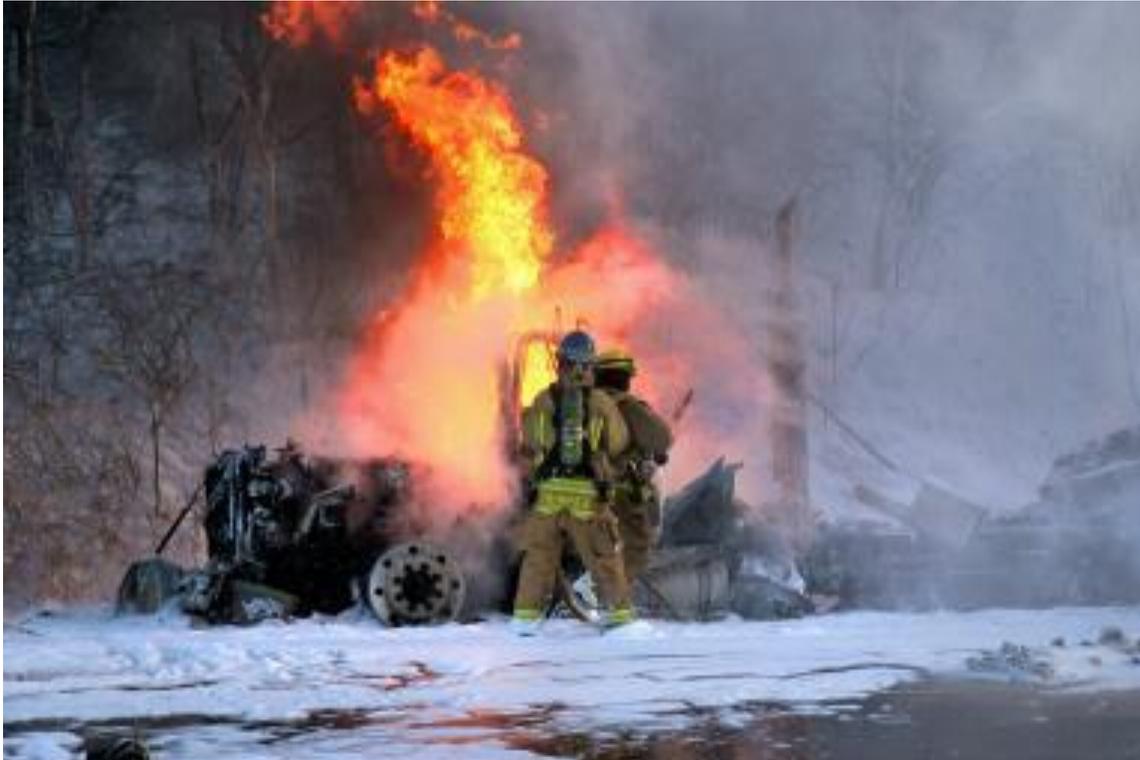
An explosion and large fire ensued, and four vehicles traveling northbound on I-95 drove into the fire. After firefighters had extinguished the fire (see figure 3), they found five vehicles at final rest positions within the burned area of I-95: the accident tanker, a 2003 Freightliner tractor dry van semitrailer combination unit, a 1999 International tractor flatbed semitrailer combination unit, a 1998 Ford Crown Victoria sedan, and a 1987 Chevrolet pickup truck.

Figure 3. Firefighters responding to the fire caused by the accident. (Courtesy of Maryland Transportation Authority Police Department)

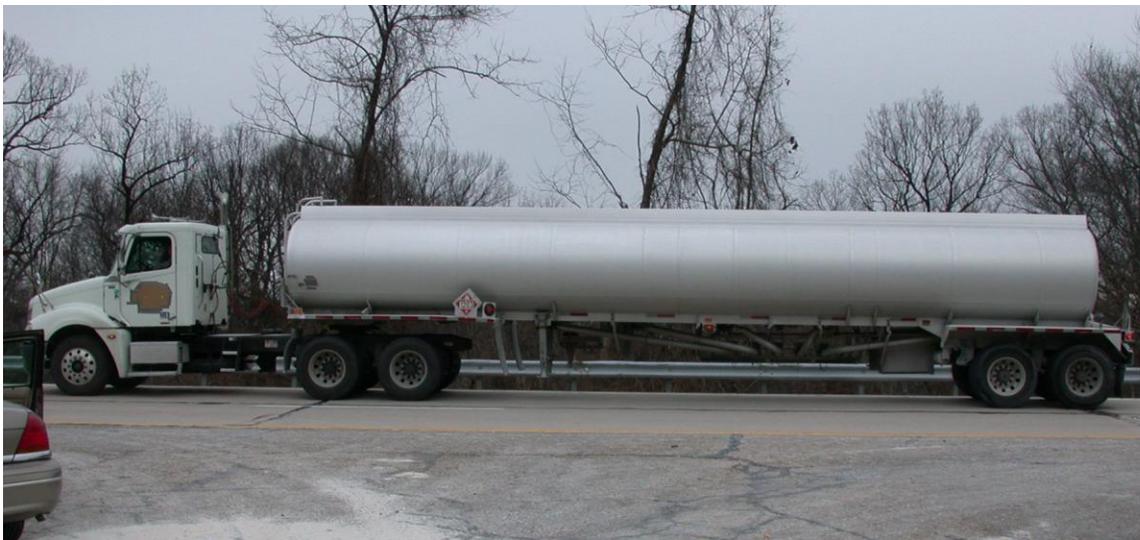
The tractor-semitrailer consisted of a 2003 Freightliner conventional "day-cab" design tractor, in combination with a 2000 Heil 406 43-foot-long elliptical cargo tank semitrailer. (See figure 4.) PCT operated the tractor, which it leased from Ryder. Ryder conducted all maintenance and repair work on the leased vehicle.

During the postaccident inspection, NTSB investigators found no mechanical defects on the tractor or semitrailer that would have adversely affected the driver's ability to control the truck. The accident vehicle was equipped with an electronic control module (ECM); however, it did not survive the fire.

Figure 4. Exemplar of accident truck.

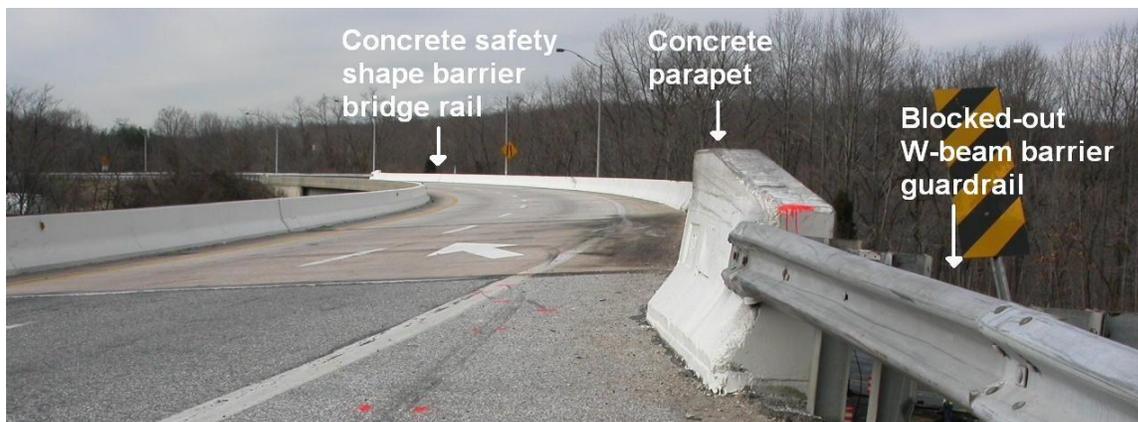
A 32-inch-high concrete safety shape barrier bridge rail was located adjacent to each shoulder along both sides of the overpass. (See figure 5.) The right shoulder had a 10-foot-long, concrete parapet at the beginning of the southbound approach to the overpass. The concrete parapet was 32 inches tall on the approach side and sloped up to a plateau height of 42 inches. It served as a transition between the W-beam barrier guardrail located along the approach roadway and the concrete bridge rail of the overpass. Both the concrete parapet and the W-beam barrier guardrail transition were flared away from the traffic lanes. This guardrail transition was an acceptable design when the overpass was constructed in 1973, but it did not conform to the design criteria in the 2002 *AASHTO Roadside Design Guide*,⁹ which state that the guardrail transition should align with the concrete bridge rail to prevent the likelihood of a vehicle's becoming snagged in the area immediately adjacent to the concrete parapet.

Figure 5. I-895 overpass barrier system.

The physical evidence indicates that the driver's efforts to regain control of his vehicle were hampered by the reduction of the right shoulder width from 10 feet to 4 feet near the overpass and by the flared layout of the parapet and W-beam guardrail transition. This reduction in shoulder width essentially forced the driver to steer abruptly back toward the travel lanes to avoid striking the guardrail or concrete parapet. As he attempted to steer back toward the travel lanes, his truck struck the flared W-beam guardrail transition and concrete parapet, which failed to redirect the truck back into the travel lanes. The orientation of the parapet allowed the truck to mount the barrier and vault over the adjoining bridge rail so that the vehicle fell onto the roadway below.

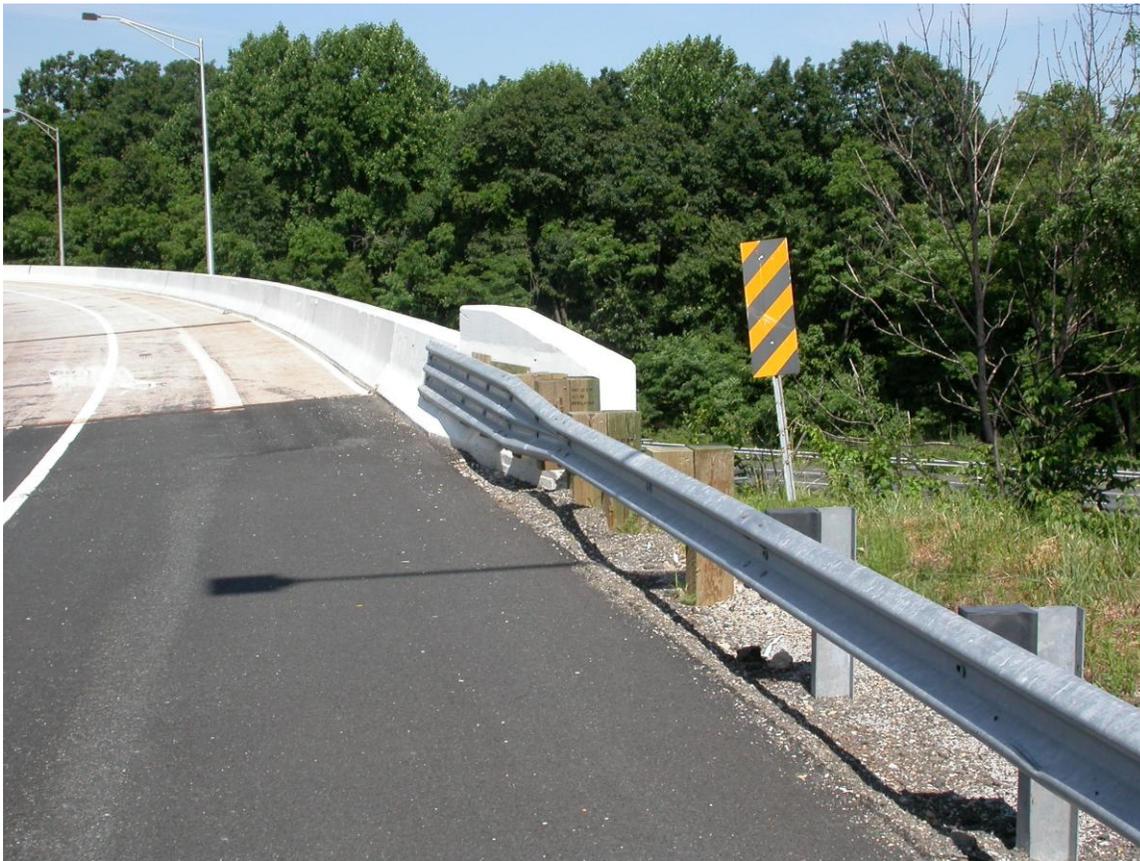
Figure 6. Postaccident modifications to the I-895 overpass barrier system.

Following the accident, the Maryland Transportation Authority (MTA) made several highway modifications at the accident location. The MTA relocated the merge point of the two southbound overpass lanes away from the horizontal curve to a tangent section of roadway about 3,168 feet before the overpass. Merging the two southbound lanes before the overpass and on the approach side of the vertical curve made this roadway comply with current AASHTO guidelines and increased the width of the right shoulder along the elevated portion of the overpass.

The MTA made additional modifications to the roadside barrier along the southbound lanes of I-895. The MTA removed the flared transition from the roadside barrier to the concrete parapet, providing a smooth and continuous transition, as recommended in the *Roadside Design Guide*.¹⁰ The MTA strengthened the roadside barrier by replacing the existing guardrail with a new strong post blocked-out W-beam barrier that has decreasing post spacing and increasing post size from the guardrail to the concrete parapet. Also, the new W-beam barrier is “nested” (one section has been placed over another to create a double thickness). (See figure 6.)
