Motorcoach Run-Off-the-Bridge and Rollover
Sherman, Texas
August 8, 2008

NTSB/HAR-09/02
PB2009-916202

Highway Accident Report

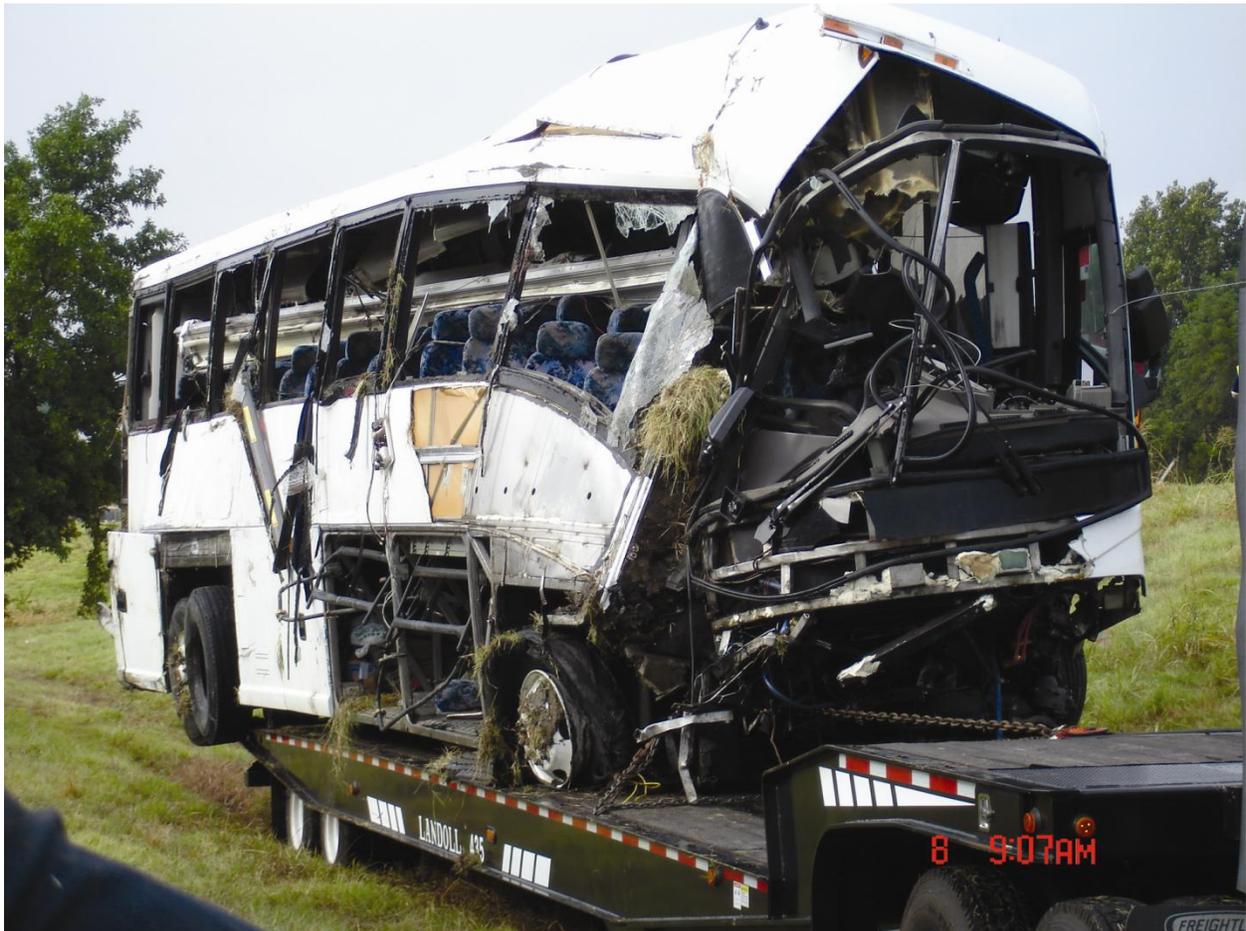
The bus sustained significant impact damage on the right front corner near the boarding door extending across the width of the front and approximately 53 inches aft from the right front corner to about the midpoint of the right steer axle wheel. (See figure 5.) The front windshield, passenger boarding door, and seven emergency window exits along the right side of the vehicle were destroyed. The roof was damaged along the front portion, especially on the right front corner. The emergency hatches were intact and functional.

Figure 5. Postaccident view of the accident motorcoach.

The sidewalls and the emergency windows on both sides of the motorcoach were vertically deformed. The window frames of the seven emergency window exits on the right side were intact; however, the safety glass was broken. The emergency windows on the left side remained intact and were functional but had not been used.

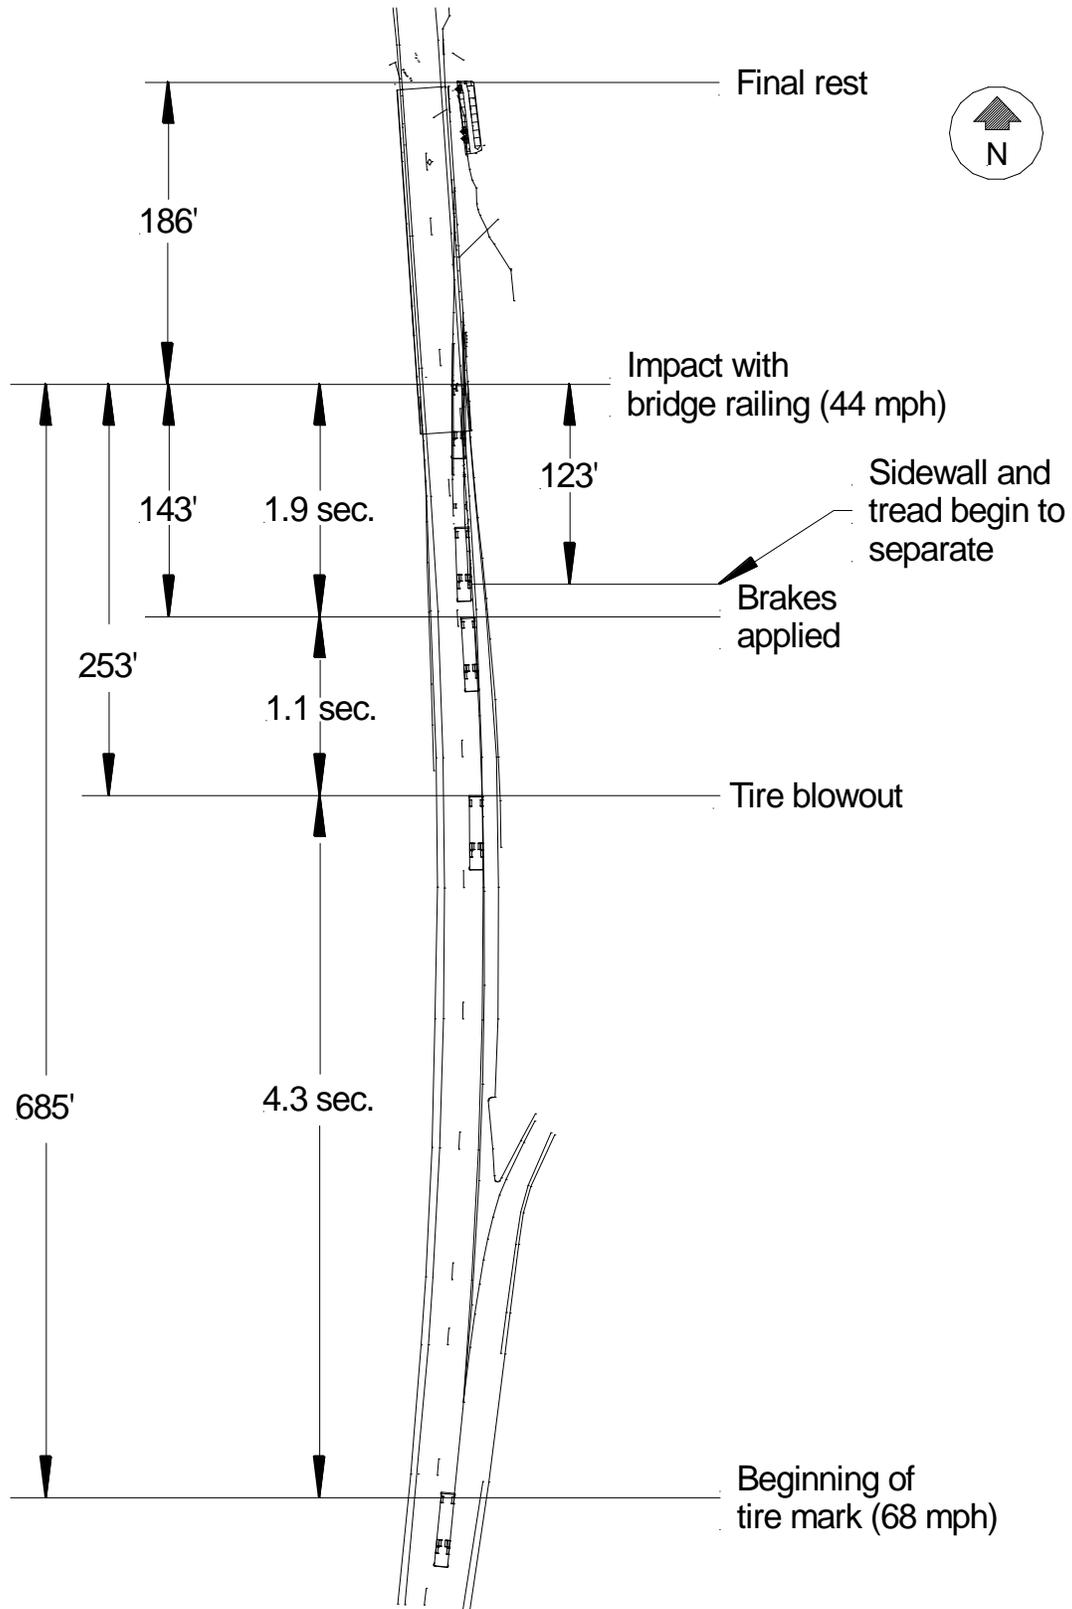
As the motorcoach traveled north toward the bridge, at a point 685 feet prior to the impact with the bridge, the motorcoach's right steer axle tire began marking and depositing tire fragments. At this time, the motorcoach was traveling about 68 mph (approximately 100 feet per second). From this point to the tire blowout, the motorcoach traveled for 4.3 seconds. Vehicle engine data indicated variation in the percent throttle in these seconds preceding the blowout.²⁶ The tire casing rupture (blowout) occurred approximately 3.0 seconds before impact with the bridge. The driver activated the brakes 1.1 seconds after the tire blowout, and the motorcoach struck the bridge railing 1.9 seconds later. Brake application reached 90 psi 0.7 second after driver input and reached maximum force about 1.0 second following driver input, when the motorcoach was traveling about 54 mph.

The motorcoach struck the bridge railing while traveling about 44 mph. The right steer wheel departed the roadway as the motorcoach rotated clockwise along its longitudinal axis, traveling approximately 35 mph. Once the motorcoach had gone through the bridge railing, traveling about 29 mph, it fell 8 feet to the earthen bridge abutment and slid 24 feet. From the point of impact with the bridge railing to final rest, the motorcoach traveled 186 feet. The sequence of events is shown in figure 7.

Figure 7. Accident reconstruction diagram.

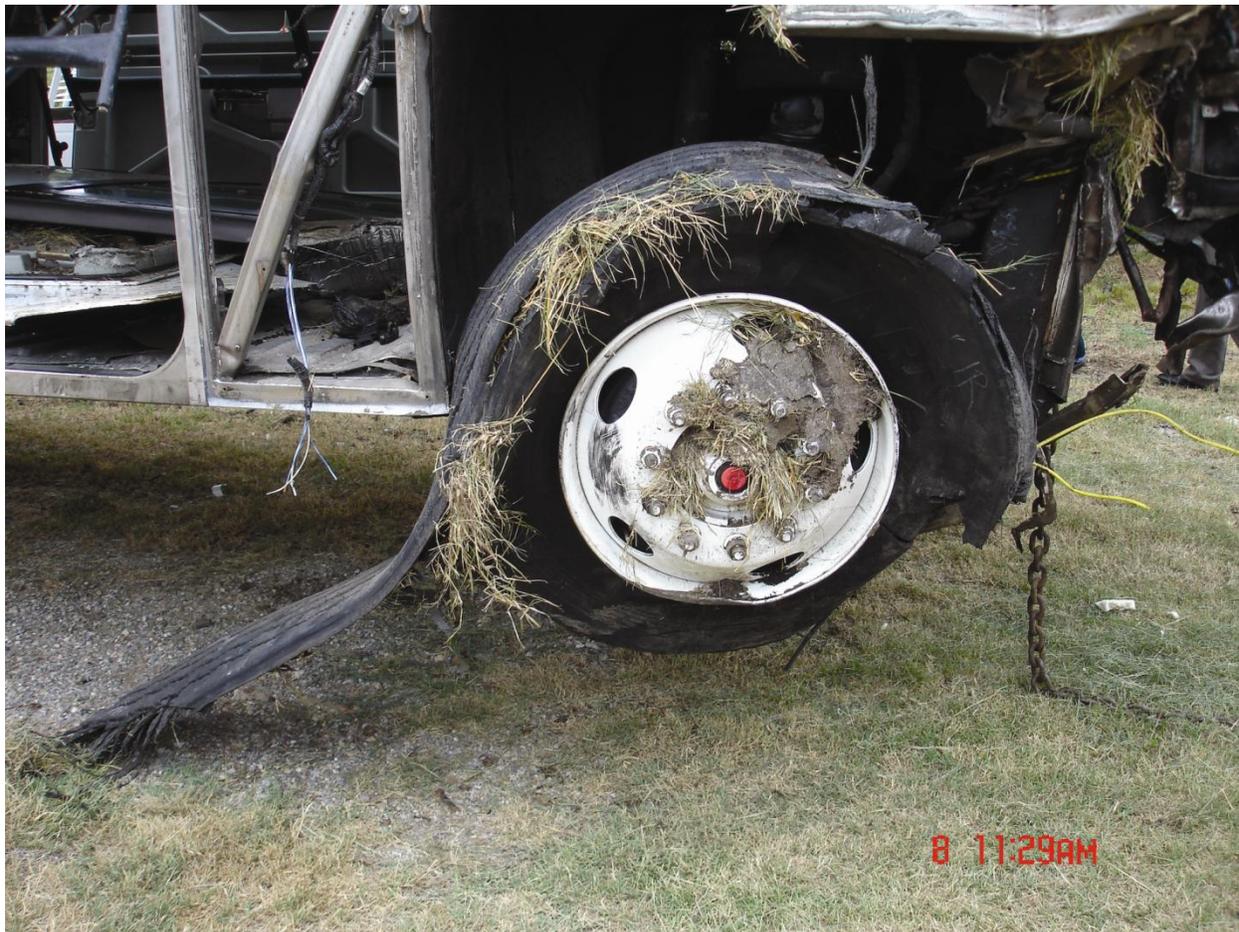
radial tire that had been retreaded with a Bandag model T4100 tread. The tire was retreaded by Henise Tire Service of Cleonea, Pennsylvania, which received the tire from MCI Sales and Service of Blackwood, New Jersey, on August 30, 2007. Henise Tire retreaded the tire and returned it to MCI Sales and Service on September 6, 2007. The accident tire is shown in figure 8.

Figure 8. Right steer axle tire of the accident motorcoach.

Inspections of Failed Tire. NTSB investigators, in conjunction with representatives of the Goodyear Tire & Rubber Company (Goodyear), examined the right steer axle tire of the accident vehicle on November 24, 2008.⁴³ They noted the following conditions:

Short term underinflation caused by the puncture/cut resulted in severe overdeflection^[44] of the tire. The stress and heat generated from the overdeflection and the forces acting on the rotating tire caused loss of adhesion between tire components, and eventual separation and detachment of tread and belt pieces.

With tread and belt detachment, the unsupported casing ruptured exhausting any remaining inflation pressure.

Damage caused by over-deflected operation. In this case, the most probable cause of over-deflection is underinflation due to an un-repaired puncture to the tire which lead [sp] to inflation pressure loss and damaging stress/strain and heat build-up...

Although it is difficult to state with precision how long the subject tire operated in an over-deflected manner, the tread/belt tear patterns and a lack of polishing of the separated surfaces indicate relatively short-term operation in such a condition, most likely for less than 1000 miles.

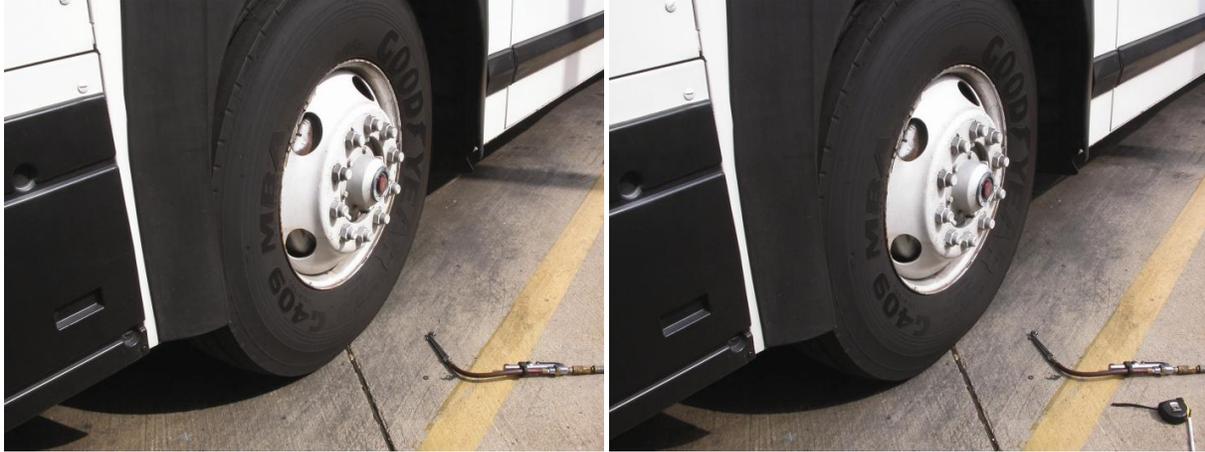
Figure 9. Photographs of a Goodyear 315/80 R22.5 tire inflated to 115 psi (left) and 60 psi (right).

The photographs illustrate the difficulty in visually detecting proper tire inflation. Visual detection of proper tire inflation on such larger vehicles may be negatively affected by the nature of commercial vehicle tire construction, which employs stronger materials, including stiffer sidewalls and harder rubber compounds, than are typically used in tires for light trucks and passenger vehicles.

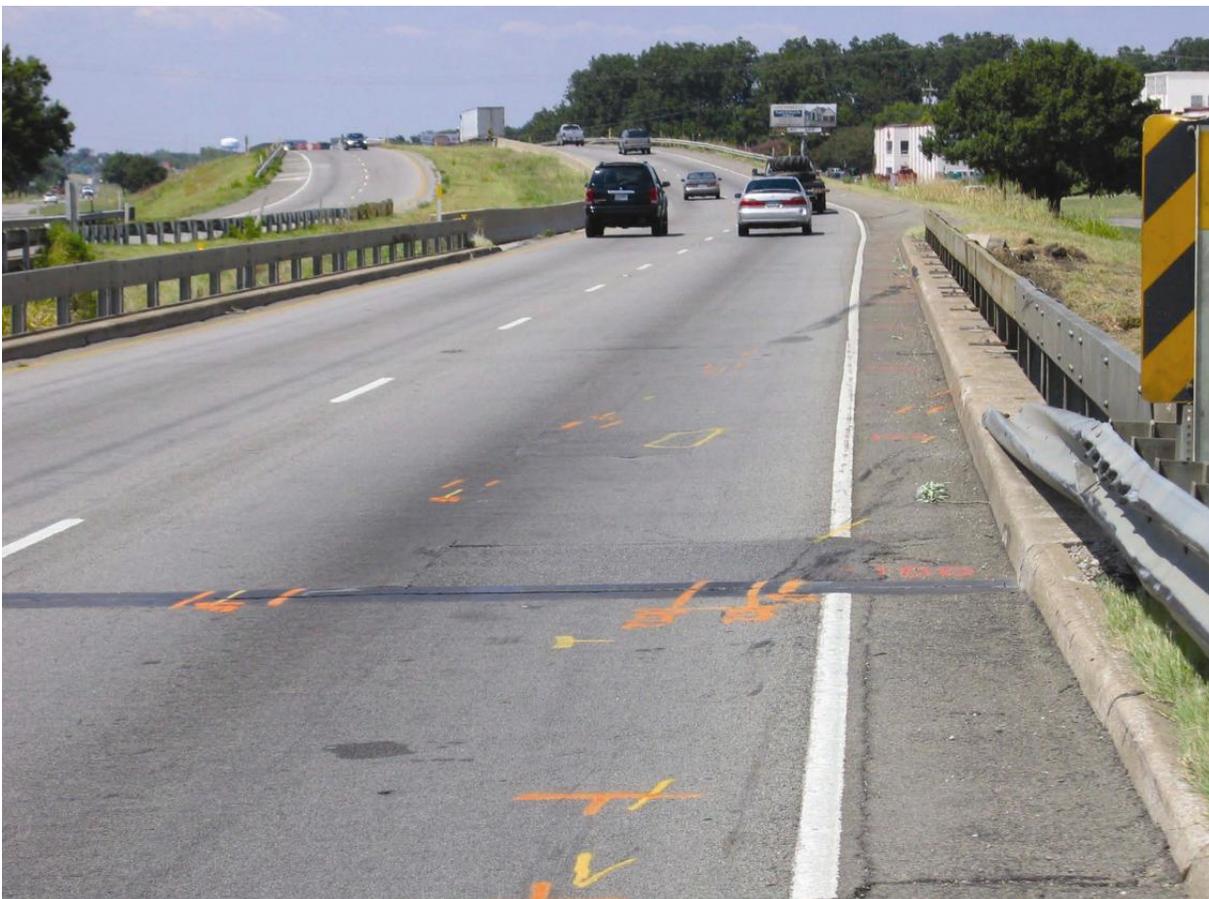
The accident occurred on the Post Oak Creek bridge, along a portion of US-75 classified as urban principal arterial roadway.⁵⁰ It is a four-lane highway with the two northbound lanes separated from the two southbound lanes by an earthen median and a 32-inch-high, Jersey-shape concrete median barrier. Lanes of same direction travel are separated by dashed white pavement striping. The right shoulder of the northbound lanes is delineated from the main travel lanes by a solid white pavement stripe, and the left shoulder is delineated from the travel lanes by a solid yellow pavement stripe. The right shoulder is 9 feet wide as it approaches the bridge and narrows to 30 inches on the bridge deck. Rumble strips are located on the right shoulder as it approaches the bridge. The left shoulder is 4 feet wide and narrows to 22 inches on the bridge deck. A speed limit sign posted about 1 mile south of the bridge indicated the daytime speed limit as 70 mph and the nighttime limit as 65 mph. Figure 10 shows the accident scene, and figure 11 shows the final position of the motorcoach near the creek.

Figure 10. Highway accident scene, looking at the motorcoach's path off the bridge. (Photograph was taken after postaccident repairs were made to the bridge.)

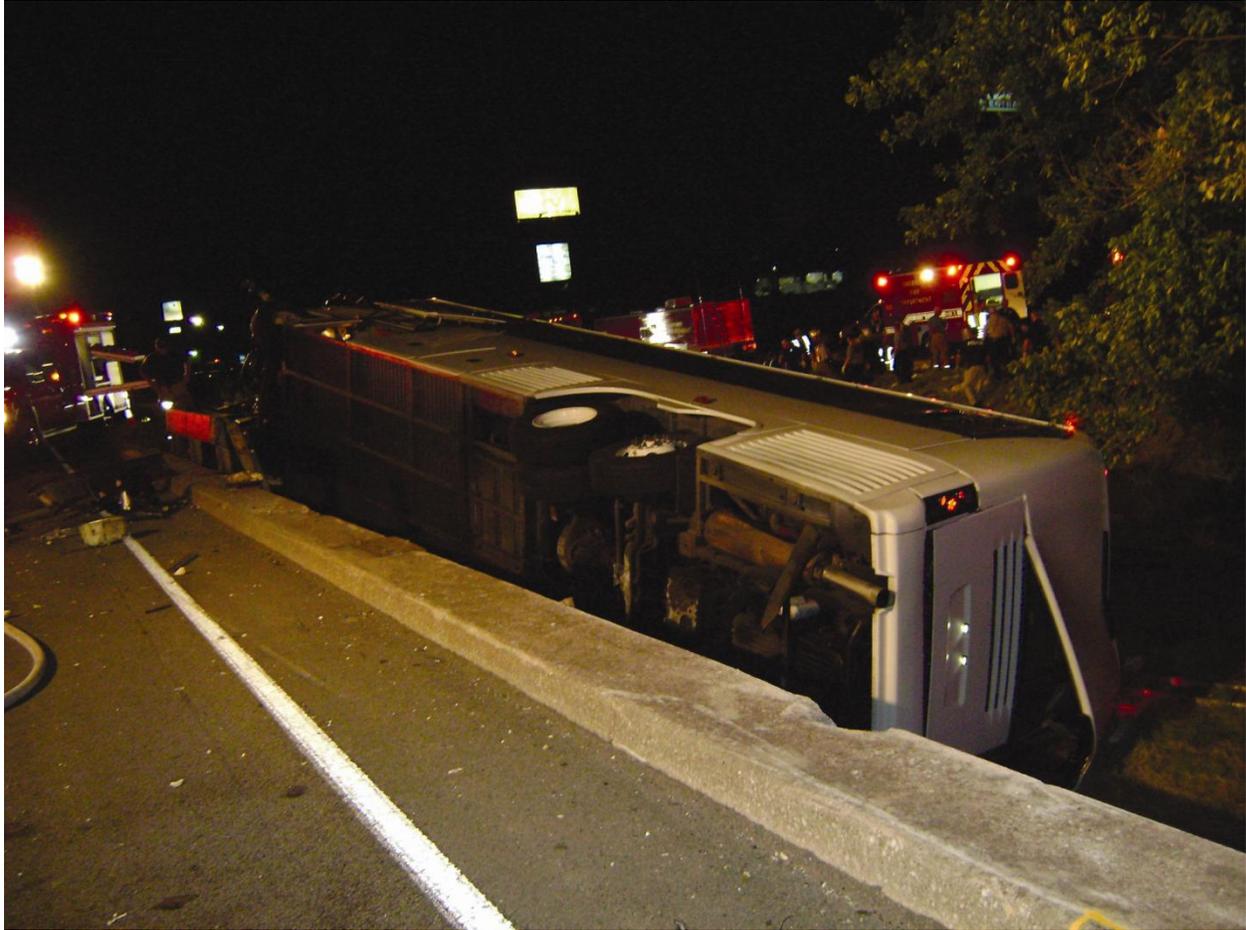
Figure 11. Motorcoach on the bank of the Post Oak Creek. [Courtesy Sherman Police Department]

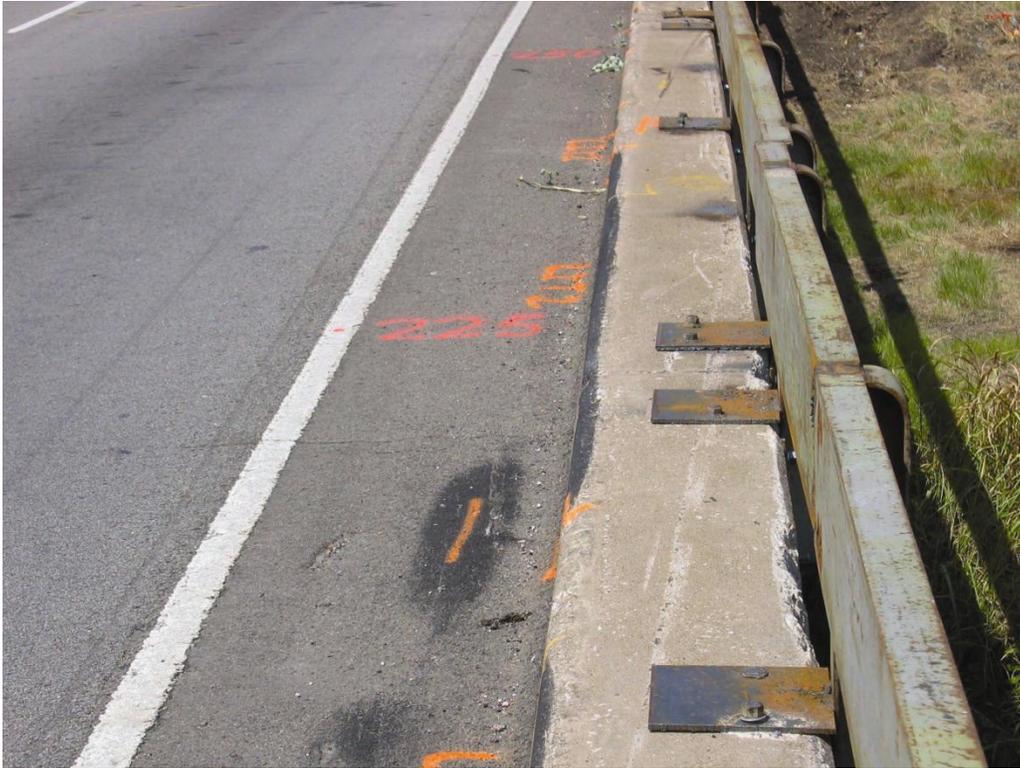
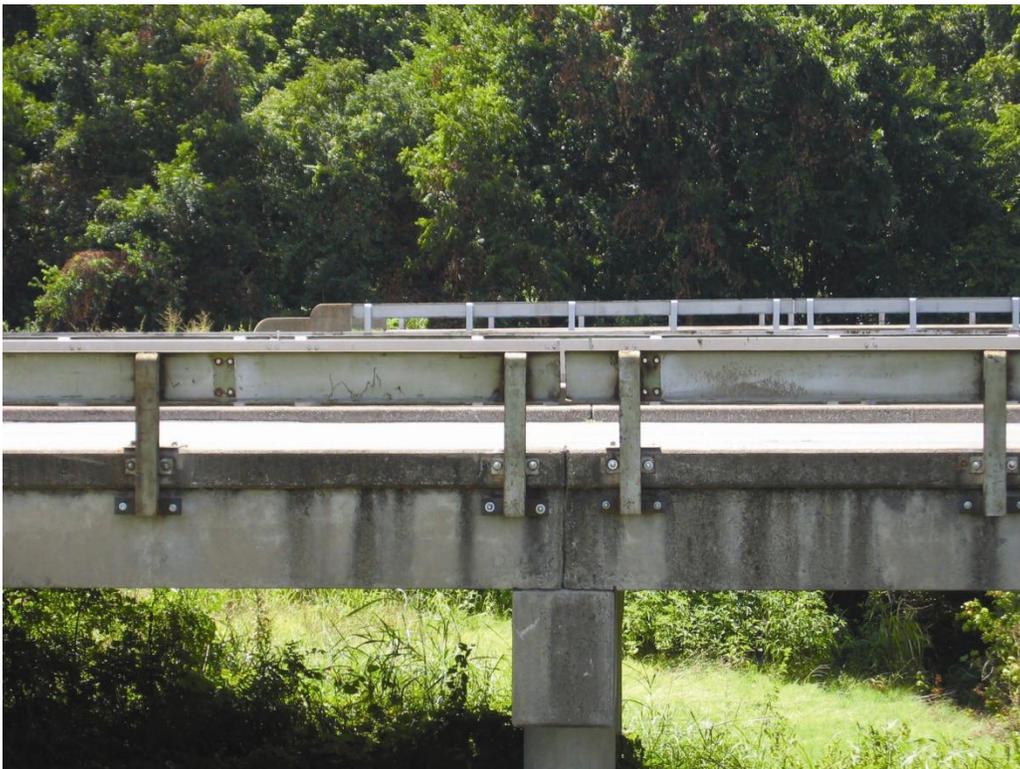
A June 10, 2007, bridge inspection report by TxDOT noted repairs to the bridge railing on two 30-foot-long sections of the east railing in the northern span of the bridge. It noted those repairs to be marginal because the original cast-in-place bolts, damaged as the result of a 2001 truck-semitractor accident that penetrated the bridge railing, were replaced with bolts into the side of the deck and reinforced with steel plates welded to the I-beam structure.

The bridge railing showed evidence of past vehicle strikes. No corrosion was found on the metal of the bridge railing or its fixtures.

Figure 12. Two views of the repaired bridge railing. (Top) Looking down along the inside of the repaired railing from the roadway. (Bottom) Looking at the outside of the repaired railing from the bank of Post Oak Creek.

Following the August 2008 accident, TxDOT repaired the bridge railing to its existing design. (See figure 12.) According to TxDOT, in September 2009 it completed a railing retrofit for the accident bridge and four others along the same road segment, upgrading the accident bridge railing to a T-501 railing, which complies with a Test Level Four standard.⁵² (Bridge railing designs are discussed in the “Other Information” section of this report.) In addition to the bridge railing retrofit project, the TxDOT Bridge Division has identified a U.S. corridor improvement project for US-75 and is exploring funding options.⁵³
