NATIONAL TRANSPORTATION SAFETY BOARD

HIGHWAY SPECIAL INVESTIGATION REPORT

BUS CRASHWORTHINESS ISSUES

National Transportation Safety Board. 1999. *Bus Crashworthiness Issues. Highway Special Investigation Report NTSB/SIR-99/04. Washington, DC.*

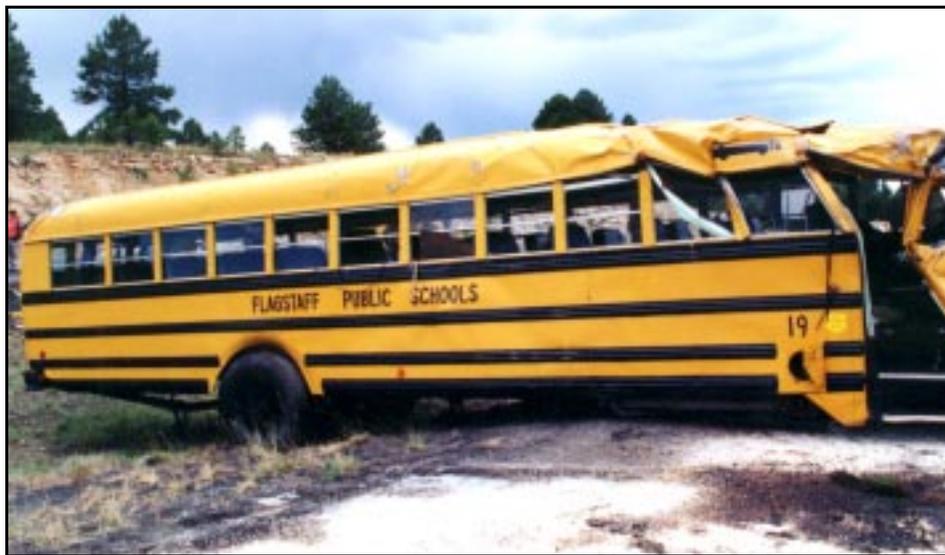
In this accident, a 72-passenger school bus rolled over after the driver lost control of it. Although no fatalities resulted, five passengers were ejected from the bus. (See figures 1 and 2.) Of the ejected passengers, one was severely injured (AIS-4)^{8,9} and four received minor to moderate injuries (AIS-1 and -2). (See seats 1A, 1F, 8A, 9A, and 10A in figure 3.) The lap-belted driver received severe injuries (AIS-4). The passengers on the driver's side received minor to moderate injuries (AIS-1 and -2). The only serious to critical injuries (AIS-3 to -5) occurred to passengers seated on the right-hand side of the bus (seats 1F, 5E, 6F, and 12D), most likely as the result of being propelled out of their compartments and striking surfaces not designed to absorb impact energy. Because only one of five ejected passengers was seriously injured and because the injury levels of passengers located in proximity to each other on the bus differed substantially, it is difficult to determine whether an occupant restraint system would have mitigated or prevented injuries.

Figure 1. Flagstaff school bus postaccident damage

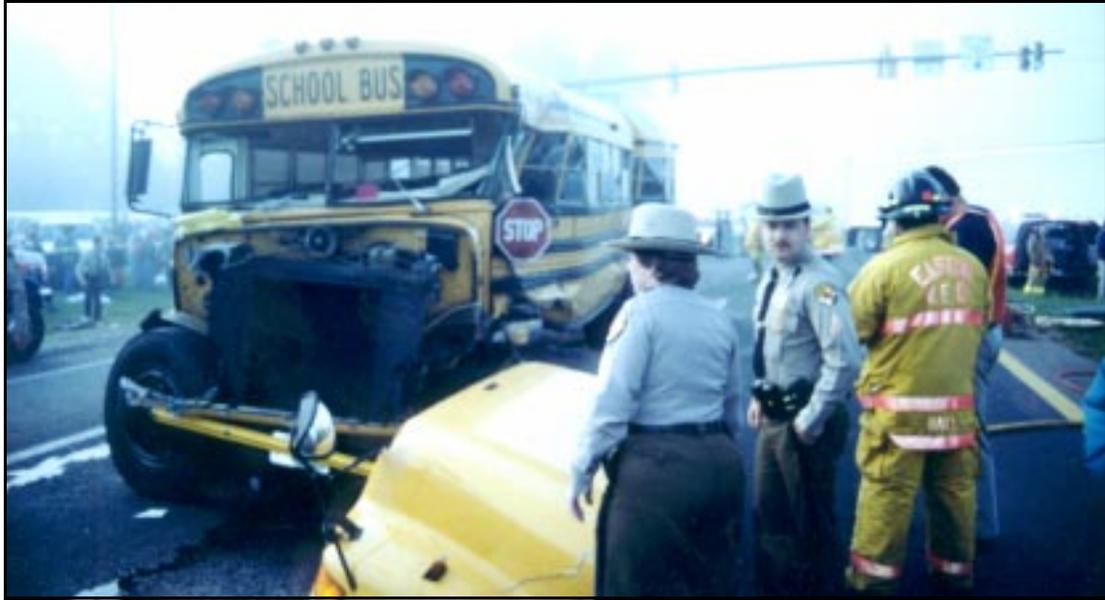
The lap-belted driver was fatally injured as a result of high crash forces in the intrusion area. Three of the four passengers seated in row 1 (figure 6), directly behind the driver, sustained minor injuries. Although these passengers would not have experienced the same level of intrusion as the driver, they would have experienced similar vehicle dynamics. The other passenger in row 1, who was furthest from the impact in seat 1F, experienced serious injuries (AIS-3), most likely sustained from being propelled toward the impact zone. Three of the four most seriously injured passengers (seats 1F, 7F, and 8E) were originally seated on the side of the bus opposite the two impact areas and were likely injured from being propelled from their compartments into the impact area by the high lateral forces experienced during the accident and from striking surfaces not designed to absorb crash energy. Passenger restraints may have reduced passenger injuries by preventing the lateral movement of passengers toward the impact area and by preventing passengers from striking each other. However, because a properly worn lap belt limits the motion of the pelvis relative to the upper body, the restrained passenger's upper body could have been whipped sideways by lateral crash forces.¹⁰ This whipping action may result in high forces being concentrated on the head, possibly causing serious injury. The passengers displaced by the initial impact away from the area of secondary impact (seats 8A, 9A, and 9C in figure 6) may have received worse injuries had they been wearing restraints because of greater exposure to intrusion.

Figure 4. Easton school bus postaccident damage

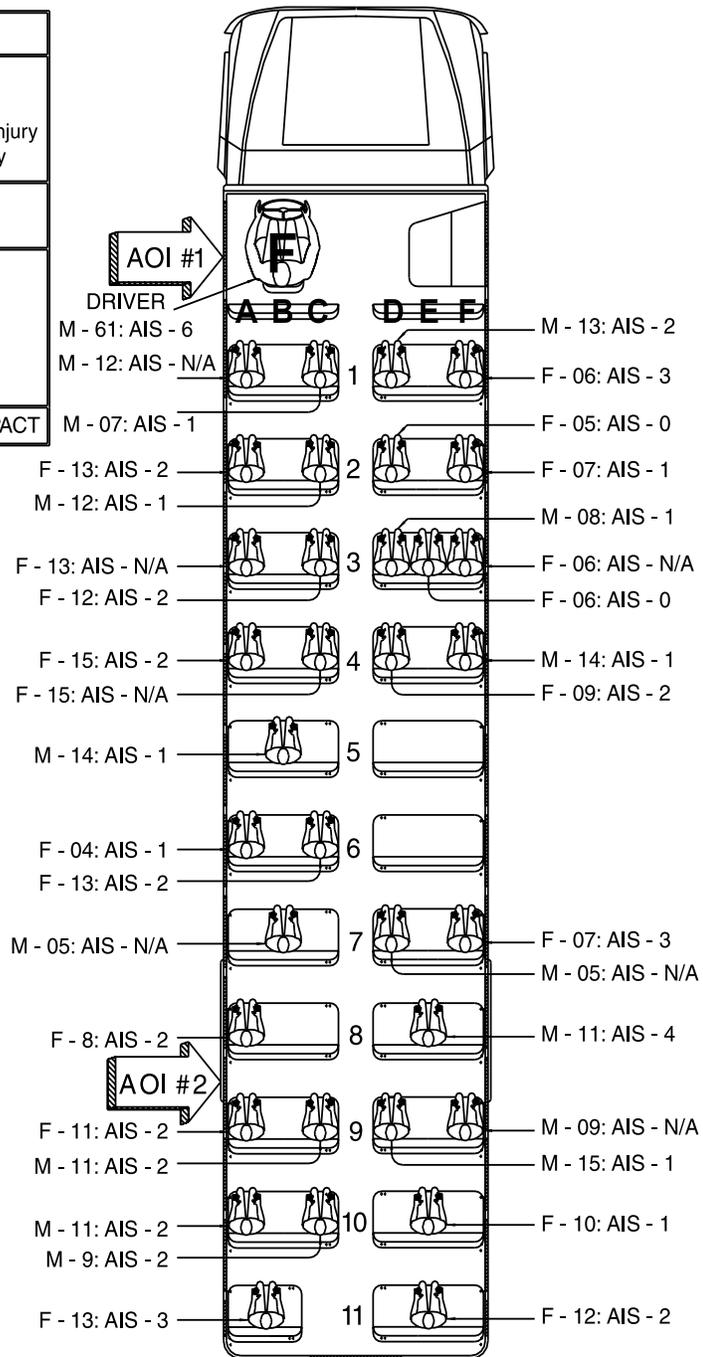
Figure 6. Easton bus seating diagram

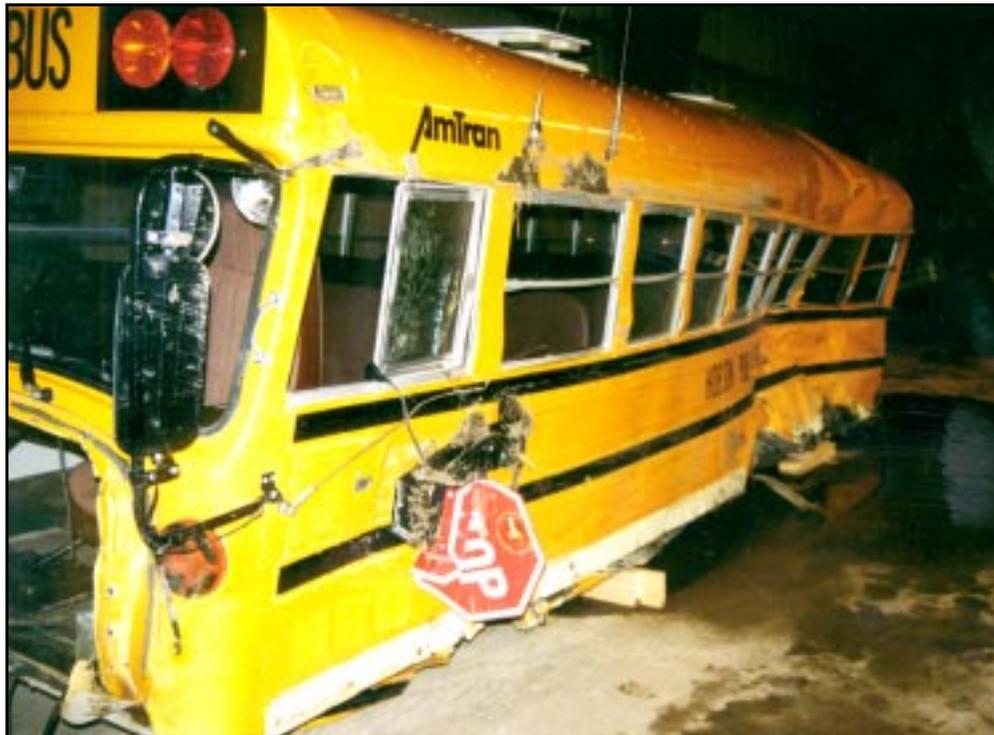
In this accident, a freight train traveling 45 mph struck a school bus between the bus' rear axle and left rear bumper. The impact caused the bus to rotate 180 degrees counterclockwise, and the bus body to separate from its chassis. (See figures 7 and 8.) The passenger in seat 7B was fatally injured from the train's intrusion and resulting crash forces. (See figure 9.) The other fatally injured passenger (seat 7E) was likely thrown into the impact zone during the collision and sustained critical head injuries from the impact forces. Although a restraint system would have reduced the chances of this passenger being propelled into the impact zone, the restraint may not have prevented injuries resulting from the high crash forces due to the severe lateral impact. In addition, had the restraint been a correctly worn lap belt, the passenger's pelvis motion would have been limited relative to the seat, causing his upper body to be whipped sideways, potentially resulting in head injuries similar to those actually received in the accident.¹¹ The driver and other passengers, who were seated at the front of the bus, did not receive serious injuries.

Figure 7. Buffalo school bus postaccident damage

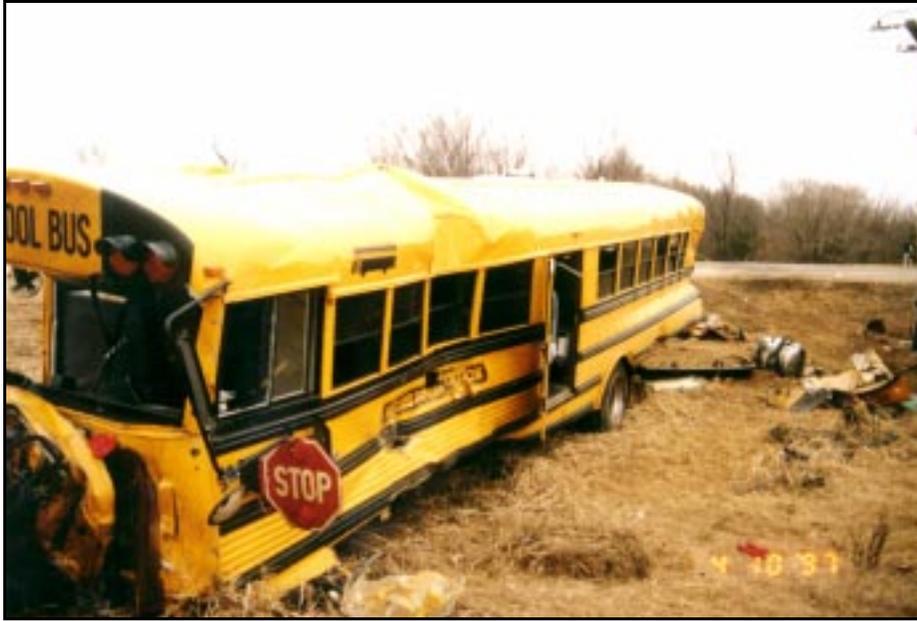
According to a witness, both vehicles approached the intersection where the tractor-semitrailer failed to stop for the posted stop sign, skidded into the intersection, and was struck by the school bus. At impact, the front of the school bus contacted the right side of the tractor at the right front wheel with approximately 43 inches of overlap. A second impact occurred when the right front corner of the semitrailer struck the left side of the school bus at the roofline, which resulted in a 17.5-inch-deep depression. During the second impact, the tractor's tandem wheels deformed the lower part of the side panel of the school bus. A third impact then occurred, when the semitrailer side-slapped the school bus, which was rotating clockwise as a result of the first two impacts. (See figures 10 and 11.)

Figure 10. Monticello school bus postaccident damage

The truckdriver and three school bus passengers seated in the left rear of the bus were fatally injured. Additionally, one school bus passenger sustained critical injuries, two sustained severe injuries, and three sustained serious injuries. The school bus driver and one passenger sustained moderate injuries, and three passengers sustained minor injuries. Details of the simulation of this accident are provided below.

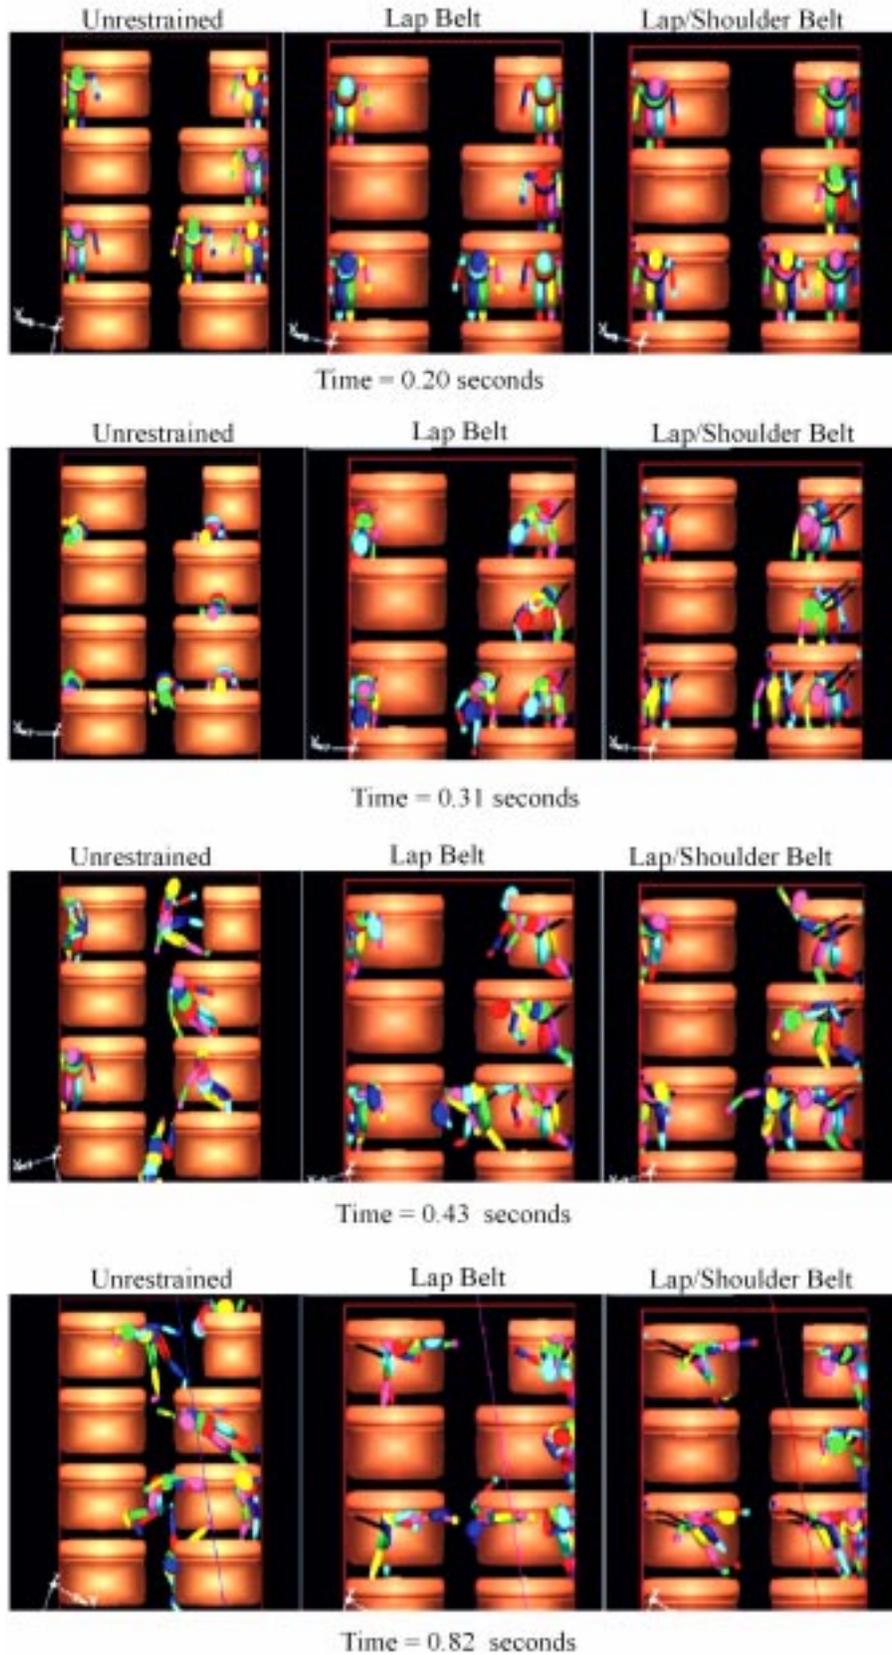
When restrained by a lap belt, the simulated occupant's pelvis was essentially fixed to the seat, causing the upper torso to whip sideways. This whipping action, in turn, caused the simulated occupants seated opposite the impact area (seats 11F and 13F in figure 13) to pivot about the pelvis and strike their heads and torsos on the seat cushions. Head injuries were predicted from these impacts. In addition, due to the seats' configuration and the dynamics of the bus, the simulation predicted hyperextension of the neck as simulated occupants on both sides of the bus rotated about the seatback.

Simulated occupants wearing lap/shoulder belts displayed similar kinematics as those restrained by lap belts alone.²¹ During the final impact, the side slap, the upper torsos of simulated occupants seated opposite the impact area (seats 11F and 13F) slid out from their shoulder belts. Previous research^{22,23} has indicated that the upper torso may slide from

Figure 12. Monticello simulation time sequence history (various restraint conditions)

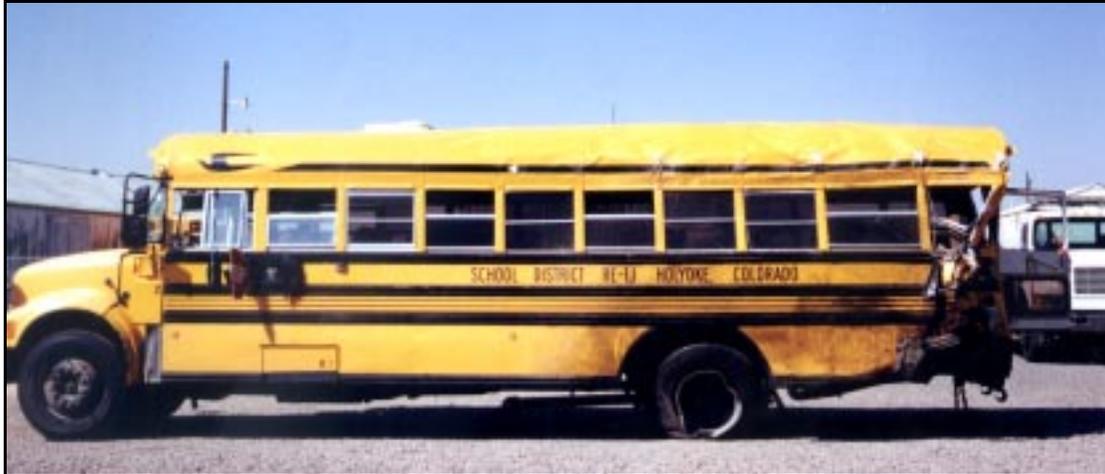
Figure 14. Holyoke school bus postaccident damage

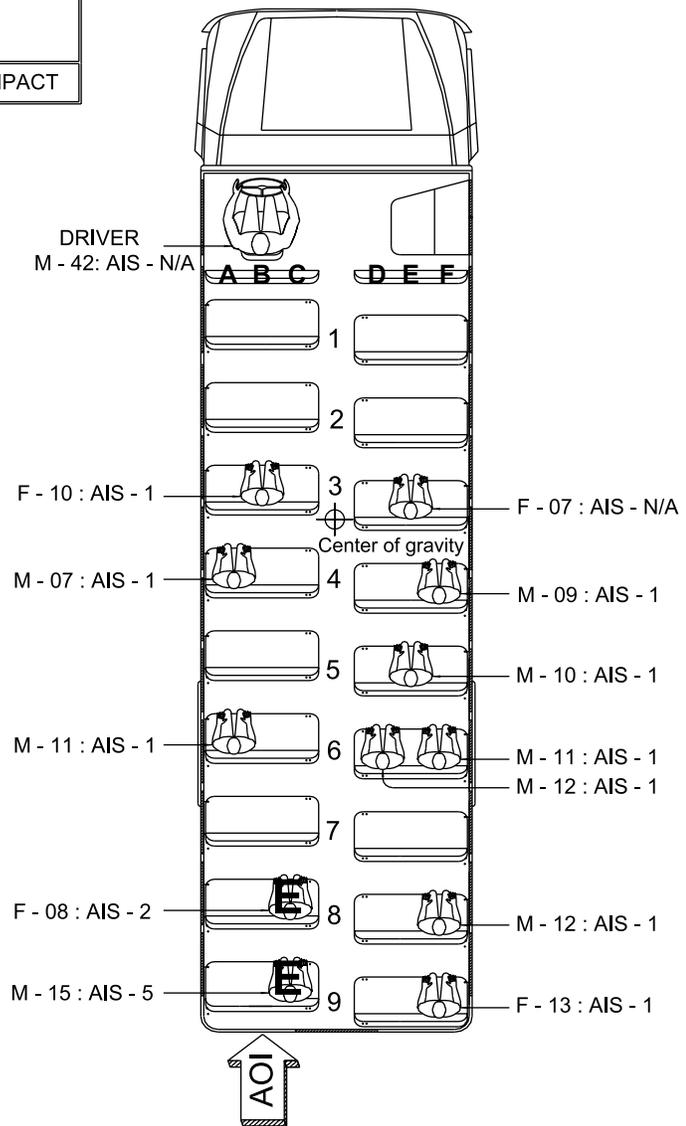
The ejection path and rest positions of the two ejected passengers (seats 8C and 9C in figure 16) were most closely matched by the simulated occupants when they stood in the aisle before impact. (See figure 17.) A slight opening of the rear emergency exit door facilitated the complete ejection of these simulated occupants.²⁶ Higher injury levels were seen for the two reportedly ejected simulated occupants in the standing position than in the seated position because they were not protected by the seating compartment. Although the bus' accelerations were low, the simulated standing occupants contacted surfaces inside

Occupants 8C and 9C may have been outside of the seating compartment at the time of impact

Figure 16. Holyoke bus seating diagram

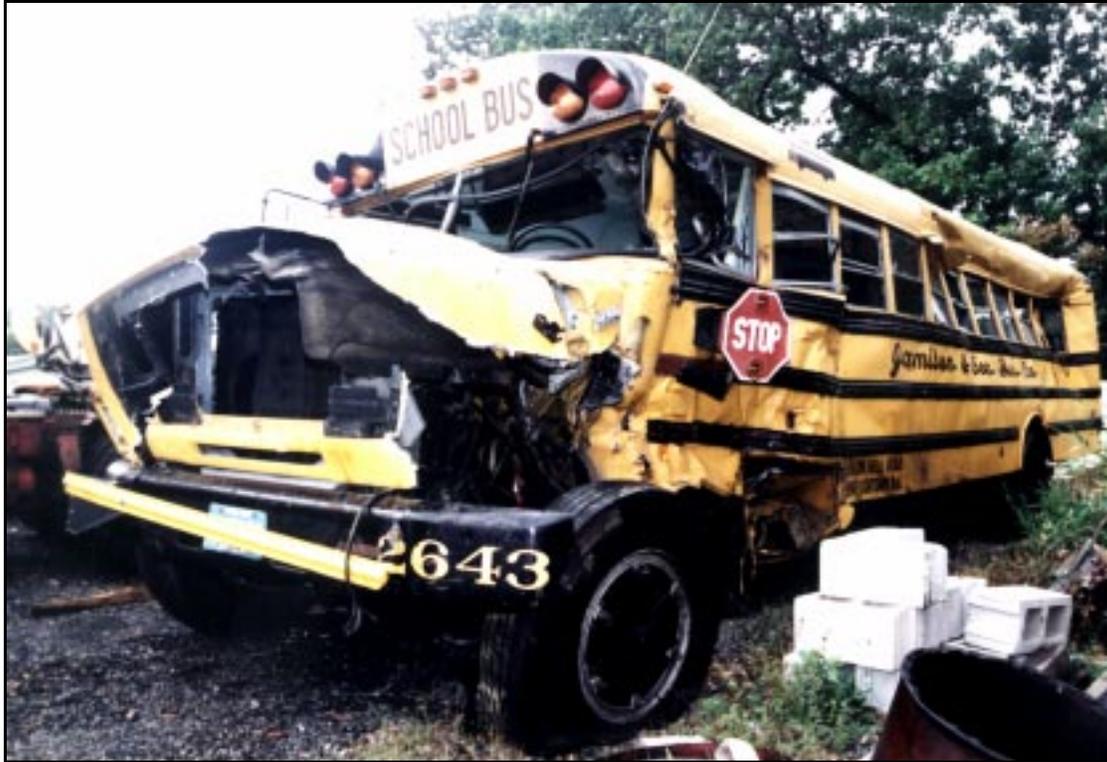
The dump truck impacted the driver's side of the school bus slightly in front of the driver's seat. After striking the school bus, the dump truck began to rotate counterclockwise. The school bus rotated clockwise and a secondary impact occurred between the left side of the bus and the right side of the truck. The majority of the damage occurred on the driver's side of the bus near the driver's seat, between approximately the fifth and sixth rows, where the dump truck overturned onto the top and edge of the bus, creating a puncture hole. (See figures 18 and 19.)

The busdriver sustained severe injuries during the accident. One passenger sustained serious injuries. Two passengers sustained moderate injuries, and three passengers sustained minor injuries. The passenger seats in the school bus were not equipped with seat belts. Details of the simulation of this accident are provided below.

Figure 18. Holmdel school bus postaccident damage

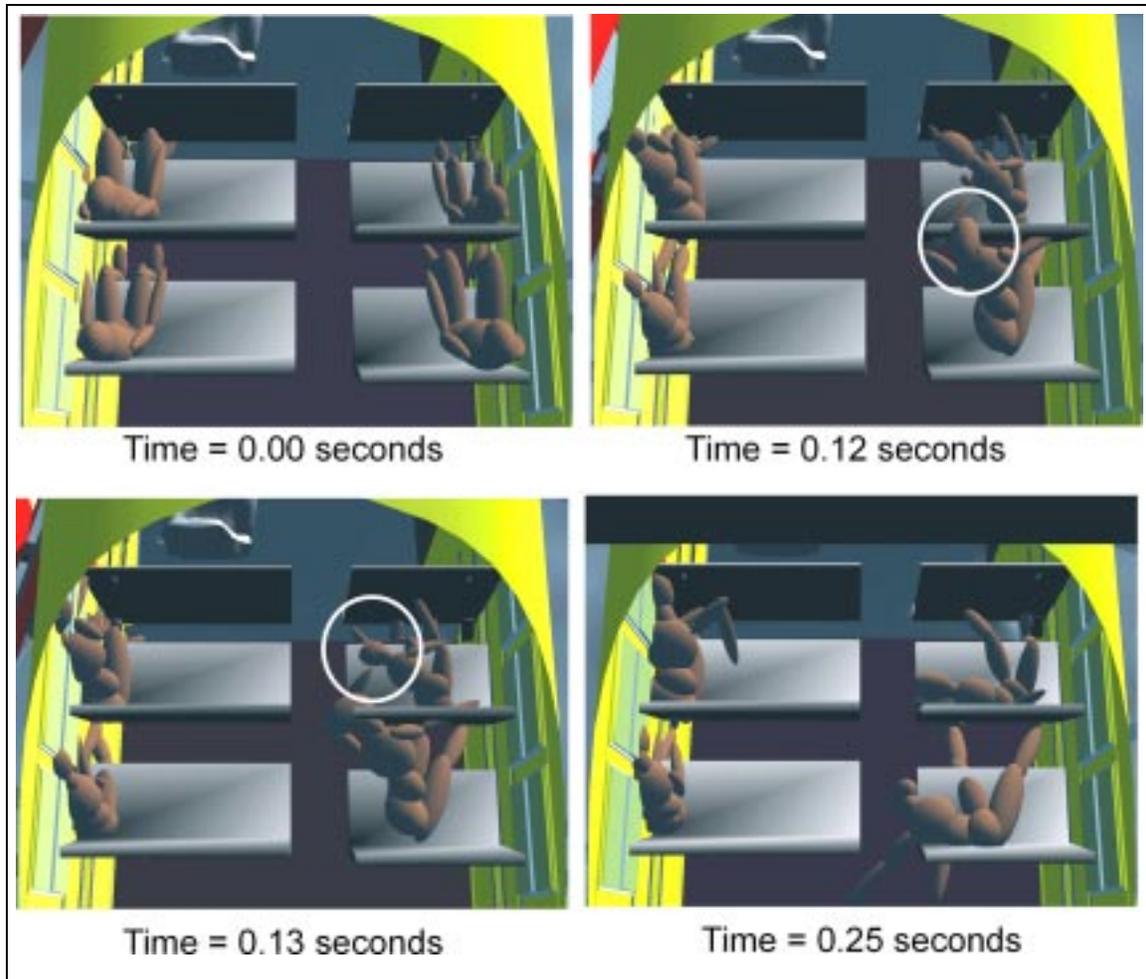
Figure 21. Holmdel simulation time sequence history (lap belt-restrained condition)

The lap belt in this simulation restrained the pelvis of the simulated occupant to the seat. (See figure 21.) For the two simulated occupants on the opposite side of the bus from the impact, the kinematics were dramatically altered from the unrestrained condition. The simulated occupant in seat 1E (see figure 22) did not contact the modesty panel as in the unrestrained condition. Instead, this simulated occupant rotated about the pelvis and struck the seat cushion with the head, resulting in a predicted head injury. (The predicted head injury level in the lap belt-restrained condition was lower than the predicted head injury level in the unrestrained condition.) Similarly, the simulated occupant in seat 2E rotated about the pelvis, but because this simulated occupant was larger than the simulated occupant in 1E, the simulated occupant in seat 2E contacted the seatback in front with the head concentrating the force of the impact in a small region. This impact resulted in a predicted head injury for this simulated occupant.

Those simulated occupants on the same side of bus as the impact displayed similar kinematics to those in the unrestrained condition but had higher predicted injury levels. The lap belt again acted to restrain the pelvis of these simulated occupants to the seat and thus allowed smaller portions of the body to absorb the impact energy.

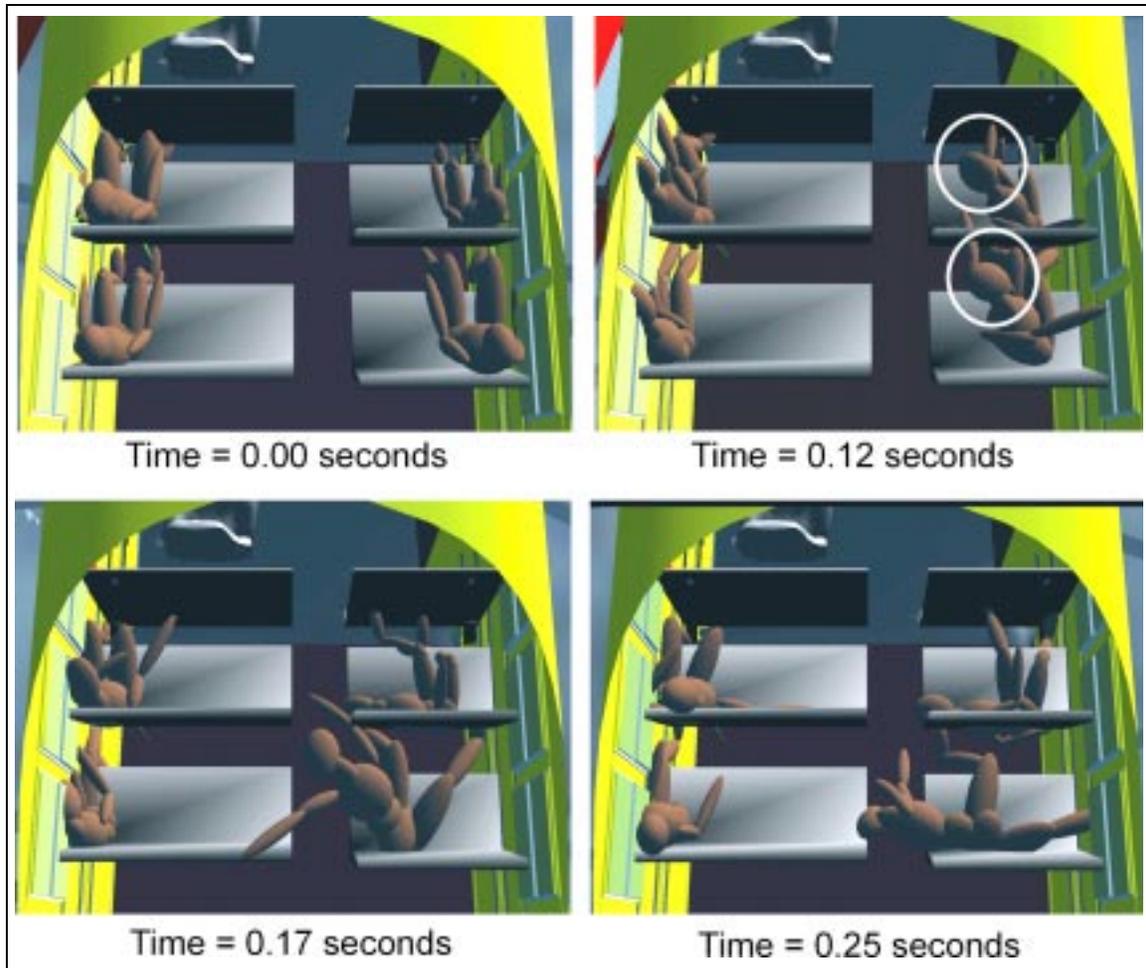
protect the simulated occupants' heads from impacts within the vehicle. (See figure 23.) The upper torso did slide from the shoulder restraint, but the trajectory of the upper body was forward and lateral, whereas for the Monticello accident it was predominately lateral (as discussed earlier.) Therefore, the velocity of the upper body was reduced enough to prevent injury before the upper torso slid from the belt. For the simulated occupants on the same side as the impact (seats 1A and 2A), the levels of predicted injury were similar to those in the lap belt-restrained condition, although both simulated occupants were predicted to sustain neck extension injuries in this restraint condition.

Figure 23. Holmdel simulation time sequence history (lap/shoulder belt-restrained condition)
