File In Section: Product Recalls
Bulletin No.: 10282B
Date: March 2011

PRODUCT SAFETY RECALL

SUBJECT: Harsh Transmission Shift, Engine Stall, Engine May Not Start, MIL or Service Engine Soon Lamp

MODELS: 2005-2008 Pontiac Vibe
Two Wheel Drive Equipped with 1.8L MFI Engine (LV6)

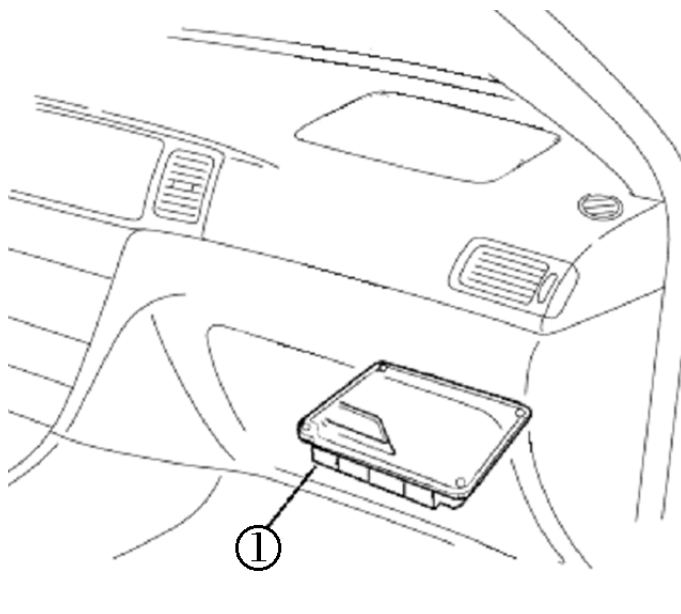
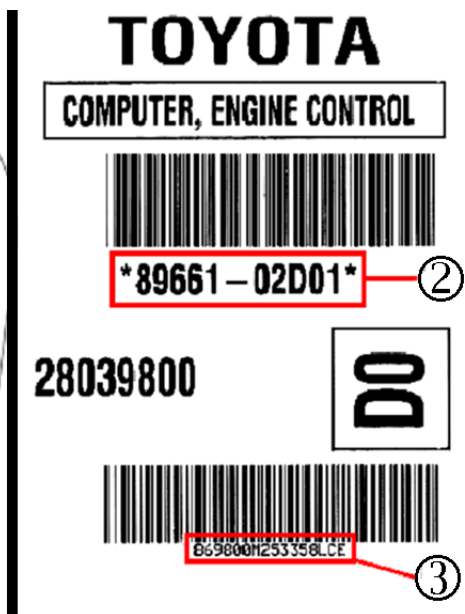
2530675

1. Locate the PCM (1) under the glove box compartment.

- Record the part number (2) and the lot number (3) on the repair order.

- Confirm the PCM part number to determine the required action using the table below.

- If the LOT number is 7227 or higher, no further action is required.
- If the LOT number is 7226 or lower, replace the PCM. Refer to *PCM Replacement* in this bulletin.
