## CERTAIN 2004 THROUGH 2006 MODEL YEAR F-150 AND 2006 MODEL YEAR MARK LT VEHICLES — CLOCKSPrING TO DRIVER SIDE FRONTAL AIR BAG WIRE HARNESS REPLACEMENT

### OVERVIEW

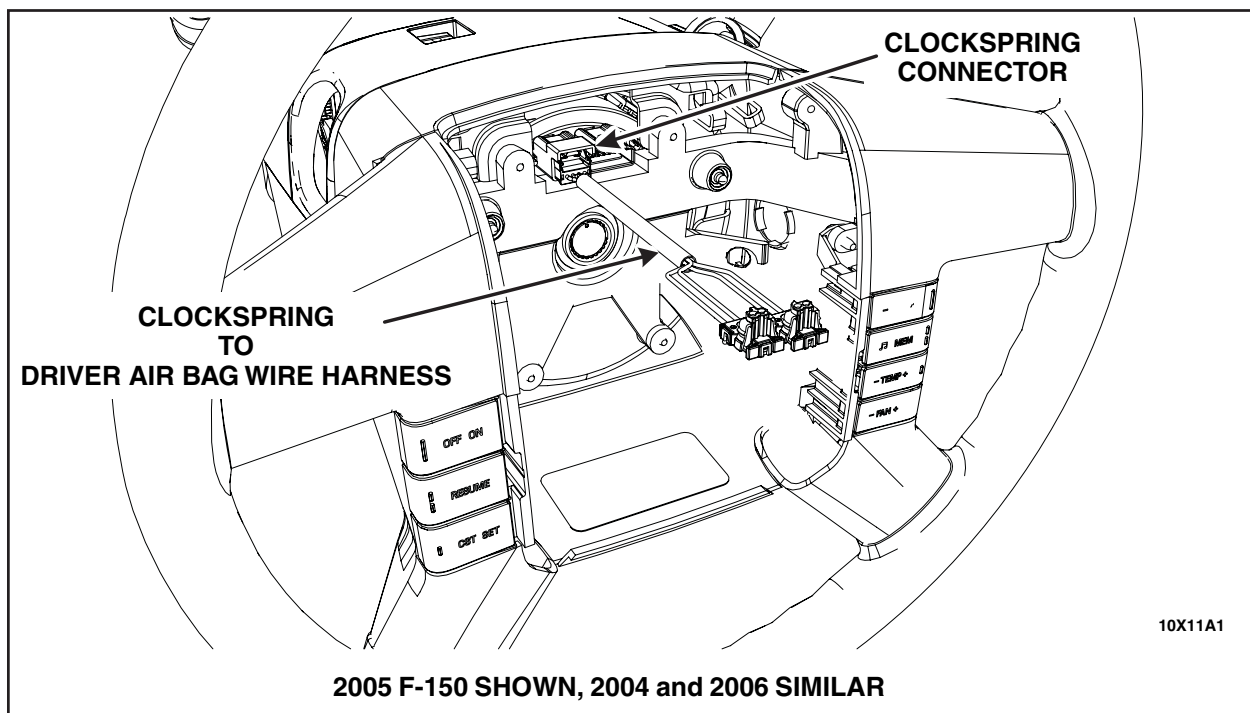
FIGURE 1

1. Remove the driver air bag. For additional information, refer to the appropriate WSM, Section 501-20B.
2. Release the clockspring connector lock and disconnect the harness from the clockspring. See Figure 1.

3. Install the **new** clockspring to driver air bag wire harness using the following sequence:
  1. Connect the harness to the clockspring.
  2. Make sure the harness lock at the clockspring is seated.
  3. Connect the harness to the air bag.
4. Install the driver air bag. For additional information, refer to the appropriate WSM, Section 501-20B.
