**RECALL  
BULLETIN:  
110520FRV**

**PRODUCT(S)  
AFFECTED:**  
Bounder,  
Bounder  
Classic, Storm,  
Southwind,  
Terra, built  
on Ford 53  
Chassis

**SUBJECT:**  
Routing the  
Wire Harness  
Away from  
Engine Manifold  
Heat Shield

**ISSUE DATE:**  
July 2011

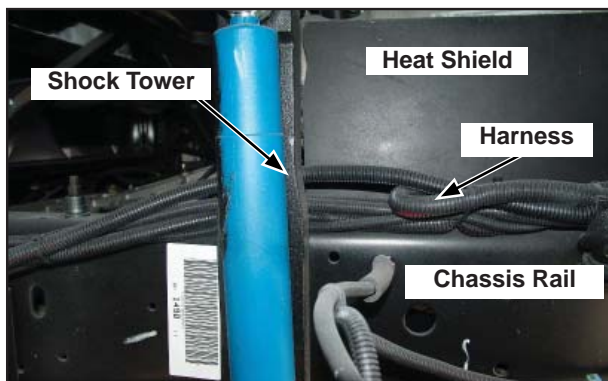
**Figure 1a - Before Correction**

On motor homes affected by this recall, a wire harness routed under the motor home can contact a heat shield located next to the passenger side engine exhaust manifold. The heat can transfer from the heat shield to the harness and can melt or otherwise damage the wiring. A damaged wire harness can result in an electrical short, which can result in intermittent operation of electrical systems, vehicle "shut down" and/or lead to a fire, and may result in loss of vehicle control, injury or death.

**(Wire Harness Routed Along Chassis Rail)**

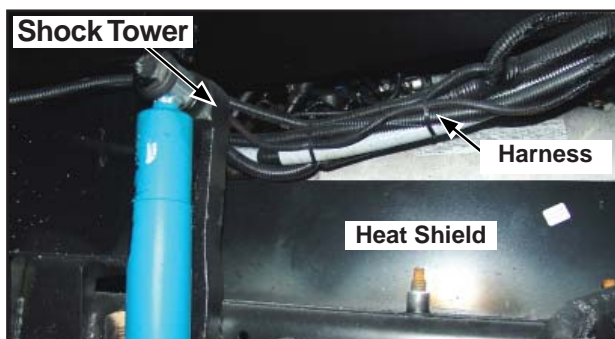
**Figure 2a - Before Correction**

**(Wire Harness Routed Attached to Underside of Floor)**
