September 6, 2011
Ref. No.: GR11-047

11V-467
(4 Pages)

RE: Part 573 Defect Information Report – Moonroof Glass Coming-off on 2011 Subaru Legacy & Outback Vehicles

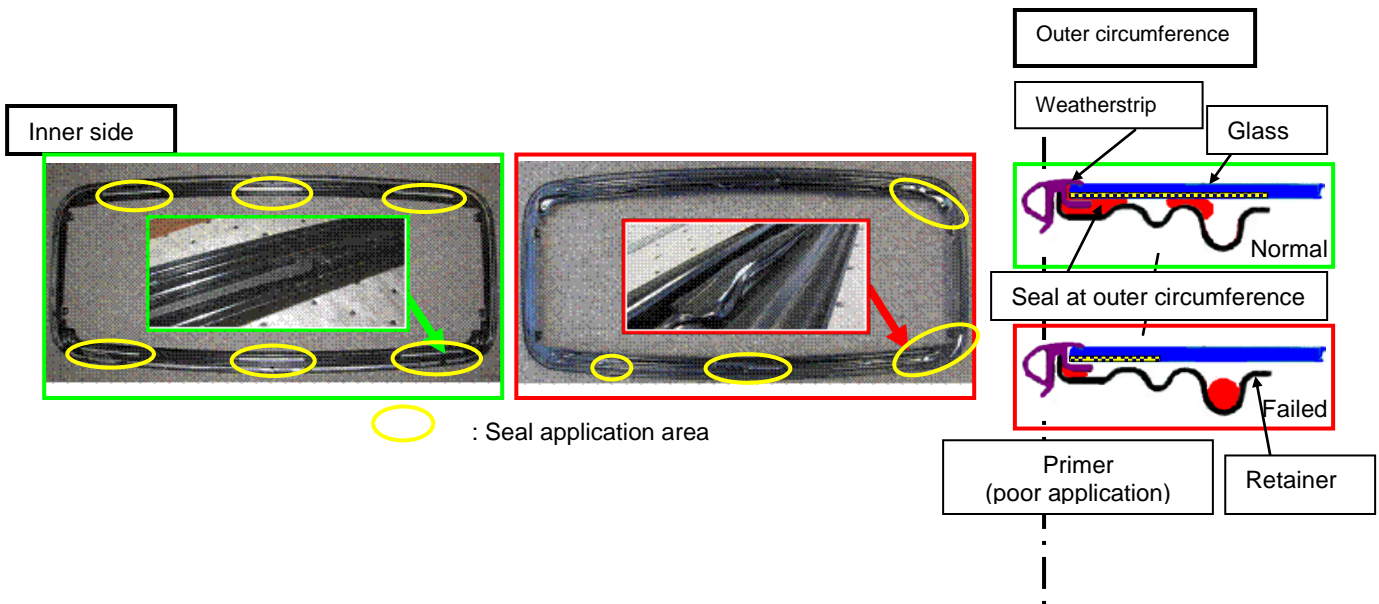
The moonroof glass can loosen and detach from the vehicle during driving, resulting in a potential road hazard for other vehicles that may lead to a collision.

(i) The remedy plan calls for dealers to inspect glass adhesion condition and dealers will either apply additional seal or replace the moonroof glass with a new one according to the inspection result.
