RECALL BULLETIN: 121025FRV

PRODUCT(S) AFFECTED:
Encounter
Storm, Terra,
produced
11-19-2009
through
9-18-2012

SUBJECT:
Entry Step
Structural
Support

ISSUE DATE:
December
2012

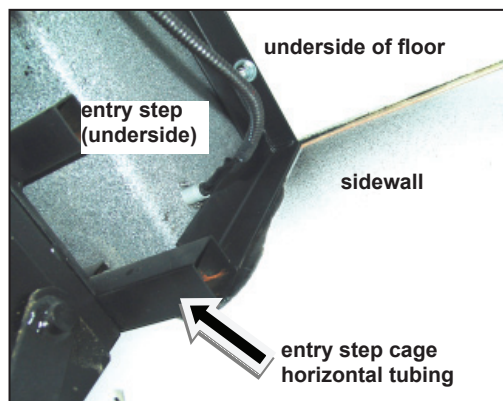
On motor homes affected by this recall, the entry step cage may separate from the sub-floor, possibly resulting in risk of personal injury, vehicle and/or other property damage.

Figure 1 - Step cage attachment area prior to repairs
