PUBLIC ROADS

VOL. 24, NO. 7

JOINTS AND CRACKS IN CONCRETE PAVEMENTS

Reported by EARL C. SUTHERLAND, Senior Highway Engineer

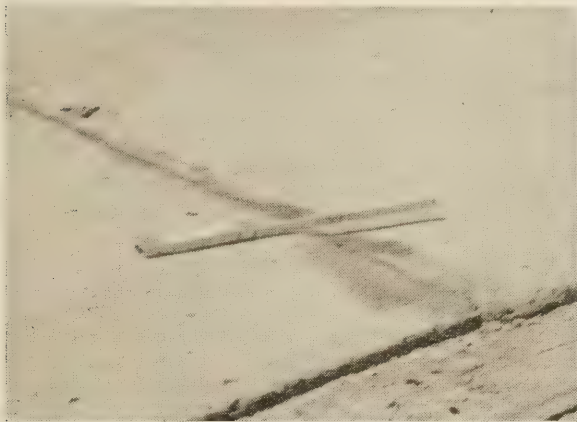
FIGURE 6.—EXPANSION JOINT FAULTED APPROXIMATELY 1 INCH WITH THE SLAB BEYOND THE JOINT DOWN.

There appears to be no uniformity in the direction or manner of the faulting. In many cases the slab beyond the joint was below the approach slab at the free edges of the pavement, while in others the opposite condition was found. The same was true of the two points adjacent to the longitudinal joint. As a general rule, however, the slab beyond the joint was below the approach slab where the faulting was severe, that is, where the relative displacement was one-half inch or more. Such a joint is illustrated in figure 6.

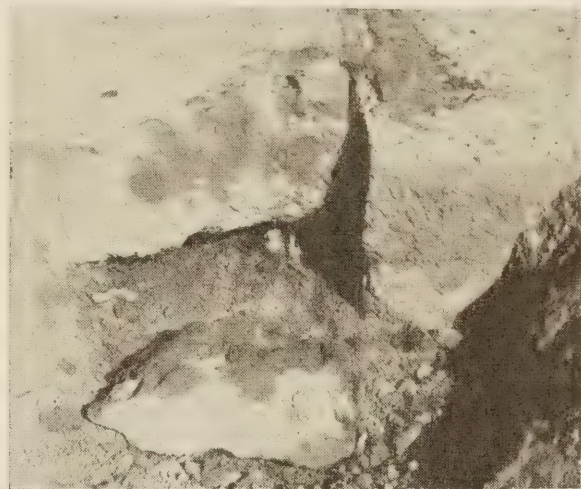
FIGURE 7.—SMALL COMPRESSION CORNER FAILURE AT A CLOSED EXPANSION JOINT.

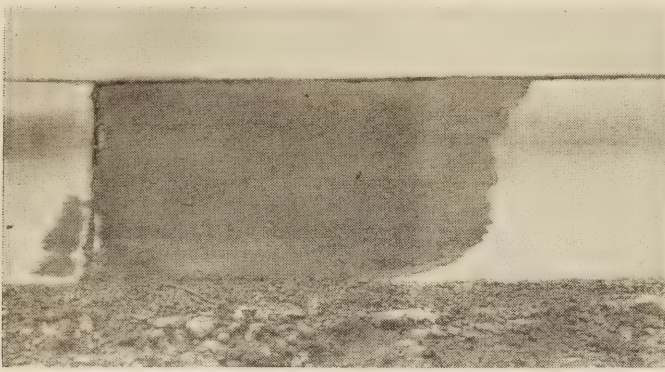
FIGURE 17.—BADLY FAULTED JOINT WITH LEADING SLAB DEPRESSED.

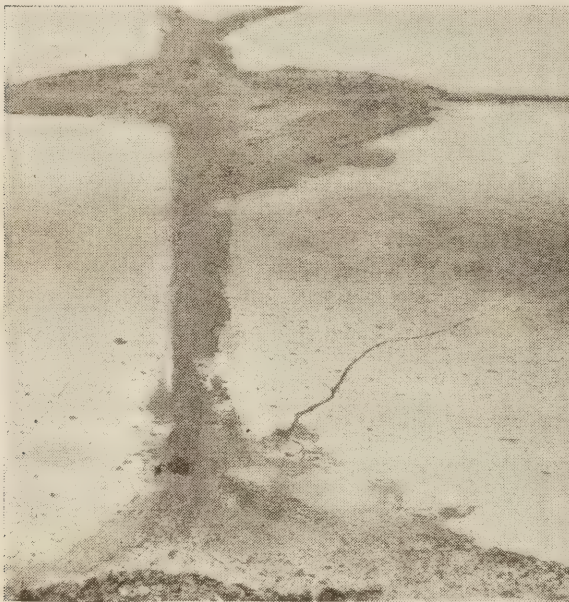
FIGURE 19.—SCALING IN CORNERS FORMED BY EXPANSION JOINT.

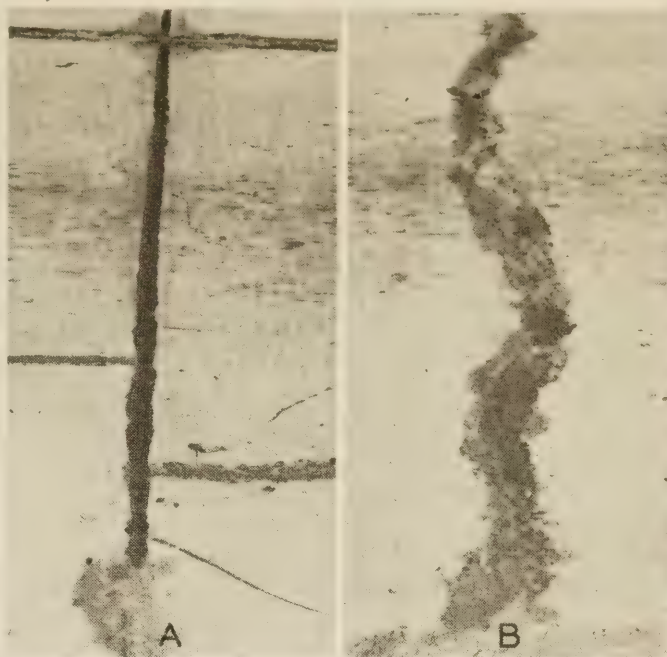
FIGURE 20.—A, NORMAL JOINT IN A TYPICAL OLD PAVEMENT; B, NORMAL CRACK IN A TYPICAL OLD PAVEMENT.

Close-up views of a joint and a crack typical of those on one of the older pavements examined are shown in figure 20. This surface was in better than average condition for pavements of the older group. Some spalling can be noted along the edges of both the joint and the crack. It is typical that the extent of the spalling was greater at the crack than at the joint.

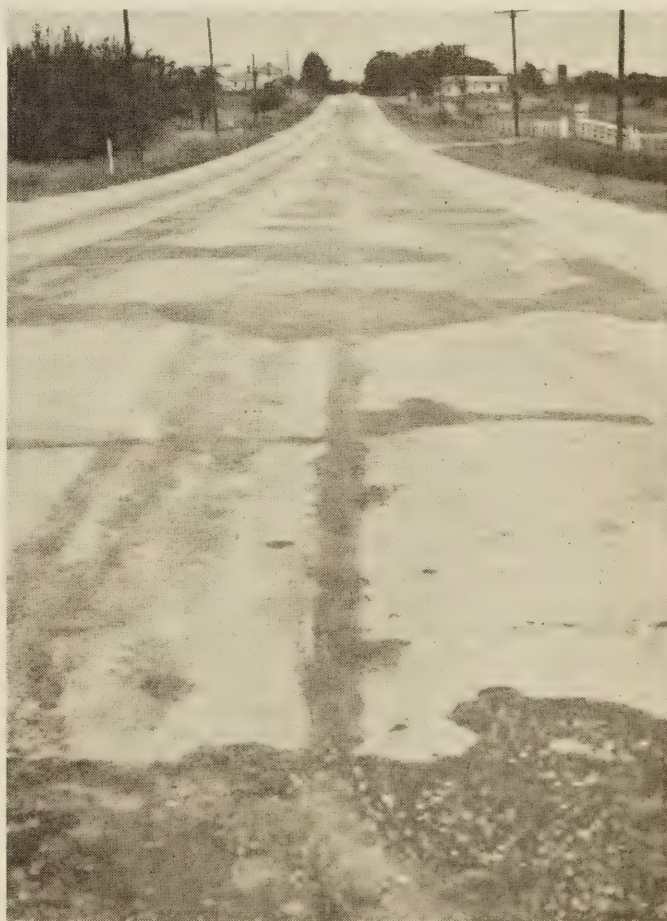
FIGURE 21.—A BADLY SCALED AND DISINTEGRATED PAVEMENT.

A general view of one of the more badly scaled and disintegrated pavements is shown in figure 21. The center and right lane of this pavement were approximately 13 years old, while the left lane was relatively new. The new pavement was in good condition. The scaling and disintegration on the old surface was largely in the vicinity of joints and cracks and especially in the corners formed by the joints and cracks. Figures 22, A, and 22, D show in detail the character of the disintegration which has developed at some of the more badly damaged areas at a crack. Figure 22, B shows similar areas at a joint where bad disintegration had developed.

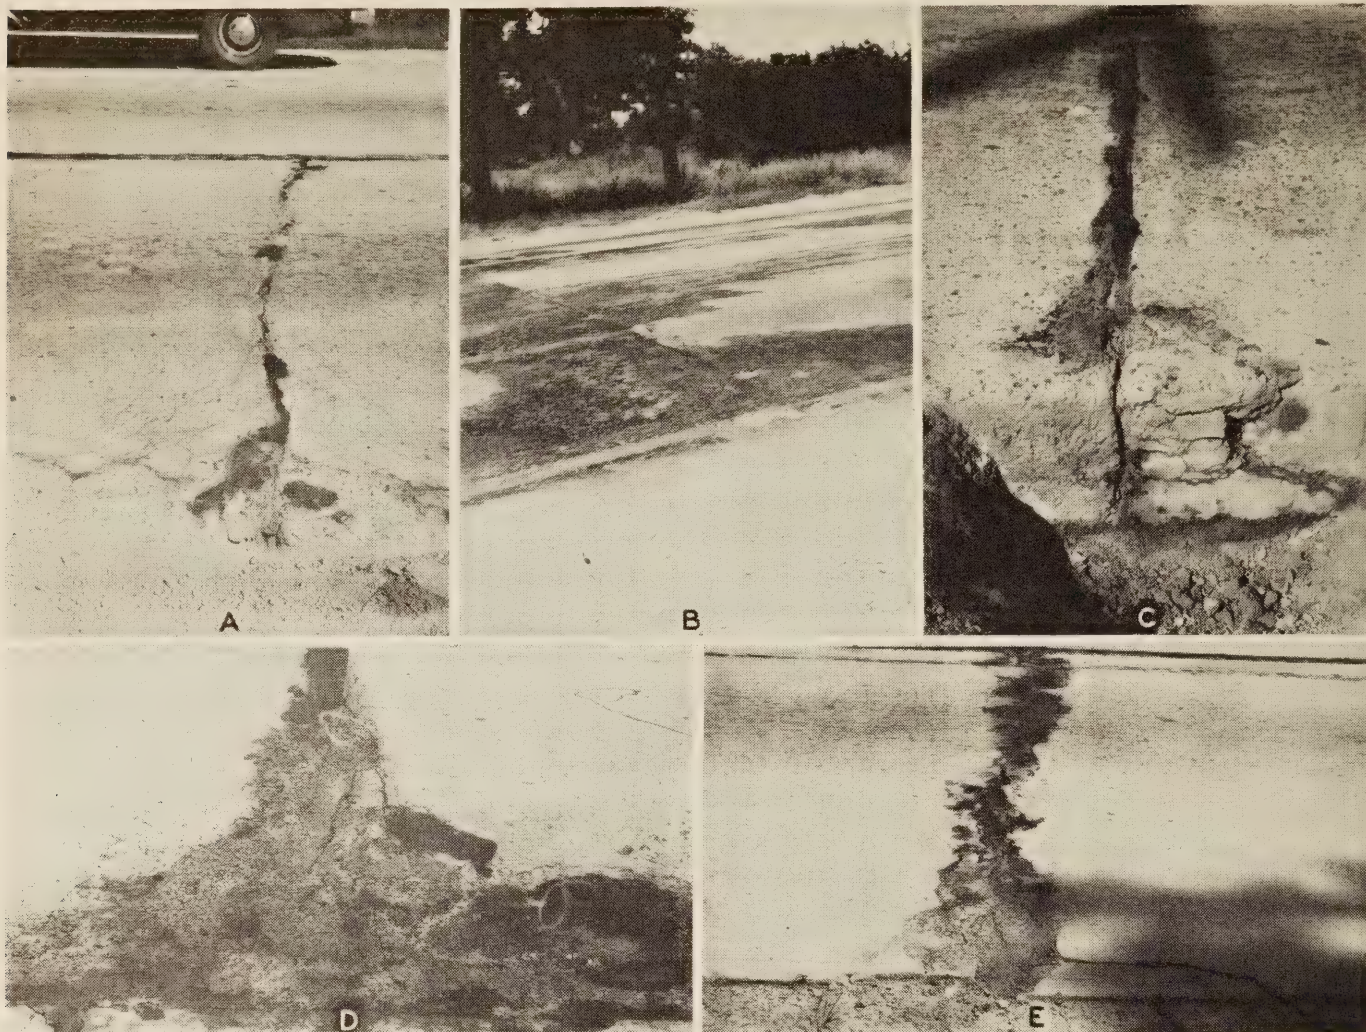
FIGURE 22.—A, SURFACE DISINTEGRATION AT CORNERS FORMED BY CRACK; B, SCALING AT CORNERS FORMED BY JOINT, COVERED WITH CRACK FILLER; C, SMALL CORNER FAILURE AT CLOSED EXPANSION JOINT; D, SCALING AT CORNERS FORMED BY CRACKS COVERED WITH CRACK FILLER; AND E, SMALL CORNER FAILURE AT CORNER FORMED BY CRACK.

The corner breaks shown in figures 22, E and 23, B are typical of a number found at the joints and cracks in the pavements of projects 116 and 91. In both of these pavements continuous plain round edge bars were used. On project 116 expansion joints were spaced at intervals of approximately 50 feet, while on

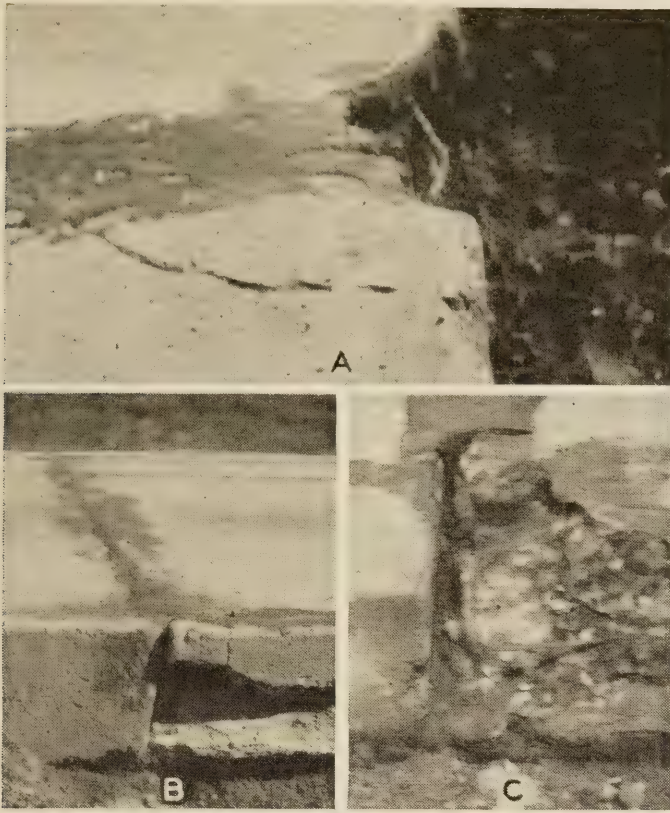
FIGURE 23.—A, BUCKLED EDGE BAR OF A SMALL CORNER FAILURE; B, SMALL CORNER FAILURE AT A JOINT; C, SMALL CORNER FAILURE ON RELATIVELY NEW REINFORCED PAVEMENT.

project 91 there were no expansion joints. At a number of corner breaks on these two pavements, an examination showed that the edge bars had buckled and apparently caused the corners to fracture. A close-up view of one of these buckled bars is shown in Figure 23, A. The edge bars in this pavement were in continuous bond and extended across the expansion joints with no provision for relative movement of the steel with respect to the concrete at these joints.

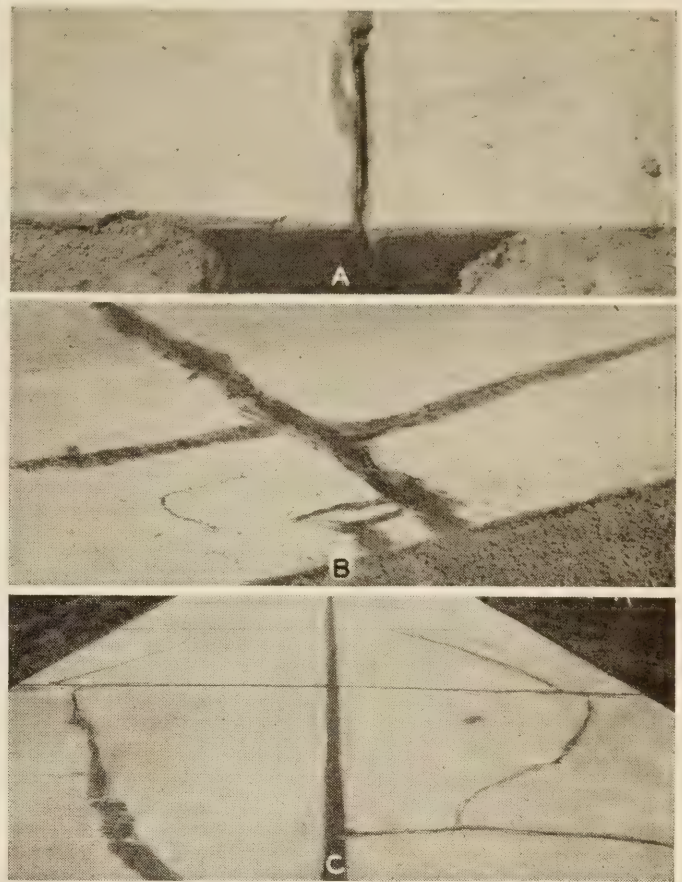
FIGURE 24.—A, INFILTRATION CRACK IN EARLY STAGE OF DEVELOPMENT IN REINFORCED PAVEMENT; B, TYPICAL INFILTRATION CRACK; C, TYPICAL INFILTRATION CRACKS THAT HAVE DEVELOPED TO A SERIOUS DEGREE.

"Infiltration crack" is a name that has been applied by engineers of the Michigan State Highway Department to a peculiar type of cracking found in many of the concrete pavements in Michigan. Figure 24 shows photographs of typical infiltration cracks.

Figure 24, A shows an early stage of development. Figure 24, B shows a more advanced stage while figure 24, C shows a number of these cracks that have developed to a serious extent.

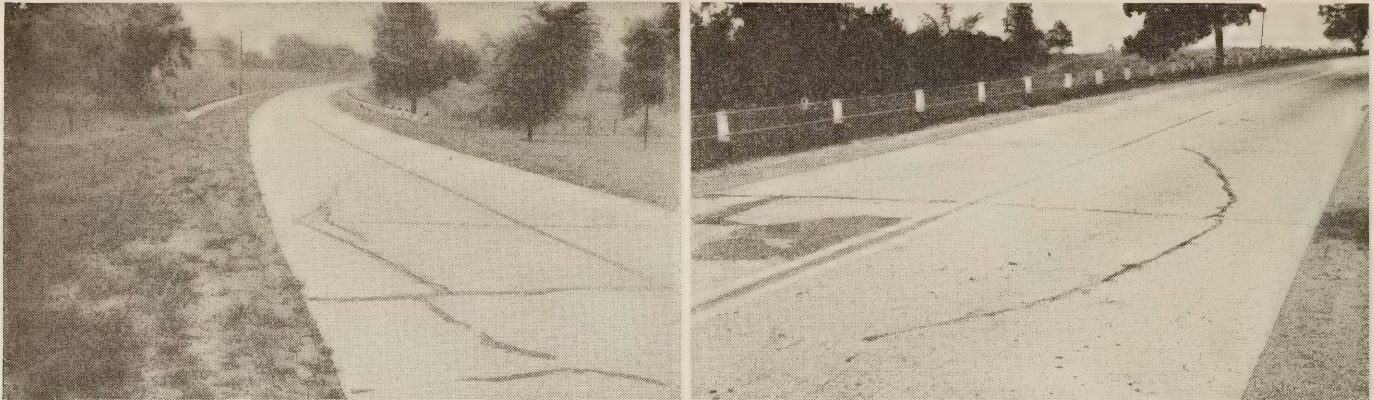
FIGURE 25.—INFILTRATION CRACKING ON STATE PROJECT 3924 C-1.

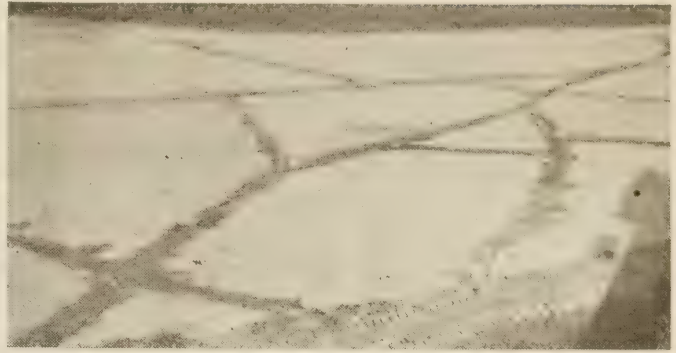
FIGURE 27.—CRACKING CAUSED BY DIFFERENTIAL FROST HEAVING AT INTERIOR OF PAVEMENT.

In the past, trouble with differential frost heaving had been experienced in the subgrades of pavements in the Upper Peninsula. Considerable effort was being made to prepare the subgrades for new pavements in a manner to avoid this trouble, but the steps taken apparently had not been entirely successful.

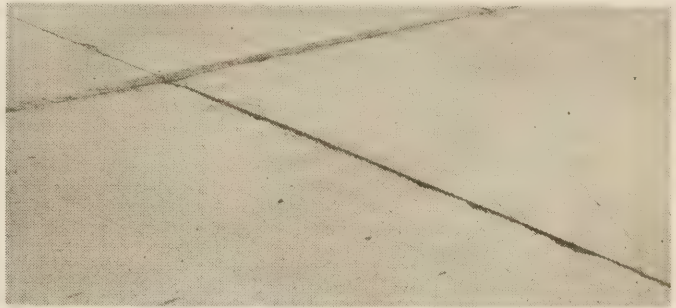
FIGURE 28.—CRACKING NEAR JOINTS CONTAINING LOAD-TRANSFER DEVICES THAT RESIST UPWARD FLEXURE.

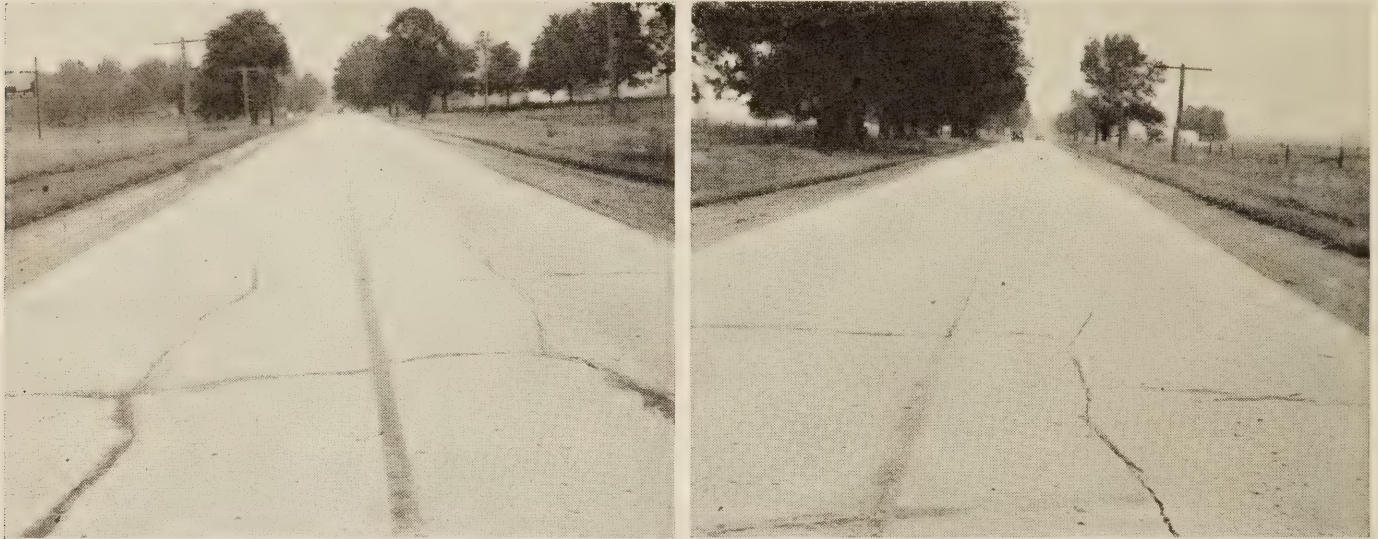
FIGURE 29.—LONGITUDINAL CRACKING IN PAVEMENT WITH RIGID LONGITUDINAL JOINT.
