Public Roads

A JOURNAL OF HIGHWAY RESEARCH

THIS report presents the results of an inspection of concrete pavements on the German motor-road system made by the authors during the summer of 1947 under instructions from the Commissioner of Public Roads. The inspection was made with the object of determining first, in what respects, if any, the German pavements are superior to ours; and second, what features of German design and construction practice, if any, can be adopted with profit by American engineers.

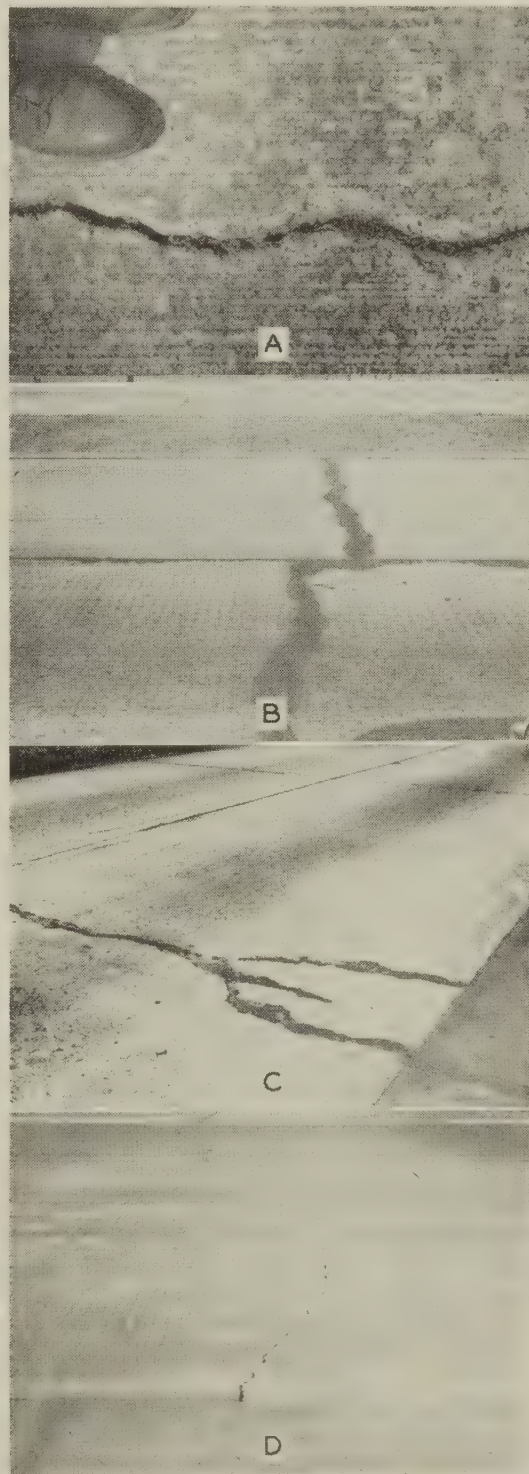
Figure 10.—Transverse cracking was common throughout the system.

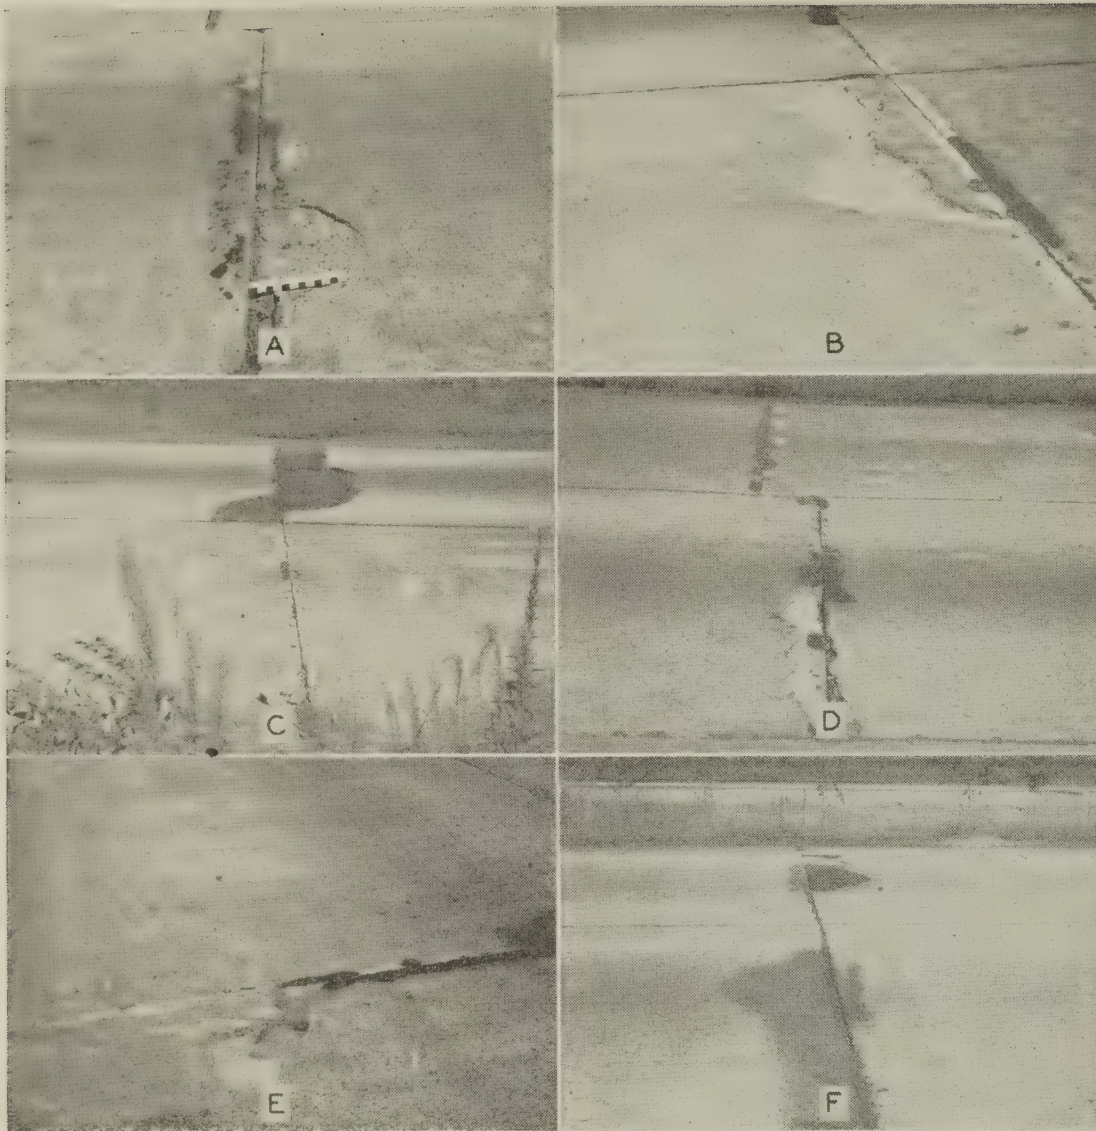
Figure 11.—Spalling at joints occurred principally in the vicinity of Frankfurt.

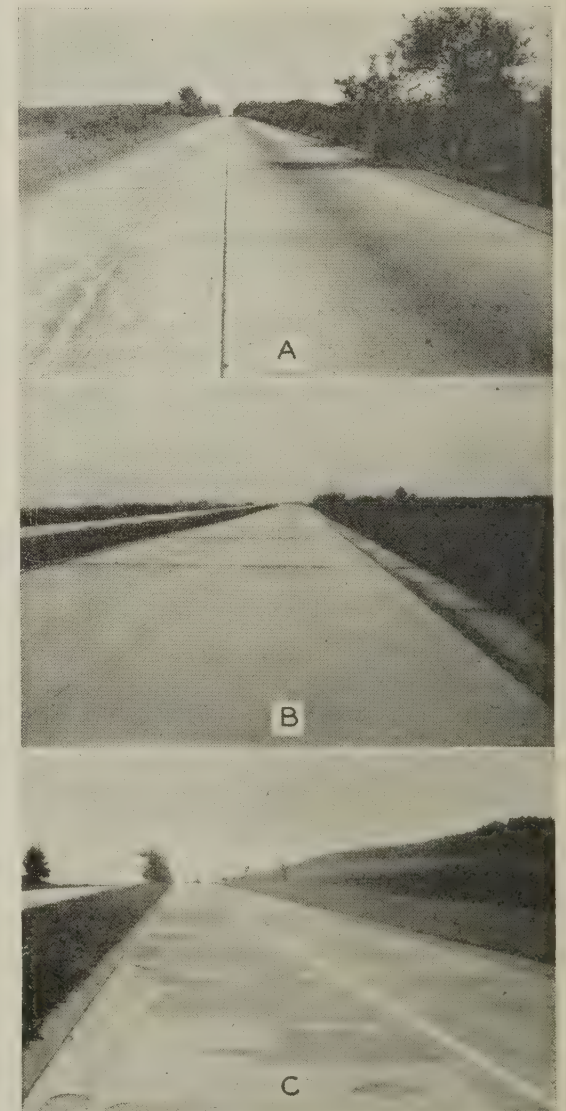
Figure 12.—(A) Joint faulting in the left lane (Ruhr-Frankfurt). (B) Warping resulted in high joints (Ruhr-Frankfurt). (C) Surface scale was seen only on the München-Salzburg route.

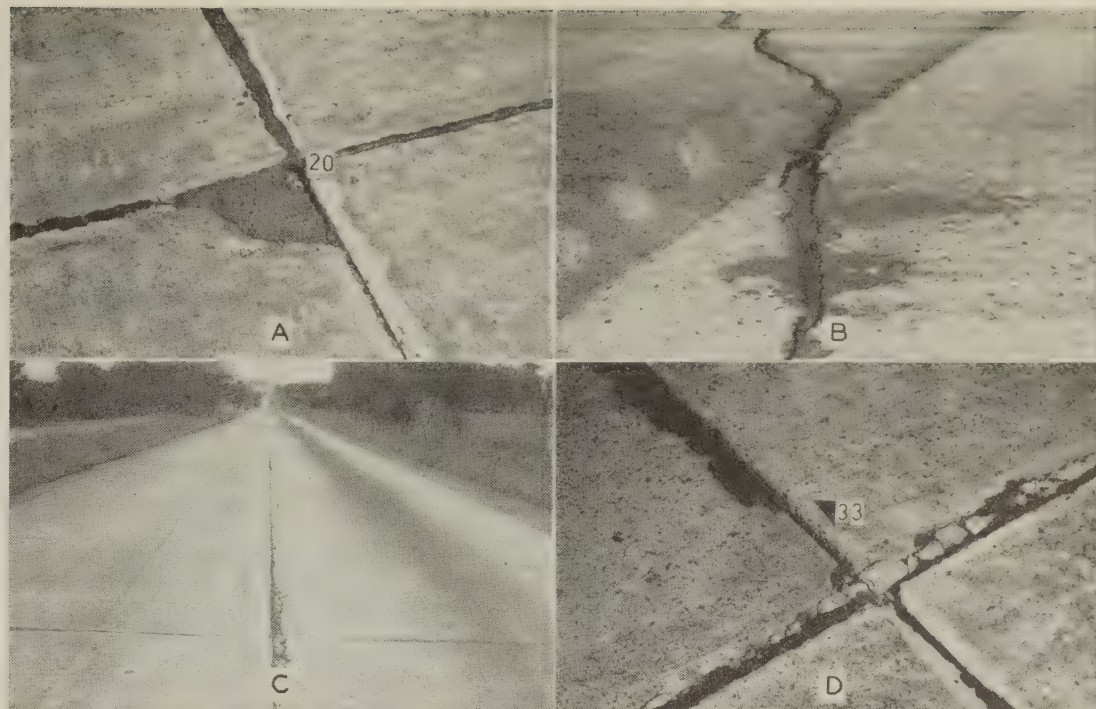
In the München-Salzburg section there were a few small corner breaks. With few exceptions, these were the only corner breaks found in the entire mileage inspected. A

small corner break which has been patched is shown in figure 13A.

Figure 13.—(A) A patched corner break (Frankfurt-Stuttgart). (B) A large random crack (Hannover-Ruhr). (C, D) Typical faulting of longitudinal joints (Ruhr-Frankfurt).

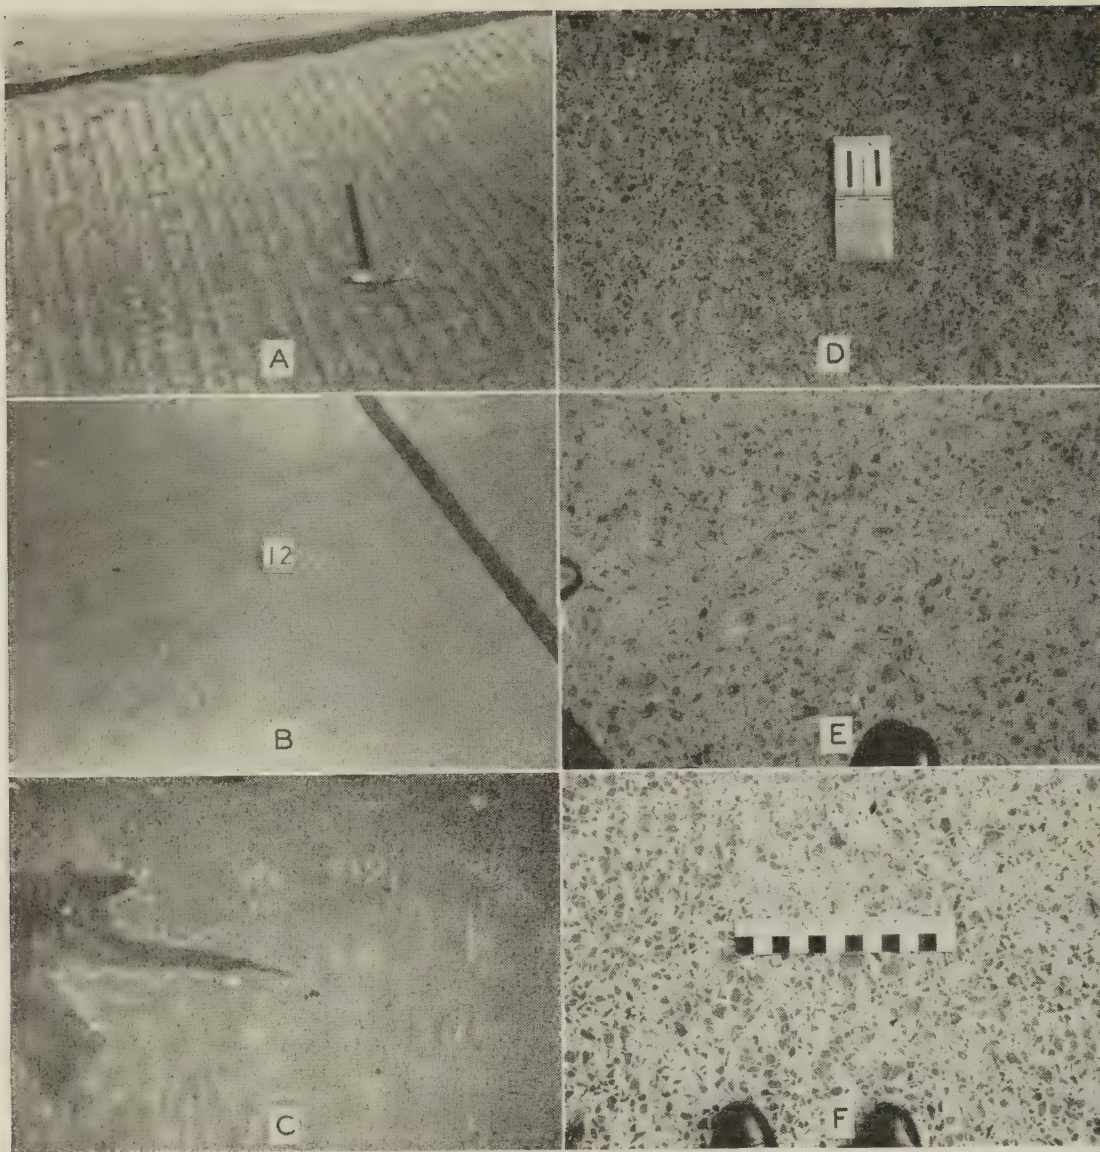
A characteristic feature of the pavement surface is the general absence of the rather heavy mortar top which we frequently leave on our roads and which so often scales off, leaving the surface rough and unsightly. An examination of the surface indicated, in most instances, the use of a mix that contained just enough paste to fill the voids in the aggregate and leave a small excess for finishing. Surfaces were dense and compact, with the coarse aggregate either just below the top or actually exposed in some degree. Typical illustrations of variations in the surface texture are shown in figure 14. Figure 14A is a view of a surface on which the screed marks are still showing. The corrugations are quite shallow and are about 1 inch apart. This particular photograph was taken just east of the Bad Oeynhaus interchange on the road to Hannover. Other sections showed the same condition, particularly on the inner lanes which, of course, carry less traffic. Figure 14B illustrates a fine-grained sand finish texture which was also noted in several places. The photograph was taken on the same road as figure 14A and about 5 miles east of the interchange.

Figures 14D-F illustrate varying degrees of coarse aggregate exposure. Figure 14D indicates the type of surface about 7 miles south of Frankfurt on the road to Stuttgart; figure 14E a section of the Hamburg-Lübeck road; and figure 14F, a section between Hannover and Berlin at kilometer post 194. Note in the last-mentioned illustration that coarse aggregate up to 1 inch in size, which is close to the maximum size used in the top course, is exposed. Many of the exposed aggregate surfaces are smooth, with a terrazzolike texture, probably the result of slight

surface wear. In many places this type of surface was noted in the center of the traffic lanes (particularly the outside lane) with the original thin mortar surface showing at the extreme edges. In other sections where the coarse aggregate was exposed, particles of the hard igneous rock protruded slightly above the mortar, producing a slightly rough surface. This condition may have resulted from the scaling off of the light surface mortar or it may have been the result of wear—it is difficult to determine the exact cause. However, it should be emphasized that the slightly rough surface is not objectionable from the standpoint of rideability. Neither should the exposure of the aggregate have any detrimental effect on the ultimate durability of the concrete, since the quality of both aggregate and concrete was excellent.

Figure 14.—(A) In some places screed marks still appear as shallow corrugations. (B) A fine-grained sand finish. (C) Black colored concrete. (D-F) Typical appearance of varying degrees of coarse aggregate exposure.

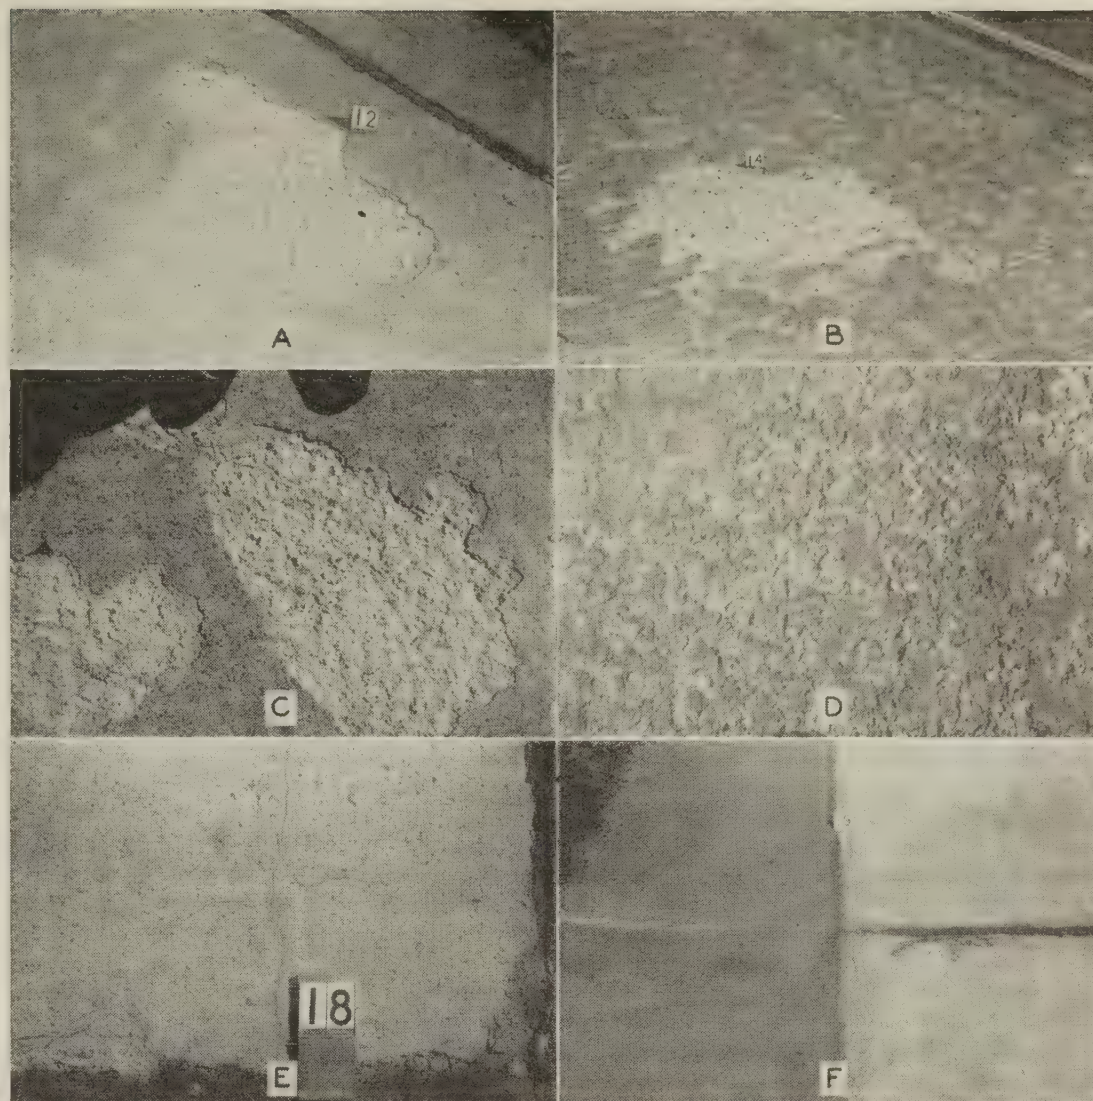
about 20 miles west of the Austrian border at Salzburg. Figures 15A and C are details showing the type of scaling that has developed on this section. It is apparently of the surface type only; that is, the concrete below the scaled areas appeared to be sound. Figures 15A and C indicate a rather heavy layer of surface mortar at this point and this fact, coupled with the possibility that the winters in this region, due to its high elevation, may be somewhat more severe than elsewhere in western Germany, may account for the scaling. However, in this connection it should be noted that, according to weather records as shown in table 1, the average January temperature at München was only slightly lower and the annual rainfall only slightly higher than for the more northern cities.

Figure 15.—(A-D) Surface scale occurred commonly on the München-Salzburg route but only isolated cases were observed elsewhere. (E, F) Incipient disintegration, revealed by D lines, was found only at one place on the system.
