**VERIDIAN REMOTE SIDE IMPACT AIR BAG AND SIDE CURTAIN
DEPLOYMENT INVESTIGATION
SCI TECHNICAL SUMMARY REPORT**

NASS/SCI COMBO CASE NO. 2000-09-004C

VEHICLE - 2000 MERCEDES-BENZ S500

CRASH DATE - JANUARY, 2000

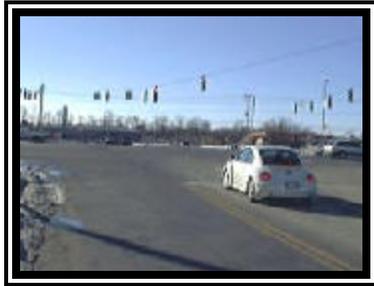
The 25 year old female driver of the 2000 Mercedes-Benz S500 was operating the vehicle westbound at a (driver reported) speed of 16 km/h (10 mph) when she entered the 4-leg intersection (**Figure 1**) and

Figure 1. Westbound approach for the 2000 Mercedes-Benz S500.

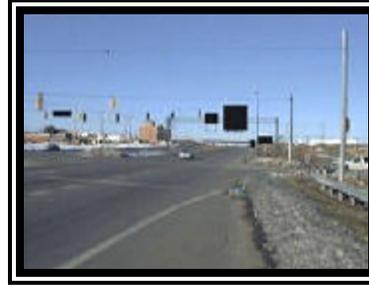
proceeded to turn left (south). The 1997 Honda Civic EX was driven by a 30 year old female who was operating the vehicle northbound (**Figure 2**) in the outboard lane at a (driver reported) speed of 64 km/h (40 mph) when she failed to detect the red phase of the overhead signal system or the Mercedes as she continued straight through the 4-leg urban intersection. Upon recognition of the impending harmful event, she braked in avoidance remaining in the northbound lanes prior to the collision (no pre-impact brake marks documented at the scene).

Figure 2. Northbound approach for the 1997 Honda Civic EX.

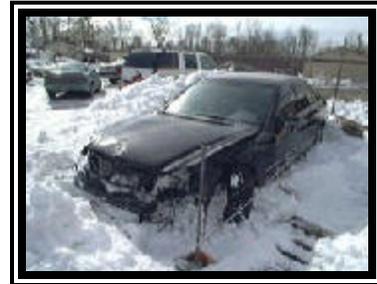
The Mercedes-Benz sustained moderate left side damage as a result of the impact with the Honda Civic (**Figure 3**). The direct damage began at the front left bumper corner and extended 63.0 cm (24.8 in) rearward. The combined direct and induced damage length (Field L) began at the front left bumper corner and extended 138.0 cm (54.3 in) rearward. Six crush measurements were documented at the level of the mid-door: C1= 0 cm, C2= 3.0 cm (1.2 in), C3= 8.0 cm (3.1 in), C4= 20.0 cm (7.9 in), C5= 31.0 cm (12.2 in), C6= 46.0 cm (18.1 in). The left front wheel was restricted (not deflated). Minor hood displacement was noted along with lateral bumper shift to the right. The windshield was undamaged.

Figure 3. Left side damage to the 2000 Mercedes-Benz S500.

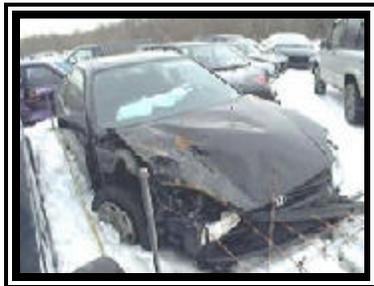
Figure 4. Frontal damage to the 1997 Honda Civic EX.

The 1997 Honda Civic EX sustained moderate frontal damage as a result of the impact with the Mercedes-Benz (**Figure 4**). The direct contact damage began at the front right bumper corner and extended 50.0 cm (19.7 in) inboard. The impact deformed the full frontal width resulting in a combined direct and induced damage length (Field L) of 103.0 cm (40.6 in). The bumper fascia separated from the reinforcement bar with an indentation noted from the left front wheel of the Mercedes-Benz. Direct contact damage was also noted along the right side surface of the vehicle from sustained contact prior to spinout. The right front wheel was deflated (not restricted). Reduction in the right side wheelbase measured 14.0 cm (5.5 in).

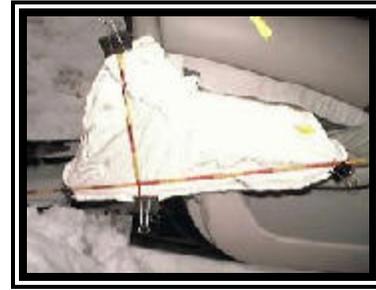
The Mercedes-Benz was also equipped with door-mounted side impact air bags for the outboard seating positions. The left side air bags deployed as a result of the crash. The air bags were housed in the door panel above the armrest with a horizontally oriented flap tear seam (H-configuration). The leather flaps were rectangular/symmetrical in shape and measured 35.0 cm (13.8 in) in width and 6.0 cm (2.4 in) in height. Although no contact evidence was identified on the exterior surface of the module cover flaps, blood spattering was found on the upper section of the air bag. The NASS researcher measured the left side impact air bag at 55.0 cm (21.7 in) in width and 40.0 cm (15.7 in) in height in its deflated state (**Figure 5**). The bag was tethered by one internal strap (no vent ports).

Figure 5. 2000 Mercedes-Benz S500 side impact air bag.

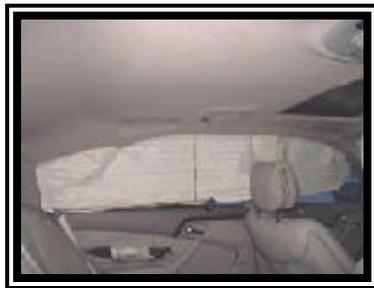
The Mercedes-Benz was also equipped with side curtains for the outboard seating positions (**Figures 6 & 7**). The left side curtain deployed as a result of the crash. The side curtain was housed between the interior roof headliner and structural roof side rail with a horizontal seam measuring 155.0 cm (61.0 in) in length (*separation of headliner versus an actual flap*). Hair strands were documented on the curtain just forward of the B-pillar area. The NASS researcher measured the left curtain at 165.0 cm (65.0 in) in width and 30.0 cm (11.8 in) in height in its deflated state. The curtain was tethered by an external strap connected to the left A-pillar.

Figure 6. Interior view of the 2000 Mercedes-Benz side impact curtain.

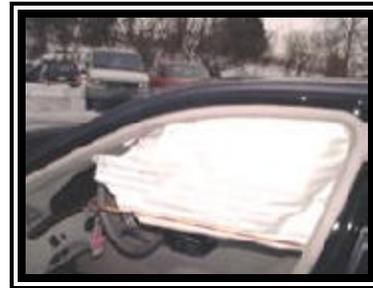
Figure 7. Secondary view of the Mercedes-Benz side impact curtain.
