**VERIDIAN REMOTE SIDE IMPACT OCCUPANT PROTECTION
INVESTIGATION
SCI TECHNICAL SUMMARY REPORT**

NASS/SCI COMBO CASE NO. 2000-09-071C

VEHICLE - 2000 LINCOLN TOWN CAR EXECUTIVE

CRASH DATE - MAY, 2000

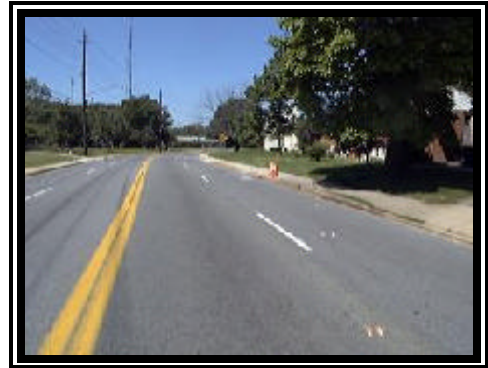
The 17 year old male driver of the 2000 Lincoln Town Car Executive was operating the vehicle westbound in the outboard lane of the 4-lane roadway and negotiating a left curve on wet pavement. As the Lincoln reached the apex of the curve, the vehicle broke traction on the wet road surface and began a counterclockwise yaw subsequently entering the eastbound lanes. Upon recognition of the impending harmful event, the driver over steered a right avoidance maneuver which re-directed the vehicle towards the north curb in a clockwise yaw (**Figure 1**).

Figure 1. Westbound approach for the 2000 Lincoln Town Car Executive.

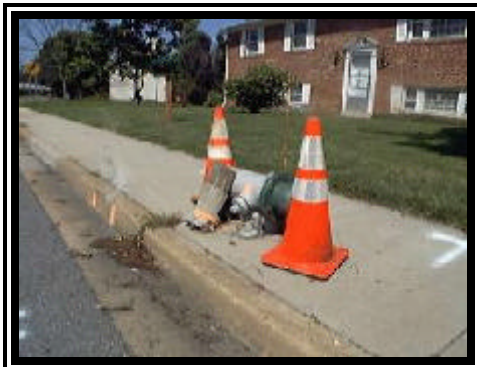
As the Lincoln departed the north pavement edge in a clockwise yaw, the vehicle traveled 0.7 meters (2.3 feet) as the left passenger area made initial contact with a fire hydrant (**Figure 2**) resulting in moderate damage. The impact induced deceleration was sufficient to deploy the left side impact air bag. *Contrary to the NASS case file*, a barrier equivalent velocity change for this impact could not be computed due to the overlapping nature of subsequent impacts. The left passenger area subsequently struck a mailbox post which resulted in minor damage. At this point, the vehicle continued in a northwesterly direction 16.7 meters (54.8 feet) as the left passenger area impacted a large diameter tree (**Figure 3**) resulting in severe damage. The Lincoln rotated counterclockwise 60 degrees and came to rest against the final impact facing northwest.

Figure 2. Struck fire hydrant (foreground) and mailbox post (background).

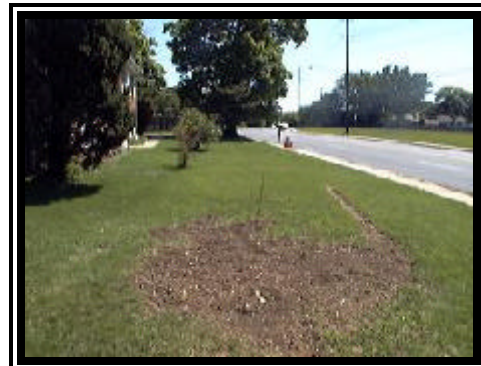
Figure 3. Southeast look back view from the tree impact and final rest (tree uprooted/removed).

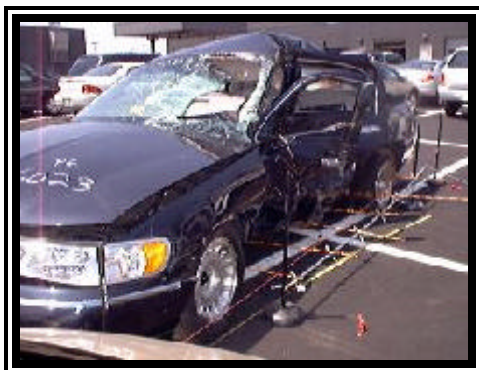
The 2000 Lincoln Town Car sustained moderate left side damage as a result of the impact with the fire hydrant (**Figures 4 & 5**). A narrow damage pattern was identified just rearward of the left A-pillar as the direct damage began 181.0 cm (71.3 in) forward of the left rear axle and extended forward 51.0 cm (20.1 in). The Collision Deformation Classification (CDC) for this initial impact to the Lincoln was 09-LPEW-9 (unknown crush extent zone represented by a "9"). Direct contact damage was also identified to the left B-pillar area attributed to the tree impact. The direct contact damage began 130.0 cm (51.2 in) forward of the left rear axle and extended forward 54.0 cm (21.3 in). The combined direct and induced damage length (Field L) for all impacts began at the left rear axle and extended forward 239.0 cm (94.1 in). Six crush measurements were documented at the level of the lower door: C1= 5.0 cm (2.0 in), C2= 17.0 cm (6.7 in), C3= 70.0 cm (27.6 in), C4= 61.0 cm (24.0 in), C5= 53.0 cm (20.9 in), C6= 20.0 cm (7.9 in). A maximum crush value of 79.0 cm (31.1 in) was documented between the C3 and C4 positions. *Contrary to the NASS case file*, the CDC for this (overlapping/highest Delta-V) final impact to the Lincoln was 09-LPAW-4 (*no vehicle bowing*). The left front wheel was restricted (not deflated) as the left rear wheel/tire was deflated (not restricted). The left side doors were jammed as the left side tempered glazings were disintegrated by the impact force. Lateral displacement of the A-pillar and B-pillar fractured the windshield and produced extensive buckling of the roof and header areas. Minor hood displacement was noted. Reduction in the left side wheelbase measured 15.0 cm (5.9 in) as the right side wheelbase was elongated 3.0 cm (1.2 in). Pry marks were noted to the left front door (with the right front door removed) from rescue personnel during occupant extrication activities post-crash, and further invalidated the crush profile for Delta-V calculations.

Figure 4. Oblique view of the 2000 Lincoln Town Car Executive.

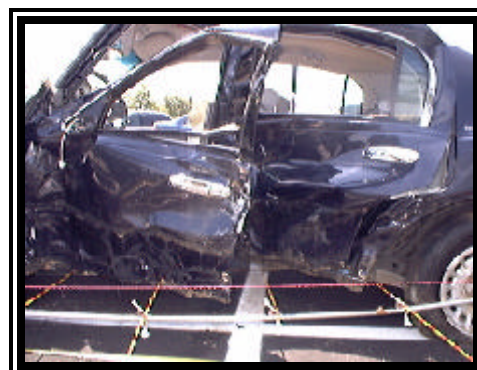
Figure 5. Overlapping damage to the left side surface.

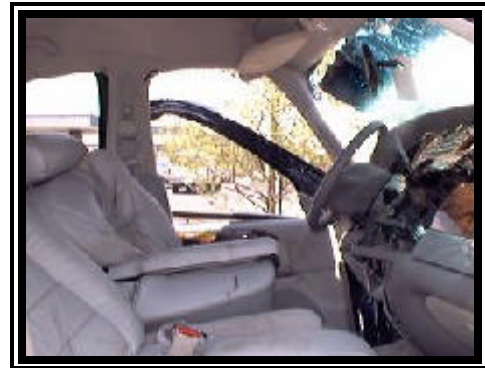
Interior damage to the Lincoln identified through the NASS vehicle inspection was severe and attributed to occupant contact and component intrusions (**Figure 6**). Scuff marks and indentations were documented on the left front door interior surface and B-pillar. Scuff marks were also noted to the upper left front door panel from the side impact air bag deployment. The center armrest was displaced to the left with loading marks noted on the right aspect of the driver seat back. The front left and center seats were deformed to a rearward mid-range position by extensive lateral intrusions. Lateral intrusions into the driver space involved 50.0 cm (19.7 in) of door panel/B-pillar, 14.0 cm (5.5 in) of sill, 25.0 cm (9.8 in) of kick panel, 26.0 cm (10.2 in) of roof side rail, 17.0 cm (6.7 in) of center armrest, and 4.0 cm (1.6 in) of A-pillar intrusion. Lateral intrusions into the rear left occupant space involved 51.0 cm (20.1 in) of door panel, 32.0 cm (12.6 in) of sill, and 6.0 cm (2.4 in) of roof side rail intrusion.

Figure 6. Interior view.

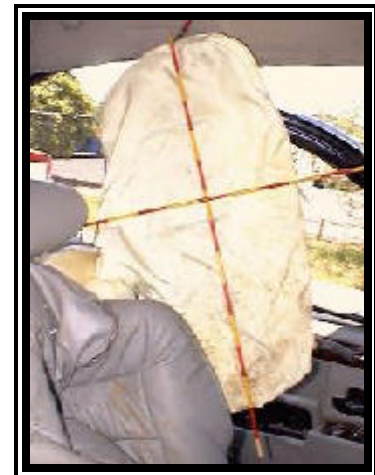
The Lincoln was also equipped with seat-mounted side impact air bags for the front outboard seating positions. The left side impact air bag deployed as a result of the crash. The air bags were housed in the outboard aspect of the front seat backs with a vertically oriented tear seam integrated into the seat back stitching. The air bag membrane inflated vertically to offer head and thoracic protection. The module was rectangular in shape and measured 9.0 cm (3.5 in) in width and 22.0 cm (8.7 in) in height. The NASS researcher measured the left side impact air bag at 35.0 cm (13.8 in) in width and 62.0 cm (24.4 in) in height in its deflated state (**Figure 7**). The bag was vented by one port located on the forward (centered) aspect of the air bag. No contact evidence was identified on the air bag membrane, however, bag interaction by the driver produced the noted scuff marks to the upper left door panel. No internal tether straps were present.

Figure 7. 2000 Lincoln Town Car Executive deployed side impact air bag.

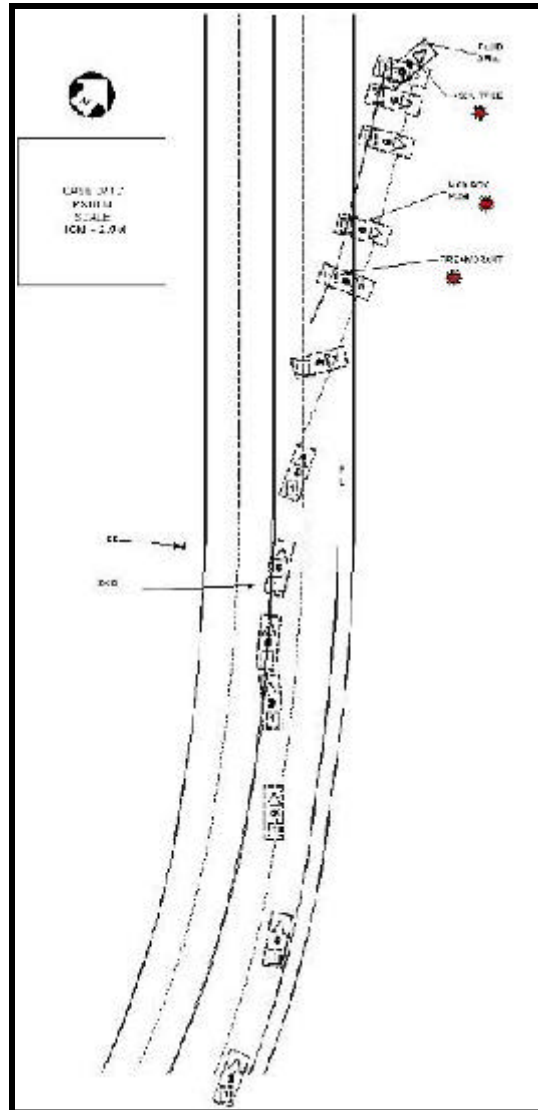
Figure 8. NASS Scene Diagram.

This single vehicle crash occurred during the early morning hours of May, 2000. At the time of the crash, it was dark (street lighted) with rainy conditions as the roads were wet. The crash occurred off the north pavement edge of a level 4-lane undivided roadway which curved left for westbound traffic (**Figure 8 - page 7**). The asphalt roadway was bordered by barrier curbs, residential driveways and mailboxes. Additional roadside objects consisted of a fire hydrant located 0.7 meters (2.3 feet) off the north curblines and a large diameter tree located 7.0 meters (23.0 feet) off the north curblines. No traffic control was present at the scene which had a posted speed limit of 48 km/h (30 mph).
