**REMOTE REDESIGNED AIR BAG DEPLOYMENT INVESTIGATION
SCI TECHNICAL SUMMARY REPORT**

NASS/SCI COMBO CASE NO. 00-08-226C

VEHICLE - 2000 NISSAN ALTIMA

CRASH DATE - DECEMBER 2000

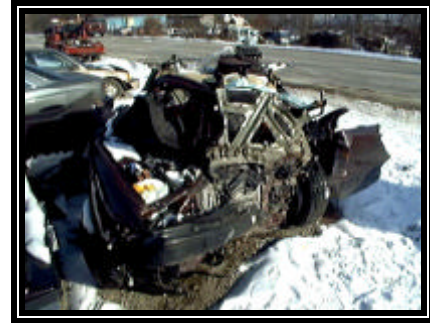
This remote investigation involved a 2000 Nissan Altima (**Figure 1**) equipped with redesigned frontal air bags, driver and front right passenger side air bags, and front seat belt pretensioners that deployed as a result of a frontal collision with a concrete bridge support. The Altima was occupied by a 42-year-old male driver that was restrained by the 3-point lap and shoulder belt. The driver was operating the Altima northbound in the outboard lane of a divided highway when he lost consciousness and relinquished control of the vehicle. The Altima drifted to the right and departed the right roadside in a tracking mode. The Altima continued along the road edge and struck a concrete bridge support with the front left area. The severe frontal impact fired the front left seat belt pretensioner, and deployed the redesigned frontal air bag system and both side air bags. The restrained driver initiated a forward trajectory in response to the frontal impact force and loaded the manual restraint which resulted in multiple left rib fractures, a liver laceration, a heart injury, and a lung injury. Due to the high delta-V, he subsequently loaded through the redesigned driver's air bag and loaded the steering wheel rim/hub. He sustained a mandible fracture from probable contact with the steering wheel rim. He sustained multiple lower extremity injuries from contact with the intruded left instrument panel, floor pan and toe pan. The driver was conscious and talking at the scene and removed from the vehicle by rescue personnel. He was transported by helicopter to a regional trauma center and expired 10 days following the crash.

Figure 1. Damaged 2000 Nissan Altima

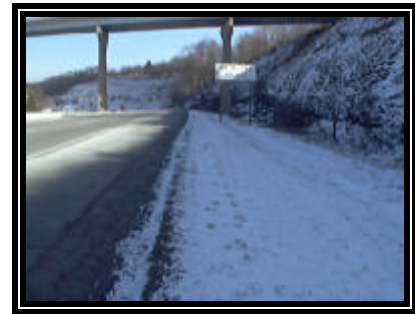
Figure 2. Approach view showing the point of roadway departure

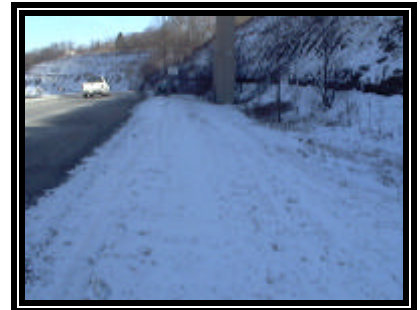
Figure 3. 2nd approach view

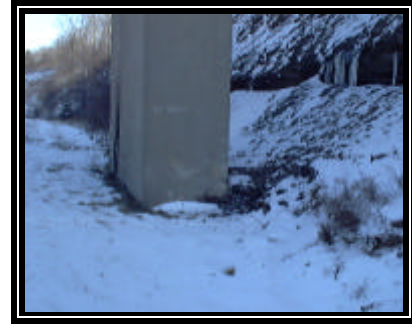
The 2000 Nissan Altima impacted the concrete bridge support (**Figure 4**) with the front left area. The bridge support measured 1.5 m (5.0') in width and 5.0 m (16.5') in length. The impact resulted in severe damage to the Altima. The direction of force was in the 12 o'clock sector. The barrier routine of the WinSMASH program computed a total velocity change of 79.4 km/h (49.3 mph) based on the documented crush profile. The impact induced deceleration was sufficient to fire the front left retractor-mounted seat belt pretensioner and deploy the redesigned frontal air bag system in the Altima. Although the Altima sustained a severe frontal impact, the driver's side air bag and right front passenger's side air also deployed. The offset left crash caused it to rotate counterclockwise (CCW) approximately 30 degrees to final rest against the bridge support.

Figure 4. Point of impact - concrete bridge support

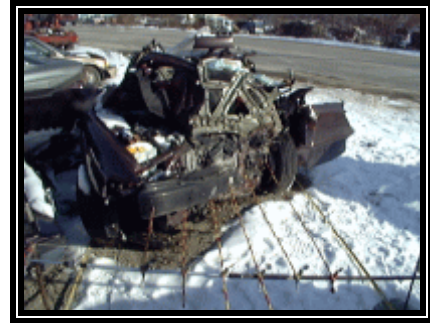
The 2000 Nissan Altima sustained severe damage as a result of the impact with the concrete bridge support. The direct contact damage began at the front left bumper corner and extended 79 cm (31") laterally across the bumper. The combined direct and induced damage involved the entire frontal width of the vehicle (**Figure 5**). The bumper fascia was separated from the vehicle. The bumper beam was crushed rearward on the left side and displaced slightly to the right. The maximum crush was located at C1 at the front left bumper corner and measured 121 cm (48"). The hood was buckled at the designated fold points. The left front wheel was crushed rearward to the left A-pillar (**Figure 6**) and was restricted and deflated. The right front wheel was also crushed rearward and was restricted. The severe frontal crush resulted in an 81 cm (32") reduction in the left wheelbase and a 12 cm (5") reduction in the right wheelbase. The left front fender was separated from the vehicle and the left front door was displaced from induced damage and rescue efforts. The front aspect of the right front fender and was pulled toward the center of the vehicle. The left aspect of the front bumper beam was fractured and separated. The roof was removed from the vehicle by rescue personnel. The Collision Deformation Classification for this impact was 12-FYEW-5. Six crush measurements were taken by the NASS researcher at the front bumper level and were as follows: C1 = 121 cm (48"), C2 = 121 cm (48"), C3 = 92 cm (36"), C4 = 70 cm (28"), C5 = 50 cm (20"), C6 = 33 cm (13").

Figure 5. Frontal view of direct damage

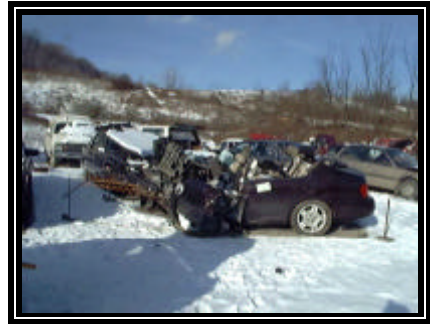
Figure 6. Left side view of the damaged Altima

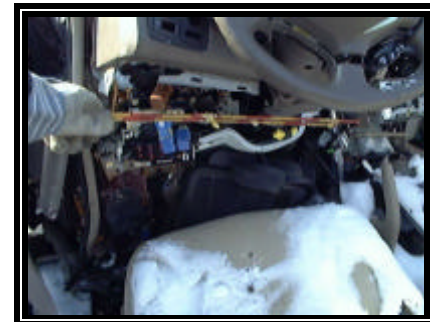
Interior damage to the 2000 Nissan Altima was severe and attributed to compartment intrusion and occupant contact. Integrity loss and glazing damage resulting from the crash or occupant contact could not be determined due to the removal of the glazing and removal of the roof by rescue personnel. Multiple intrusions were documented by the NASS researcher. The most severe intruded component into the front left seat area was the left toe pan which intruded 70 cm (28") longitudinally (**Figure 7**). The instrument panel was damaged from intrusion and occupant contact, and multiple instrument panel components were displaced and separated. The rigid plastic knee bolster was deformed and separated from the lower left instrument panel from contact with the driver's legs. The front left seat back was also deformed rearward and slightly clockwise (CW) from

Figure 7. Intruded left toe pan and left instrument panel

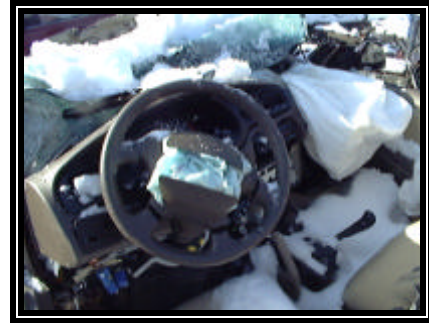
occupant contact, and the adjustable head restraint was separated from the seat back. The steering wheel rim was uniformly displaced forward and was partially separated at the inboard edges of the spokes (**Figure 8**). Although the NASS case file coded “no steering rim deformation,” the SCI case review identified that the steering wheel sustained a complete collapse. The glove box door opened as a result of the crash.

Figure 8. Uniform steering wheel rim displacement

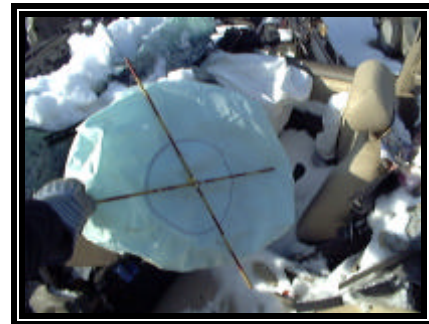
The 2000 Nissan Altima was equipped with redesigned frontal air bags for the driver and front right positions that deployed as result of the impact with a concrete bridge support. The driver’s redesigned air bag was housed in the center of the steering wheel with H-configuration module cover flaps. The top flap measured 15 cm (6") in width and 7 cm (3") in height. The bottom flap measured 15 cm (6") in width and 9 cm (4") in height. The redesigned air bag was circular in shape and measured 60 cm (24") in diameter in its deflated state (**Figure 9**). It was vented by two ports that were located at 10 and 2 o’clock on the rear aspect of the air bag. The redesigned air bag was not tethered. Blood spattering was noted on the lower front quadrants and on the lower rear left aspect of the air bag membrane.

Figure 9. Redesigned driver’s air bag

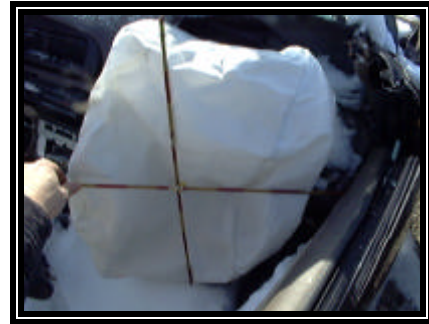
The front right passenger's redesigned air bag deployed from a top-mounted module with H-configuration module cover flaps. The entire module panel measured 32 cm (13") in width and 15 cm (6") in height and was configured with a horizontal tear seam. The upper and lower cover flaps within the module panel were symmetrical and measured 15 cm (6") in width and 5 cm (2") in height. The redesigned front right passenger's air bag was rectangular in shape and measured 30 cm (12") in width and 50 cm (20") in height in its deflated state (**Figure 10**). It was vented by two circular ports located on the side aspects at the 9 and 3 o'clock positions. The air bag was not tethered. There was no contact evidence on the membrane of the air bag.

Figure 10. Redesigned front right passenger's air bag

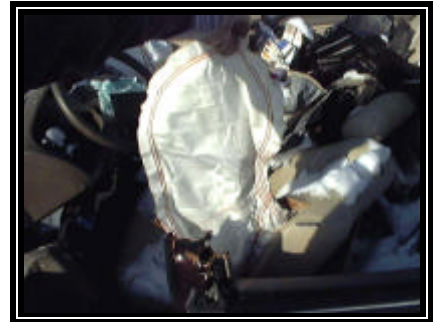
The 2000 Nissan Altima was equipped with a seat mounted side air bags for both front seated occupants that deployed as a result of the impact with the bridge support. Although the side impact occupant protection system is not designed to deploy in a frontal collision, the severe impact force in this crash resulted in deployment of the system. Both side air bags offered head and thorax protection. The driver's side air bag deployed in a forward direction from the left aspect of the front left seat back (**Figure 11**). The vertical tear seam extended along the outboard forward stitching on the seat back from the top aspect to the bottom aspect. The driver's side air bag measured 30 cm (12") in width at the top aspect and 70 cm (28") in height. The air bag was not vented and there were no internal tethers. No contact evidence was found on the driver's side air bag.

Figure 11. Driver's side air bag

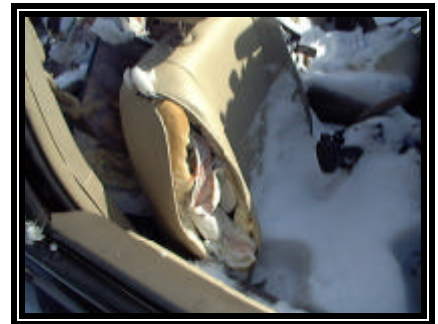
The front right passenger's side air bag deployed in a forward direction from the right aspect of the front right seat back. The vertical tear seam extended along the outboard forward stitching on the seat back from the top aspect to the bottom aspect (**Figure 12**). The front right passenger's side air bag measured 30 cm (12") in width at the top aspect and 70 cm (28") in height. The air bag was not vented and there were no internal tethers. No contact evidence was found on the front right passenger's side air bag.

Figure 12. Right front passenger's side air bag tear seam
