**ADVANCED OCCUPANT PROTECTION SYSTEM STUDY
2000 MERCURY SABLE INVESTIGATION**

VERIDIAN CASE NO. 2000-11-075E

LOCATION - MICHIGAN

CRASH DATE - JUNE 2000

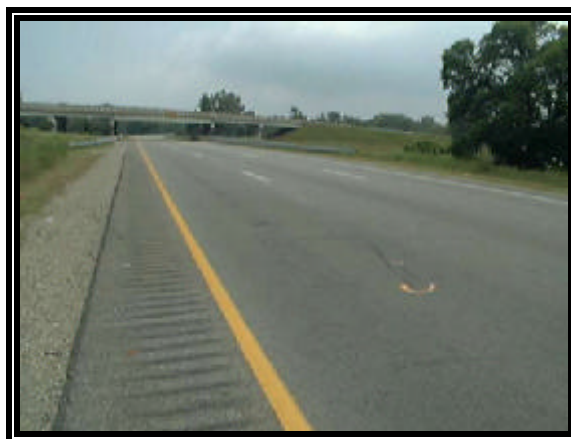
Figure 1: Eastbound trajectory at the point of impact.

The front left corner of the Mercury struck the rear right corner of the Lincoln in an offset front-to-rear impact configuration. The point of impact was identified by two gouge marks attributed to the left front suspension of the Mercury (refer to Figure 1). The force of the impact displaced the Lincoln forward and to the left into the median. The steering maneuver altered the trajectory of the Mercury to the northeast. The impact force caused it to begin rotating counterclockwise. The vehicle slid across the eastbound traffic lanes and came to rest facing westward on the outboard road shoulder. **Figure 2** is a schematic of the crash scene. The force of the impact fired the pretensioner in the driver's buckle assembly. It did not deploy the front or side air bags of the Mercury.

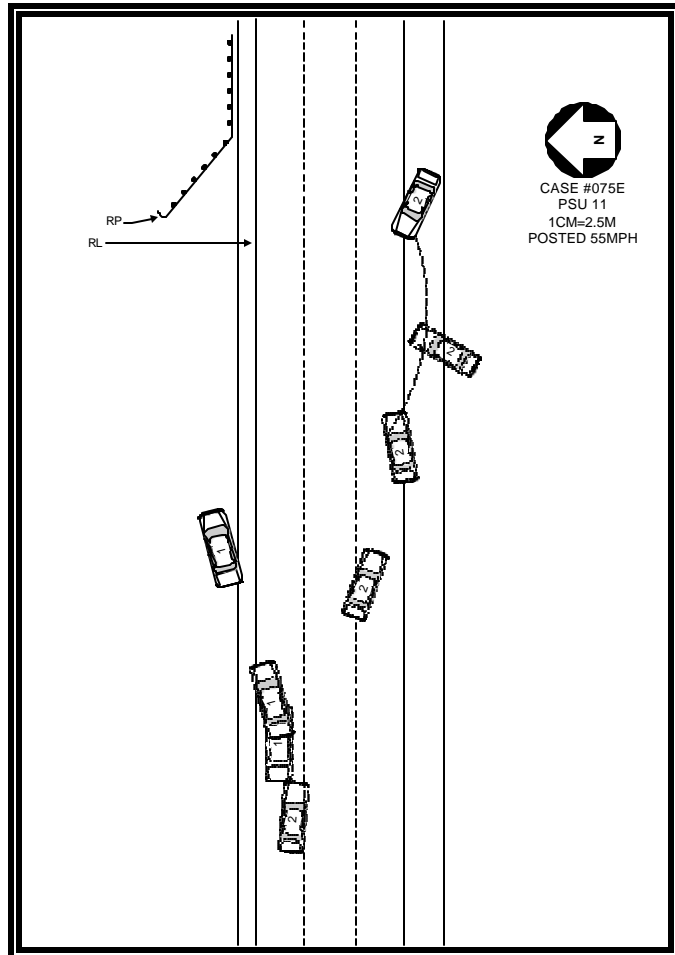
Figure 2: Crash scene schematic.

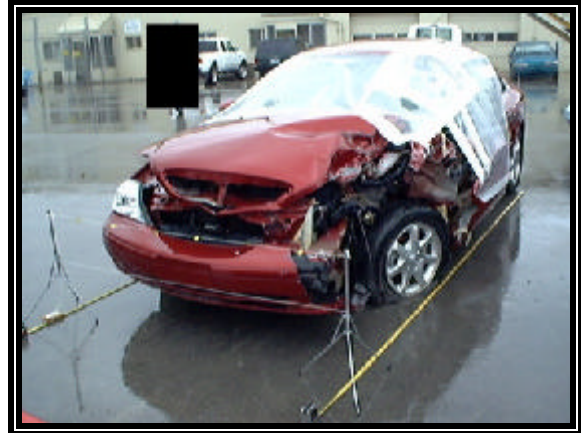
Figure 3 is a left front view of the Mercury. The vehicle's front plane sustained 28 cm (11 in) of direct contact damage that began 48 cm (19 in) left of center and extended to the left corner of the front bumper. The direct contact was confined to the left front aspect of the vehicle immediately outside the left uni-body frame rail and extended longitudinally into the left front suspension area. The left side damage extended rearward onto the left front door panel 264 cm (104 in) from the front of the vehicle. The crush profile measured at the bumper elevation was as follows: C1=38 cm (15 in), C2=2 cm (1 in), C3=0, C4=0, C5=0, C6=0. The left wheelbase was foreshortened

Figure 3: Left front view of the Mercury's damage.

11.4 cm (4.5 in). The windshield was fractured and the left front glazing had disintegrated. The left front door was jammed shut by deformation. The remaining doors were operational. The Collision Deformation Classification (CDC) was 12-FLEE-6. The principle direction of the force was estimated to be 350 degrees. The total delta V calculated by the Damage Only algorithm of the WINSMASH model was 21.4 km/h (13.3 mph). The longitudinal and lateral components of the delta V were -21.1 km/h (-13.1 mph) and 3.7 km/h (2.3 mph) respectively. It should be noted the calculated delta V was slightly less than the values reported in the NASS file. The SCI revised calculation utilized a crash test based stiffness coefficient rather than the default stiffness values used by NASS.

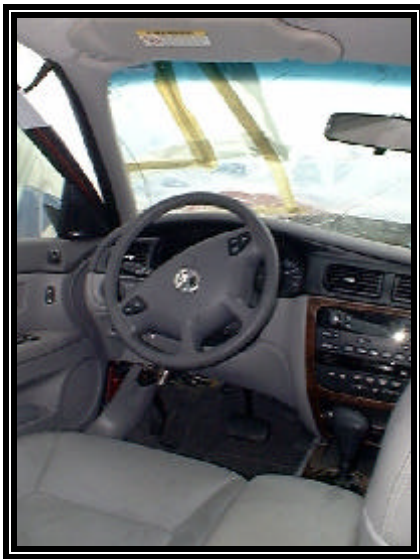
Figure 4 is a view of the driver's interior. The 6-way power driver's seat was adjusted to the full-rear track position. This was the at-crash position of the seat due to crash damage to the vehicle's electrical system. There was approximately 2 cm (1 in) of intrusion of the left kick panel into the driver's foot well due to the exterior crash force. The Mercury was equipped with adjustable foot controls. The pedals were in the full-forward position with respect to the vehicle, **Figure 5**.

Figure 4: View of the driver's position.

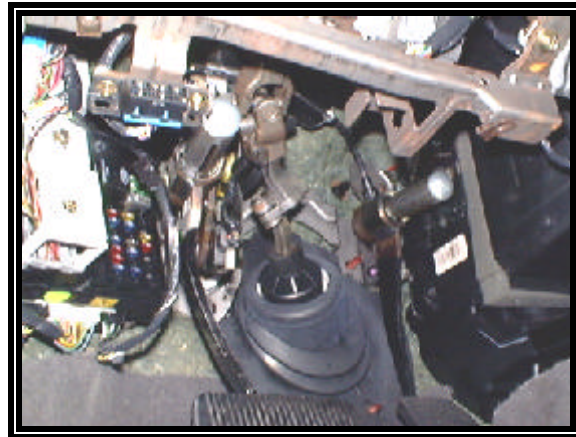
Figure 5: View of the adjustable pedals.

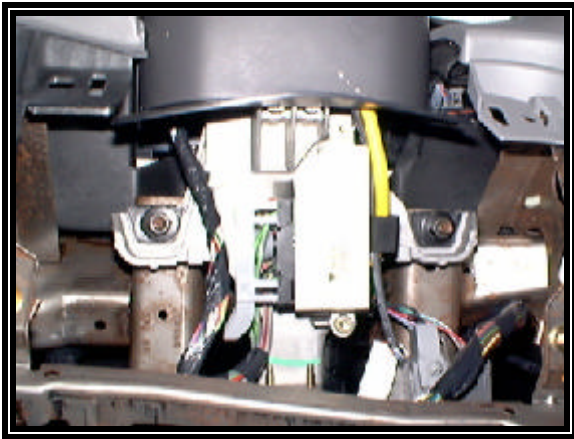
The tilt steering wheel was adjusted to a position between center and full-up. There was no steering wheel rim deformation. There was approximately 31 mm (0.12 in) movement of the left shear capsule. The right shear was not displaced. The steering column's lower support bracket was slightly bent on the outboard

side. The lower coupling was intact. Refer to **Figure 6**.

Figure 6: View of the steering column's shear capsules.

The driver's left lower extremity contacted and scuffed the left aspect of the bolster. The driver probably loaded the steering wheel rim through his arms causing the small displacement of the left shear capsule and bent the lower mounting bracket. The driver then rebounded back into his seat coming to rest.

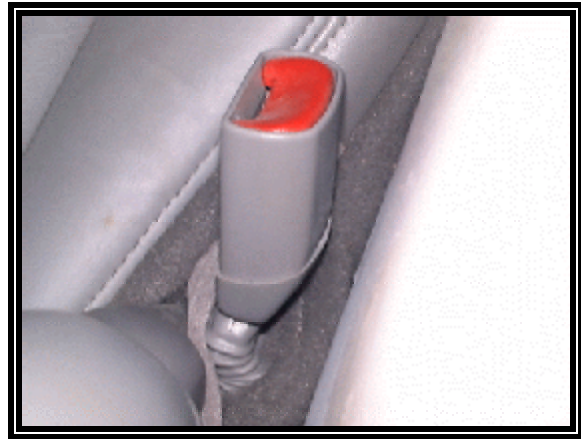
The vehicle was equipped with 3-point lap and shoulder belt systems in the front outboard seat positions. The front seat belt systems consisted of a continuous loop lap and shoulder belt webbing with a sliding latch plate. The vehicle sensitive/energy management retractors were located in the base of the B-pillars. The left latch plate exhibited marks consistent with belt use and the vehicle's age. There was no direct evidence of occupant loading to the left restraint webbing. The front restraints were also equipped with buckle mounted pretensioners. The driver's pretensioner fired as a result of the crash, **Figure 7**. The post-crash measurement of the pretensioner's barrel was 60.4 mm (2.38 in). The right buckle pretensioner did not fire.

Figure 7: View of the left buckle from above.

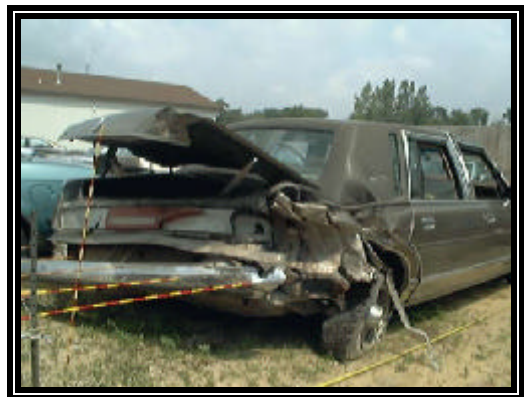
Figure 8: Right rear view of the Lincoln.

The back plane of the Lincoln sustained 41 cm (16 in) of direct contact damage that began 44 cm (17 in) right of center and extended to the right corner of the rear bumper. Refer to **Figure 8**. The crush profile measured at the rear bumper elevation was as follows: C1=0, C2=0, C3=12 cm (4.7 in), C4=31 cm (12.2 in), C5=46 cm (18.1 in), C6=63 cm (24.8 in). The crash damage collapsed the trunk and buckled the right rear quarter-panel. The right wheelbase was foreshortened 8 cm (3 in). The Collision Deformation Classification was 06-BREE-03. The Lincoln's delta V calculated by the Damage Only algorithm of the WINSMASH model 17.7 km/h (11.7 mph). The SCI revised calculated delta V differed slightly from the values reported in the NASS file.
