**VERIDIAN ON-SITE CHILD SAFETY SEAT CRASH INVESTIGATION
SCI TECHNICAL SUMMARY REPORT**

NASS/SCI COMBO CASE NO. 00-11-134K

VEHICLE - 1994 FORD TEMPO

CRASH DATE - SEPTEMBER 2000

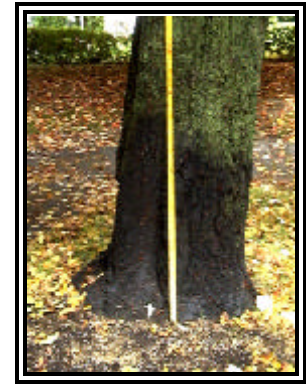
The Ford Tempo impacted a tree that measured 61cm (24") in diameter with the front center area (**Figure 4**). The NASS-reported principal direction of force and WinSMASH results were revised by SCI based on the on-site investigation. The trajectory algorithm of the WinSMASH program computed an impact speed of 64.1 km/h (39.8 mph). The principal direction of force was 0 degrees. The damage algorithm of the WinSMASH program computed a total velocity change of 58.8 km/h (36.5 mph). The longitudinal and latitudinal components were -58.8 km/h (36.5 mph) and 0.0 km/h, respectively. The vehicle came to rest on the roadside adjacent to the tree facing north.

Figure 4. Impact area on the tree

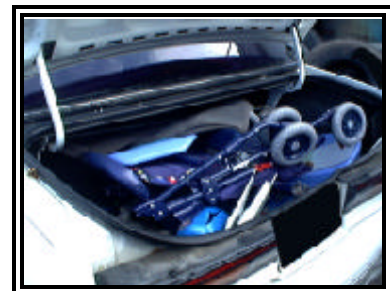
The 1994 Ford Tempo had numerous unsecured items in the trunk which loaded the rear seat back at impact. Based on the vehicle inspection, the trunk contents included the following: a bag containing two pairs of shoes, a child stroller, child bathtub, two containers of radiator coolant, and a temporary spare tire (T125/80D13) which was also unsecured (**Figure 5**).

Figure 5. View showing loose contents in the trunk

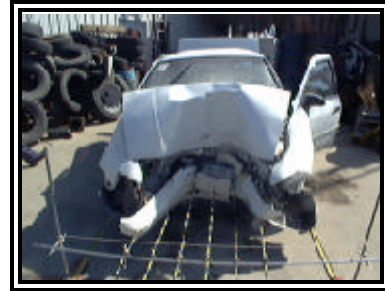
The 1994 Ford Tempo sustained severe frontal damage as a result of the impact to the tree (**Figure 6**). Maximum crush was located at C4 and measured 75 cm (30"). Direct contact damage began 39 cm (15") inboard of the front left bumper corner and measured 47 cm (19"). The combined direct and induced damage measured 75 cm (30"). The Collision Deformation Classification (CDC) was 12-FYEW-3. The hood was buckled rearward and upward at the designated fold points. The bumper fascia and bumper beam were bowed inward on both outboard sides, and the center of the beam was crushed rearward to the lower radiator support. Both front fenders were deformed inward at the front aspects. Both front wheels were restricted and left front tire was deflated (**Figure 7**). The left wheelbase was reduced by 29 cm (11") and the right wheelbase was reduced by 13 cm (5"). The leading edge of the sills were buckled on both sides and both fenders overlapped the leading edges of the front doors. The roof was buckled on both sides at the B-pillars. The windshield was cracked from impact forces. Six crush measurements were taken by the NASS Researcher at the level of the bumper and were as follows: C1: 21 cm (8"), C2: 74 cm (29"), C3: 72 cm (28"), C4: 75 cm (30"), C5: 46 cm (18"), C6: 10 cm (4").

Figure 6. Frontal damage to Ford Tempo

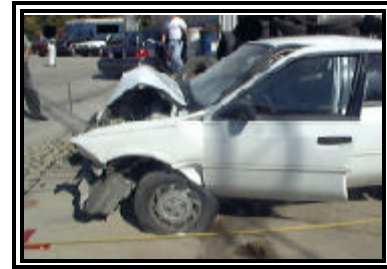
Figure 7. Left side view of exterior damage

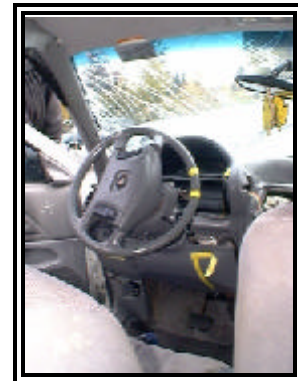
Interior damage to the 1994 Ford Tempo was moderate and attributed to occupant contact and compartment intrusion (**Figure 8**). A scuff mark was noted on the left instrument panel under the headlight switch. The plastic bolster cover under the steering column was displaced from occupant contact. Scuff marks were documented on the right aspect of the cover. A small abrasion was noted on the upper aspect of the steering wheel rim. The top half of the steering wheel rim was bent forward 5 cm (2") from occupant loading and the spokes were displaced from the steering wheel hub. The steering column was compressed from occupant loading. The left and right shear capsules were displaced rearward 1.2 cm (0.5"). The center instrument panel was fractured and the circular control knob for the fan control was displaced from the instrument panel. The rearview mirror was displaced, but remained fixed on the windshield. The driver's 2-point shoulder belt showed signs of loading. The center console between the front bucket seats was displaced forward. The glove box door had opened as a result of the impact. The front left seat back and right side aspect were deformed and scuffed from occupant loading and loading of the child safety seat.

Figure 8. Interior view of front left position showing contacts

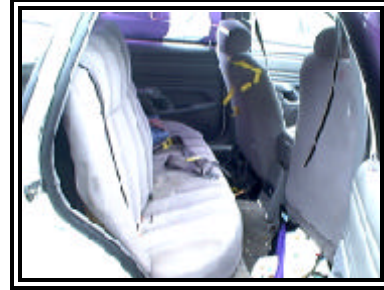
The rear seat back was intruded (**Figure 9**). The most severe portion of the intruded rear seat back was the center position.

Figure 9. Interior view of rear seat showing intrusion

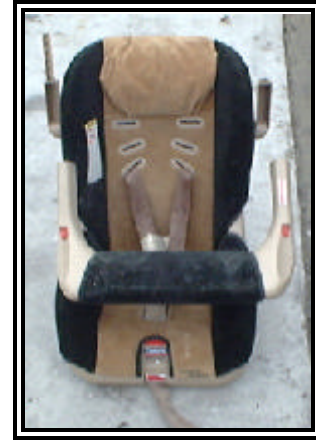
Figure 10. Convertible child safety seat

Misuse of the child safety seat was noted in this crash. According to the observations of the on-scene police officer, the child was found in the child safety seat with the harness system latch plate disengaged from the buckle. Based on the damage to the latch plate of the harness system, the latch plate was probably secured properly in the buckle assembly however, it can not be confirmed. The harness straps were in the lowest slot position even though the seat was in a forward orientation. The harness straps were probably not tight enough to properly restrain the child. At the time of the vehicle inspection, the one-piece plastic harness retainer clip was placed at the lowest point on the right harness strap, and the left harness strap was not routed through the harness retainer clip.

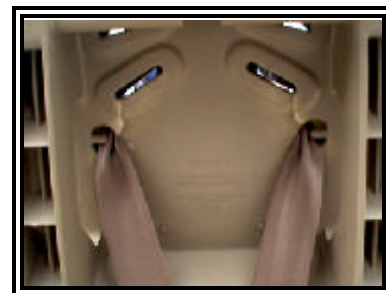
The child safety seat involved in this crash sustained moderate damage as a result of occupant loading. Because the harness straps were not placed in the upper-most slot position, they were not positioned over the reinforced portion of the child safety seat, which allowed the harness straps to pull through the plastic shell on the rear aspect when the child loaded the harness straps (**Figure 11**). Tears in the plastic rear aspect of the seat measured 3 cm (1") downward from outboard aspects of the lower slots. Damage was also noted to the rigid plastic tray shield which was displaced forward from the arms on the side of the seat. The occupant loading to the tray shield and the contact with the front left seat back caused the inside arm to

Figure 11. Harness straps pulled through plastic shell

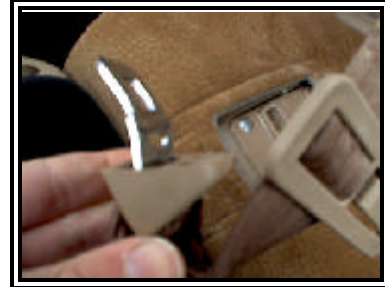
fracture on the left side and become disengaged. The right side of the tray shield was displaced from the right arm. The harness latch plate was deformed in a forward direction from occupant loading (**Figure 12**). The rigid plastic bottom aspect of the child safety seat was scuffed from the forward travel on the rear seat cushion.

Figure 12. Damage to the harness latch plate and improper positioning of the harness retainer clip

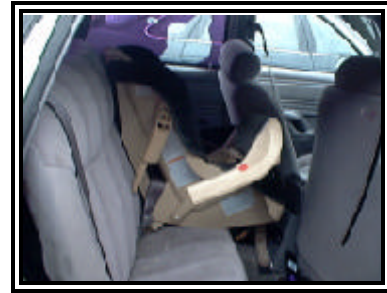
The loose contents of the trunk loaded the rear seat back, causing the center rear seat back to intrude forward 36 cm (14") (**Figure 13**). This caused the child safety seat to travel forward and load the lap belt. The child safety seat was probably not tightly secured, as there was minimal abrading to the plastic shell through which the lap belt was routed. The lack of more severe loading evidence to the lap belt indicates that there was probably slack in the lap belt prior to the loading applied to it. The lap belt buckle assembly remained engaged and there were no performance failures despite the intrusion and forward travel of the child safety seat. The forward travel of the child safety seat allowed it to contact the rear aspect of the center console which displaced the top portion of the console.

Figure 13. Approximate position of the child safety seat and intruded rear seat back
