**REMOTE REDESIGNED AIR BAG RELATED ADULT PASSENGER FATALITY  
INVESTIGATION  
SCI TECHNICAL SUMMARY REPORT**

**NASS/SCI COMBO CASE NO. 00-12-091A**

**VEHICLE - 1999 BUICK PARK AVENUE**

**CRASH DATE - MAY 2000**

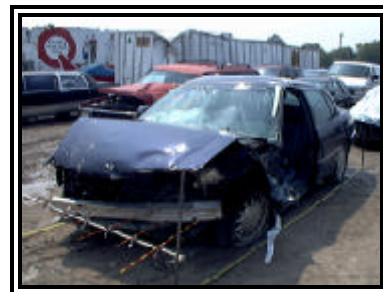
**Figure 4. Damage to the 1999 Buick Park Avenue**

The 1999 Buick Park Avenue sustained severe damage as a result of the impact with the Chevrolet Corsica (**Figure 4**). The direct contact damage began at the front left bumper corner and extended 79 cm (31") across the frontal plane. The combined direct and induced damage involved the entire frontal width of the vehicle and measured 132 cm (52"). The maximum crush measured 90 cm (35") and was located at the front left corner at C1. The entire bumper fascia, grille, and headlights were separated from the vehicle. The bumper beam was crushed rearward on the left side. The hood was buckled rearward, and direct contact abrasions were visible on the left leading aspect of the hood. The left front wheel was restricted and the tire was deflated. Due to the crush on the left side of the vehicle, the left wheelbase was shortened by 21 cm (8"). The leading edge of the left front fender was crushed rearward and the rear edge was

deformed by rescue personnel. The left roof side rail was buckled at the left B-pillar and the left front door was removed by rescue personnel. The Collision Deformation Classification for the initial impact with the Corsica was 12-FYEW-3. Six crush measurements were taken by the NASS researcher at the level of the bumper beam, and were as follows: C1 = 75 cm (30"), C2 = 71 cm (28"), C3 = 65 cm (26"), C4 = 46 cm (18"), C5 = 23 cm (9"), C6 = 0 cm.

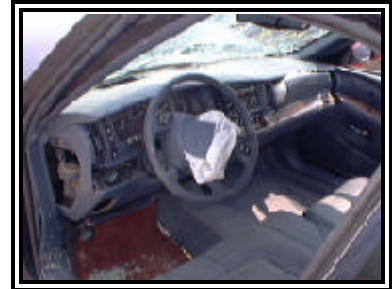
**Figure 5. Interior view of the 1999 Buick Park Avenue**

Interior damage to the 1999 Buick Park Avenue was moderate and attributed to occupant contact and compartment intrusion (**Figure 5**). The windshield glazing was fractured from impact forces. The left lower instrument panel was displaced from impact forces and the rigid plastic knee bolster was deformed from occupant contact. The left quarter area of the steering wheel rim was deformed forward 2 cm (1") from occupant loading. The left toe pan intruded longitudinally 15 cm (6") and the roof intruded vertically 9 cm (4") into the driver's seating position. The driver's foot controls were slightly displaced. The driver's sun visor and rear view mirror were displaced from occupant contact. The glove compartment door was scuffed from occupant contact. The cover on the left aspect of the driver's seat back over the integrated seat belt was separated from the seat back. The left and middle aspects of the rear seat cushion became separated and displaced forward from the rear seat anchors.

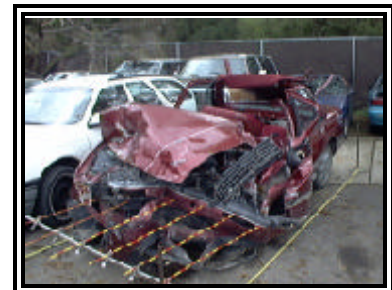
**Figure 6. Damage to the 1989 Chevrolet Corsica**

The 1989 Chevrolet Corsica sustained severe damage as a result of the impact with the Buick Park Avenue (**Figure 6**). The direct contact damage began at the front left bumper corner and extended 104 cm (41") across the entire frontal plane. The combined direct and induced damage involved the entire frontal width of the vehicle. The front bumper was fractured in the center and partially separated from the vehicle on the right side. The left side of the front bumper and left front fender were crushed rearward to the left A-pillar. The maximum crush was located at the front left bumper corner at C1 and measured 114 cm (45"). The hood was buckled rearward and the displaced slightly to the left. The right fender and right front wheel were displaced toward the center of the vehicle. The left wheel was restricted and deflated, and was crushed rearward behind the bumper. The left front door was buckled outward. The roof and both A-pillars were removed by rescue personnel. The Collision Deformation Classification for the frontal impact with the Buick Park Avenue was 12-FDEW-5. Six crush measurements were taken by the NASS researcher at the bumper level and were as follows: C1 = 114 cm (41"), C2 = 114 cm (41"), C3 = 111 cm (44"), C4 = 104 cm (41"), C5 = 67 cm (26"), C6 = 47 cm (19").

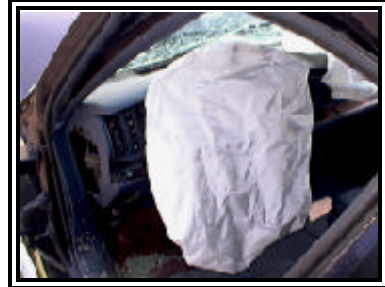
**Figure 7. Redesigned driver's air bag**

The 1999 Buick Park Avenue was equipped with redesigned air bags for the driver and front right passenger positions that deployed as a result of the impact with the Chevrolet Corsica. The driver's air bag was housed in the center of the steering wheel with symmetrical I-configuration module cover flaps (**Figure 7**). Each cover flap measured 11 cm (4") in width and 9 cm (4") in height. The redesigned driver's air bag measured 63 cm (25") in diameter in its deflated state and was tethered by two internal straps. The air bag was vented by two ports located at the 11 and 1 o'clock positions.

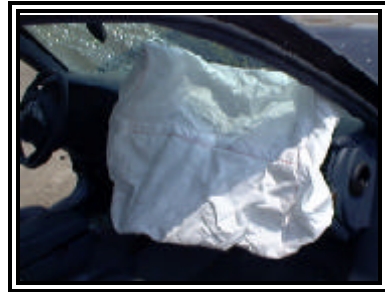
**Figure 8. Redesigned front right passenger's air bag**

The redesigned front right passenger's air bag deployed from the mid-instrument panel area with a single cover flap design hinged at the bottom aspect (**Figure 8**). The cover flap was rectangular in shape and measured 37 cm (15") in width and 15 cm (6") in height. The redesigned front right passenger's air bag measured 60 cm (24") in width and 32 cm (13") in height in its deflated state. The air bag was tethered by one internal strap and vented by two ports located at the 9 and 3 o'clock positions. A makeup transfer was identified on the lower right aspect from the unrestrained front right passenger.
