**ADVANCED OCCUPANT PROTECTION SYSTEM STUDY  
2000 FORD TAURUS INVESTIGATION**

**VERIDIAN CASE NO. 2000 12-093G**

**LOCATION - MICHIGAN**

**CRASH DATE - JUNE 2000**

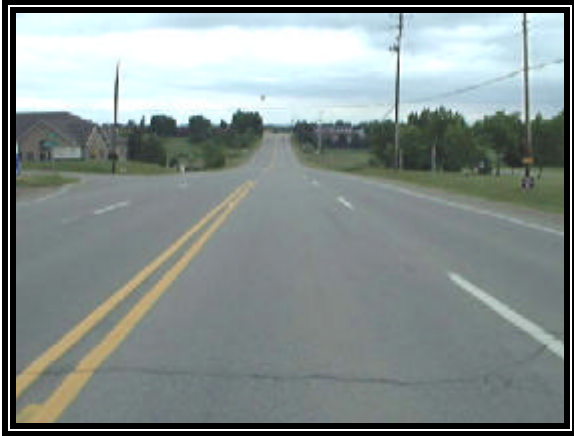
**Figure 1:** Northbound pre-crash trajectory view.

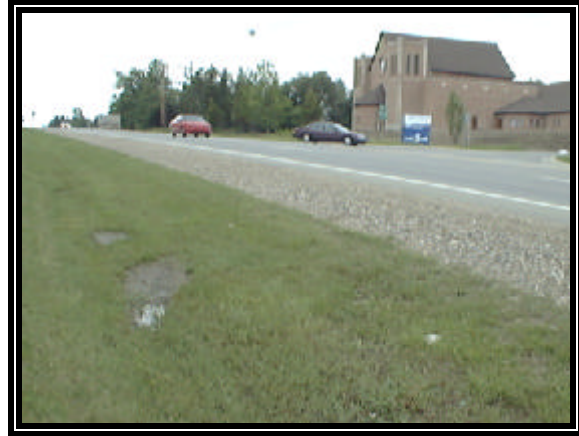
**Figure 2:** Look back from the area of final rest toward the intersection.

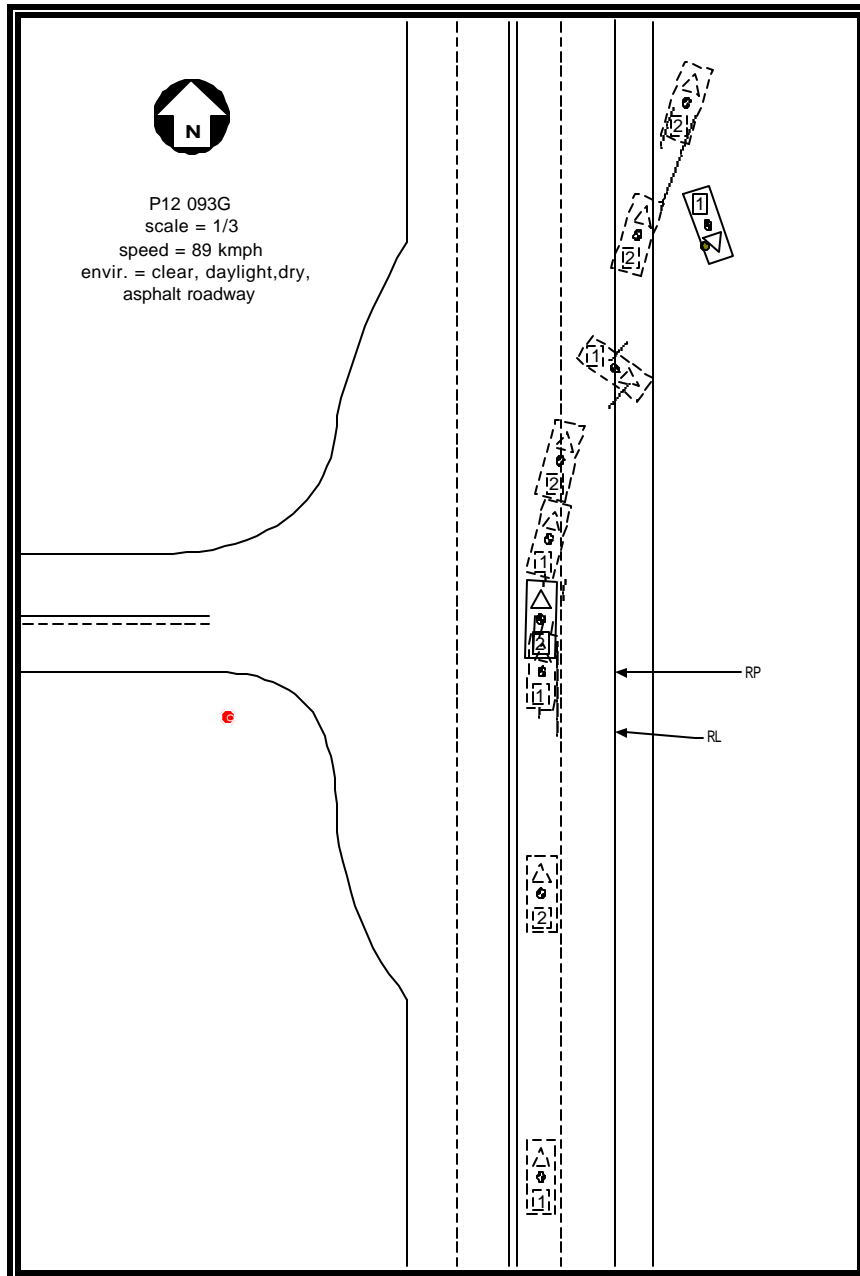
The crash occurred when the front plane of the Ford Taurus impacted and under-rode the back plane of the Ford Expedition in a 12/6 o'clock impact configuration. The force of the impact deployed the Taurus's left pre-tensioner and frontal air bags. The magnitude of the underride was moderate. During the impact sequence, the front structural third of the Taurus drove underneath the Ford Expedition and lifted its rear axle off the ground. Damages to the hood and forward body structures on the Taurus extended rearward 123 cm (48 in) from the front plane. The Expedition's rear bumper contacted and fractured the windshield of the Taurus at maximum engagement.

The northeastward momentum of the Ford Taurus displaced both vehicles forward and to the right. The vehicle's crossed into the outboard (right) lane and off the right side of the roadway during disengagement. The Ford Expedition came to rest off the east shoulder facing northeast approximately 36 m (120 ft) northeast of the impact. After separation, the Ford Taurus began to rotate clockwise. It came to rest off the east shoulder facing southeast, approximately 32 m (105 ft) northeast of the point of impact.

**Figure 3:** Crash schematic

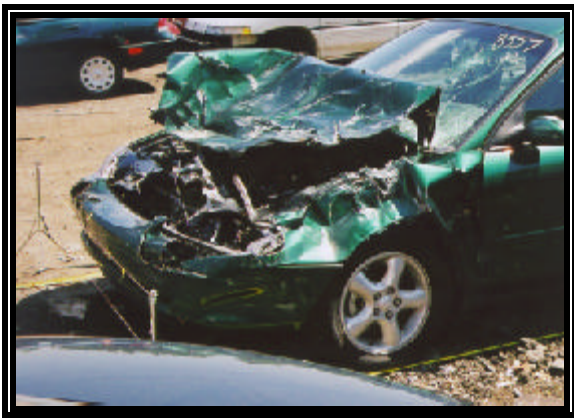
**Figures 4 and 5** are the left front and front views of the Taurus, respectively. The front plane sustained direct and induced damage that extended across the entire 157 cm (62 in) end width of the vehicle. The damage was biased to the vehicle's left side as a result of the pre-crash right steering maneuver. The direct contact damage began 47.0 cm (18.5 in) right of center and extended 119.0 cm (44.5 in) to the left front bumper corner. The crush profile measured on the bumper reinforcement bar was as follows: C1=5 cm (2 in), C2=10 cm (3.9 in), C3=12 cm (4.7 in), C4=13 cm (5.1 in), C5=10 cm (3.9 in), C6=0. The bumper reinforcement had rotated clockwise during the under-ride (when viewed from the left end) and indicated the direct bumper to bumper contact at impact was minimal.

**Figure 4:** Left front view of the Taurus.

The direct contact damage due to the under-ride extended rearward onto the hood and left front fender. The damage was comprised of longitudinal scraping and scratches caused by the rear bumper and undercarriage of the Expedition. The damage on the surface on the hood extended rearward 122 cm (48 in) from the front of the Taurus. The hood was buckled and had shifted rearward fracturing the lower aspect of the windshield. The exterior surface of the windshield was fractured directly in front of the driver's position by contact from the Expedition's rear bumper. (Note, this windshield fracture was inaccurately attributed to an interior occupant contact in the NASS file). The left fender was buckled and crushed down during the under-ride. The left front door had shifted rearward, overlapping the left rear door at the B-pillar. All the doors remained operational. The left wheelbase was foreshortened approximately 2.5 cm (1.0 in). The Collision Deformation Classification (CDC) was 12-FDEW-01. The

Damage Only Algorithm of the WINSMASH model calculated a total delta V of 35.0 km/h (21.7 mph) for the Taurus in this impact. The longitudinal and lateral components were -35.0 km/h (-21.7 mph) and 0 km/h, respectively. The calculated Barrier Equivalent Speed was 18.9 km/h (11.7 mph). The results of the WINSMASH reconstruction appeared reasonable.

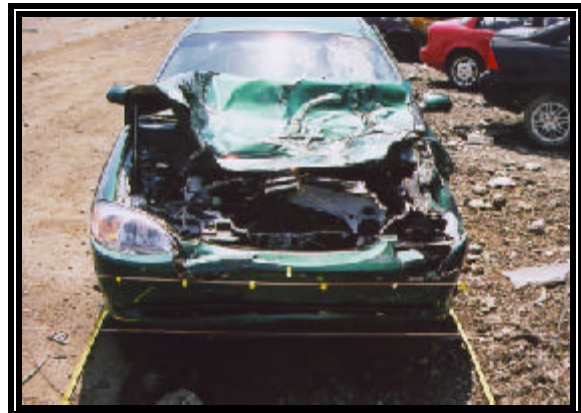
**Figure 5:** Front view of the Taurus.

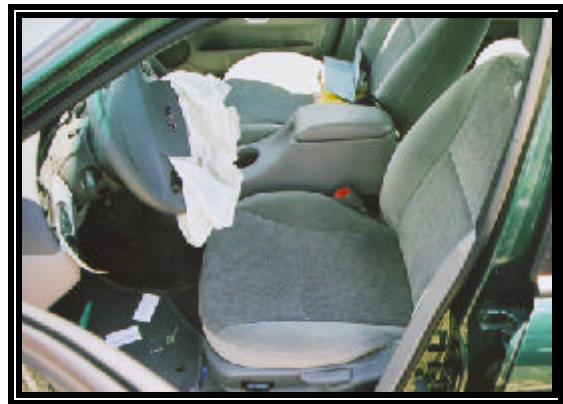
**Figure 6** is a left interior view of the front occupant compartment. The electrically adjustable driver's seat was adjusted to a full rear position at inspection. This was the at-crash adjustment of the seat as the seat track could not have been altered due to damage to the vehicle's electrical system. The horizontal distance between the center hub of the steering wheel and seat back measured 66 cm (26 in). The seat back was reclined 17 degrees aft of vertical. The foot controls were not adjustable.

**Figure 6:** Left interior view of the Taurus.

There was no intrusion or interior damage related to the exterior forces of the crash. The driver knee bolster was not deformed, however two areas of contact were identified. The surface of the panel was scuffed from minor contact by the driver's lower extremities. The left scuff measured 2.0 cm (0.8 in) in diameter and was located 3.8 cm (1.5 in) left of the steering column centerline and 42.7 cm (16.8 in) above the floor. The right contact measured 3.8 cm x 5.0 cm (1.5 in x 2.5 in), width by height, and was located 5.0 cm (2 in) right of the steering column centerline, 43.7 cm (17.2 in) above the floor. These contacts were not noted by the NASS researcher.

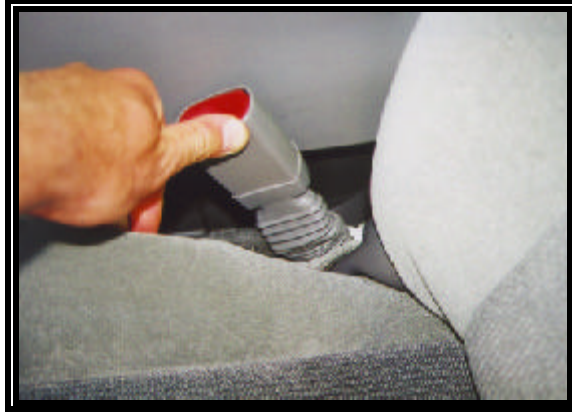
The vehicle was equipped with 3-point lap and shoulder belt systems in the front outboard seat positions. The front seat belt systems consisted of a continuous loop lap and shoulder belt webbing with a sliding latch plate. The vehicle sensitive/energy management retractors were located in the base of the B-pillars. The front restraints were also equipped with buckle mounted pretensioners. The driver's pre-tensioner fired as a result of the crash, **Figure 7**. The post-crash measurement of the pre-tensioner's piston was 57.2 mm (2.25 in). The front right seat belt pretensioner did not fire, (as reported in the NASS file).

**Figure 7:** View of the left inboard buckle anchor.

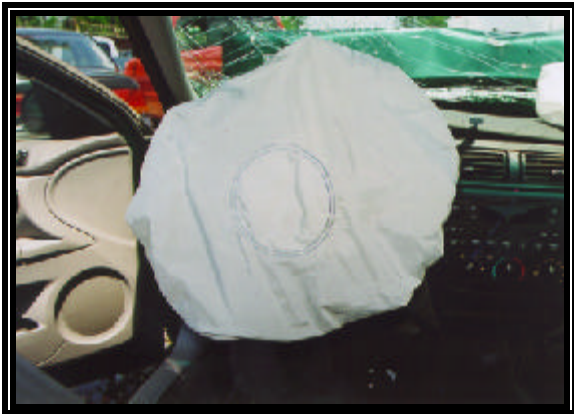
The driver air bag, **Figure 8**, was located in the typical configuration in the center hub of the steering wheel. It had deployed as designed from the H-configuration module. The width of the module cover flaps measured 16.5 cm (6.5 in). The height of the upper and lower flaps measured 7.5 cm (3.0 in) and 5.0 cm (2.0 in), respectively. There was no contact evidence to the cover flap. The bag measured 50 cm (20 in) in its deflated state. It was vented by two ports located in the 11/1 o'clock sectors on the back side of the

bag. The port diameter measured 2.5 cm (1.0 in). The bag was tethered by two straps. The straps measured 11.4 cm (4.5 in) in width. Black vinyl scuffs from deployment contact with the cover flaps was dispersed over the 2 to 6 o'clock sectors on the face of the air bag. The 2 to 4 o'clock sectors on the back side of the bag were scuffed from steering wheel rim contact. There was no direct evidence of driver contact on the air bag. The following nomenclature identified the driver air bag and was located in its 12 o'clock sector:

**Figure 8:** Driver air bag.

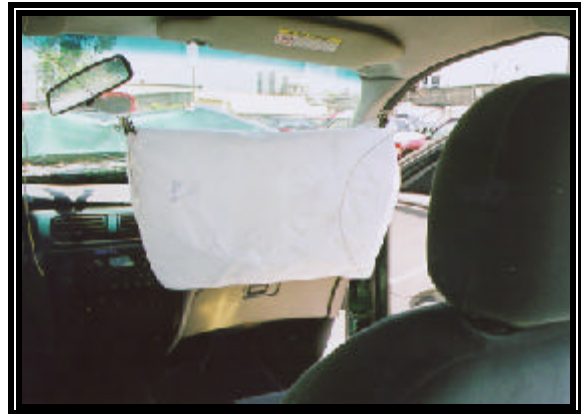
The front right passenger air bag, **Figure 9**, was a top-mount design housed in the right aspect of the instrument panel. The module cover flap was vinyl and measured 27.9 cm x 14.0 cm (11.0 in x 5.5 in), width by depth. The face of the passenger air bag measured 55.9 cm x 30.5 cm (22.0 in x 12.0 in). The bag extended rearward from the module 40.6 cm (16 in) in its deflated state. The bag was vented by two ports measuring 4.6 cm (1.8 in) in diameter. The ports were symmetrically located on the side panels of the bag. The only contact evidence on the face of the bag consisted of a 20 cm x 30 cm (8 in x 12 in) area of patterned vinyl transfers. This transfers were the result of contact with the aft edge of the air bag module during the deployment sequence.

**Figure 9:** Front right passenger air bag.

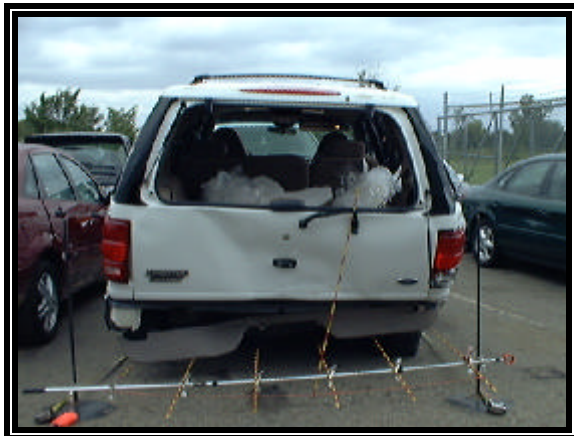
**Figures 10 and 11** are the rear and right side views of the Ford Expedition, respectively. The back plane of the Expedition sustained a combination of direct contact and induced damages that extended across the entire 178 cm (70 in) end width. The damage was biased to the right side as a result of the Taurus's pre-crash steering maneuver. The direct contact damage width measured 131 cm (52 in). The direct contact began 43 cm (17 in) left of center and extended to the right rear bumper corner. The crush profile measured at the rear bumper elevation was as follows: C1=47 cm (18 in), C2=52 cm (20 in), C3=62 cm (24 in), C4=64 cm (25 in), C5=64 cm (25 in), C6=64 cm (25 in). The rear bumper rotated down as a result of the under-ride. The rear hatch was jammed shut by the deformation and the backlight disintegrated during the impact. Both rear quarterpanels were buckled and deformed forward. The induced damages extended along the sides of the vehicle's to the rear doors. The left and right wheelbase was foreshortened 1 cm (0.5 in) and 8 cm (3 in), respectively.

The Collision Deformation Classification was 06-BDEW-03. The total delta V of the Expedition calculated by the Damage Only Algorithm of the WINSMASH model was 24.9 km/h (15.5 mph). The longitudinal and lateral components were -24.8 km/h (-15.4 mph) and 2.2 km/h (1.3 mph), respectively. The calculated Barrier Equivalent Speed was 35.5 km/h (22.1 mph). These results appeared reasonable based on SCI experience.

**Figure 10:** Rear view of the Ford Expedition.

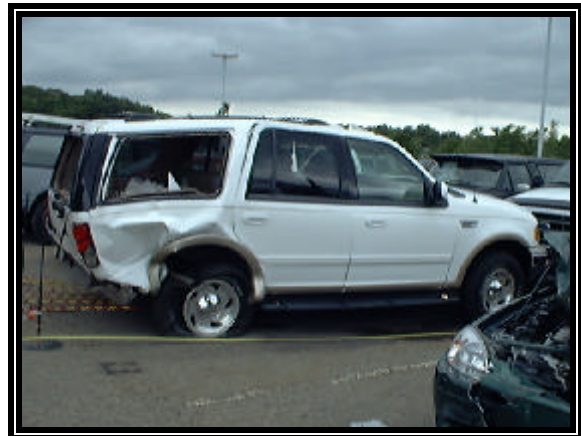
**Figure 11:** Right side view of the Expedition.

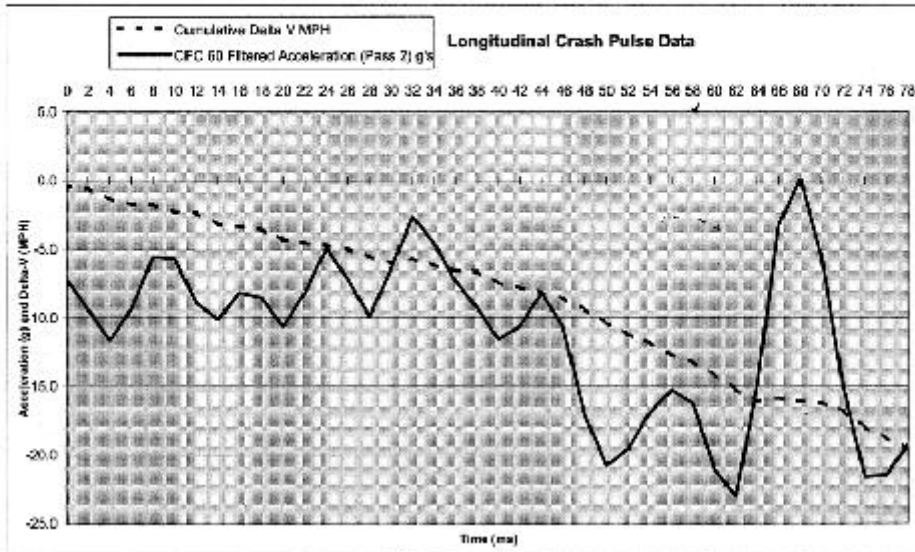
### Longitudinal Cumulative Delta-V

Time (ms)	0	10	20	30	40	50	60	70	78
Delta-V (MPH)	-0.4	-2.3	-4.3	-5.9	-7.4	-10.3	-14.1	-16.3	-19.5

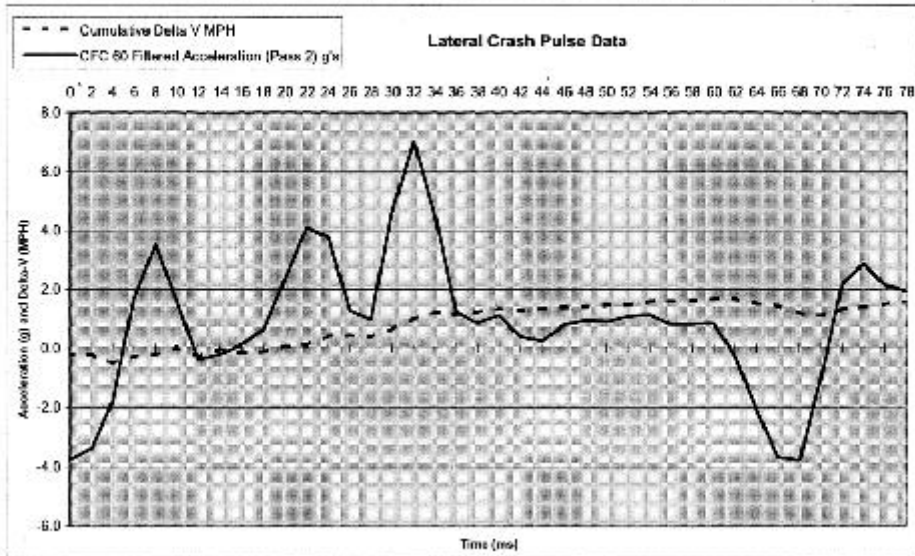
### Lateral Cumulative Delta-V

Time (ms)	0	10	20	30	40	50	60	70	78
Delta-V (MPH)	-0.2	0.0	0.1	0.7	1.4	1.5	1.7	1.1	1.6
