**VERIDIAN ON-SITE CHILD PASSENGER FATALITY  
INVESTIGATION**

**VERIDIAN CASE NO. CA00-003**

**VEHICLE - 1996 FORD CONTOUR GL**

**CRASH DATE - JANUARY, 2000**

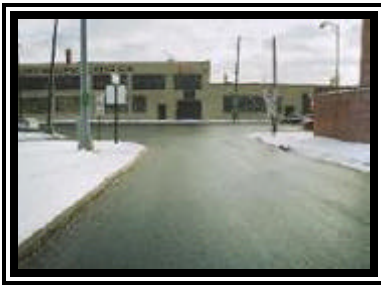
The 25 year old female driver of the 1996 Ford Contour GL was transporting her children to school and day care. She was operating the vehicle eastbound on the inboard lane of an urban two lane (one-way) local street on approach to a 3-leg intersection (**Figure 1**). She stopped at the signalized intersection and initiated a left turn to proceed northbound on the one-way connector. As the Ford entered the northbound lanes, the driver became distracted by the rear seated child occupants and continued a 125 degree constant radius turn towards the west pavement edge (**Figure 2**).

**Figure 1.** Eastbound approach for the 1996 Ford Contour GL.

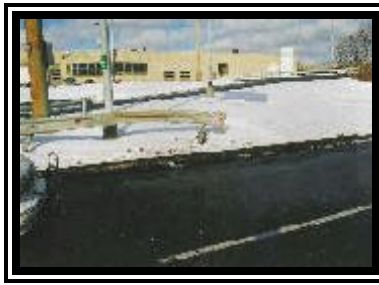
**Figure 2.** Northwest approach into the guardrail impact.

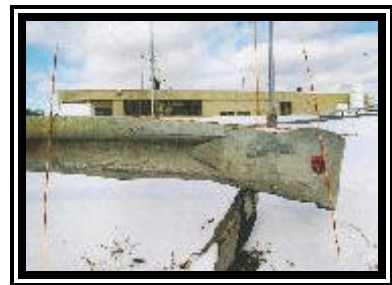
**Figure 3.** Impacted guardrail.

As the Ford exited the west pavement edge of the one-way connector, the front wheels/tires made initial contact to the barrier curb. The vehicle's trajectory was not altered by the curb as it continued 0.7 meters (2.3 feet) to impact with the W-beam guardrail (**Figure 3**). The front left area initially impacted the guardrail between the I-beam posts resulting in minor damage. The subsequent underride allowed the grille area to engage the horizontal component of the structure which produced a sufficient longitudinal deceleration to deploy the Ford's frontal air bag system. The minor severity crash probably resulted in a late deployment of the frontal air bag system due to the sheet metal engagement against the mid-point of the W-beam guardrail. Although the impact was classified as out of scope (yielding object), the WinSMASH damage algorithm computed a barrier equivalent velocity change of 14.0 km/h (8.7 mph) with a matching negative longitudinal component. The Collision Deformation Classification (CDC) for this impact to the Ford Contour was 12-FLEE-2 with a principal direction of force of 0 degrees. At this point, the vehicle was re-directed 18 degrees clockwise and came to rest with the front left corner area under the guardrail facing northwest.

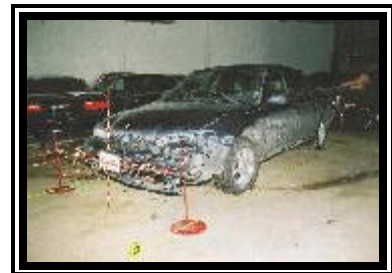
The Ford sustained minor frontal damage as a result of the impact with the guardrail (**Figure 4**). The direct contact damage began at the front left bumper corner and extended 42.0 cm (16.5 in) inboard. The combined direct and induced damage length (Field L) measured 144.0 cm (56.7 in). Although no crush was identified at any of the six *bumper level* measurements, a secondary profile was obtained at the level of the mid-radiator [11.0 cm (4.3 in) above the level of the bumper] to capture the underride damage resulting in an *averaged* profile of: C1= 13.0 cm (5.1 in), C2= 7.0 cm (2.8 in), C3= 0 cm, C4= 0 cm, C5= 0 cm, C6= 0 cm. The left portion of the bumper fascia fractured and separated from the reinforcement bar during the collision sequence. The left headlamp assembly shattered with minimal hood displacement noted from the guardrail underride (**Figure 5**). The left fender was deformed slightly rearward with 75.0 cm (29.5 in) of direct contact damage documented rearward along the side surface of the vehicle. The right front wheel was deflated (not restricted) with no notable rim damage from the barrier curb contact. A film of road salt was noted over the surface of the vehicle. The windshield was undamaged.

**Figure 4. Frontal damage to the 1996 Ford Contour GL.**

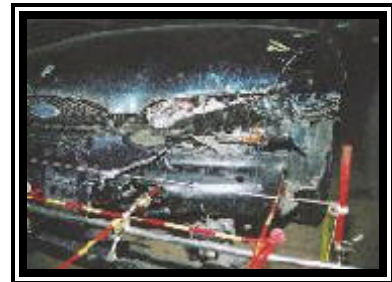
**Figure 5. Close-up view of the damaged area.**

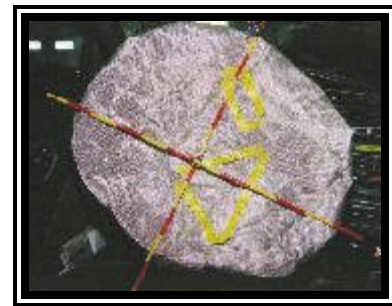
The Ford Contour was equipped with frontal air bags for the driver and right passenger positions. The air bags deployed as a result of the crash. The driver air bag was housed in the center of the steering wheel with a horizontally oriented flap tear seam (H-configuration). The flaps were asymmetrical in shape as the upper flap measured 26.0 cm (10.2 in) in width along the upper portion, 19.0 cm (7.5 in) along the lower portion and 10.0 cm (3.9 in) in height. The lower flap measured 19.0 cm (7.5 in) in width along the upper portion, 21.0 cm (8.3 in) along the lower portion and 7.0 cm (2.8 in) in height. Although no contact evidence was identified on the exterior surface of the module cover flaps, eye makeup was documented to the upper (centered) portion of the air bag along with facial makeup to the right (centered) portion. The diameter of the driver air bag measured 51.0 cm (20.1 in) in its deflated state (**Figure 6**). The bag was tethered by two internal straps and vented by two ports located at the 11 o'clock and 1 o'clock sectors on the rear aspect of the air bag.

**Figure 6. 1996 Ford Contour GL deployed driver air bag.**

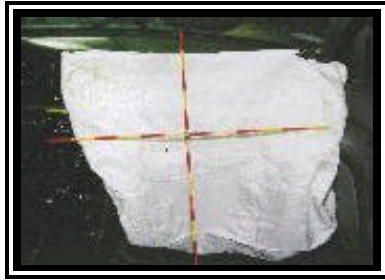
The front right passenger air bag deployed from the right top instrument panel area with a single cover flap design hinged at the forward aspect. The sheet metal reinforced flap opened in an upward direction towards the windshield. The cover flap was irregular in shape and measured 37.0 cm (14.6 in) in width along the rear aspect of the flap and 52.0 cm (20.5 in) along the forward aspect. The flap measured 33.0 cm (13.0 in) in height along the left edge of the flap and 21.0 cm (8.3 in) along the right edge. No contact evidence was found on the exterior surface of the module cover flap. The passenger air bag measured 73.5 cm (28.9 in) in width and 53.5 cm (21.1 in) in height in its deflated state (**Figure 7**). Although no contact evidence was identified on the face of the air bag, blood transfers were documented to the bottom portion. These transfers were attributed to the child passenger's chin laceration as he laid against the deflated air bag following the crash (**Figure 8**). His interaction with the

air bag during the collision sequence produced two distinct scuff marks on the right mid-windshield area from the upper portion of the air bag. In addition, small abrasions were noted to the bottom portion of the air bag from intra-flap snagging during bag expansion. The bag was tethered by two internal straps sewn to the top seam and vented by one port located at the 10 o'clock sector on the inboard aspect of the air bag.

Figure 7. 1996 Ford Contour GL deployed passenger air bag.

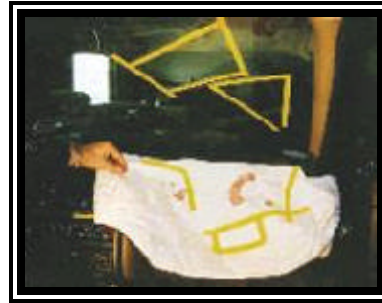
Figure 8. Air bag scuffs to the right windshield area and blood stains to the bottom portion of the passenger air bag.

The child came to rest across the front right floor of the vehicle (head oriented towards the gearshift) on or under the deflated air bag as evidenced by the blood stains identified on the bottom portion of the bag. The driver subsequently placed the unconscious child passenger on her lap until rescue personnel arrived. The child was transported to a local hospital and admitted for treatment. Treatment at the hospital included placement of an ICP to monitor cranial pressure and subsequent removal of a 10.2 cm (4.0 in) section of skull to further alleviate extensive brain swelling. The child was hospitalized for one day before succumbing to his injuries.

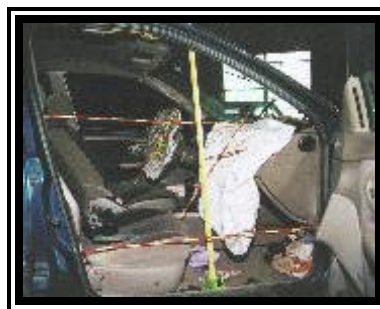
The unrestrained 5 year old male passenger of the 1996 Ford Contour GL was presumed to be seated in an upright posture with the seat track adjusted to the full rearward position (**Figure 9**). The length of the seat cushion and short femur length of an average child this age probably necessitated a more comfortable forward position in the seat with the upper body more upright. Lack of restraint usage was determined by the trajectory of the child and contact points within the vehicle. In addition, there was no loading evidence on the belt system and the system yielded minimal routine usage indicators for the recorded mileage. He was wearing a blue winter parka which was later found to be stained with blood and cut by paramedics during post-crash treatment at the scene.

**Figure 9. Interior view of the front right passenger space.**

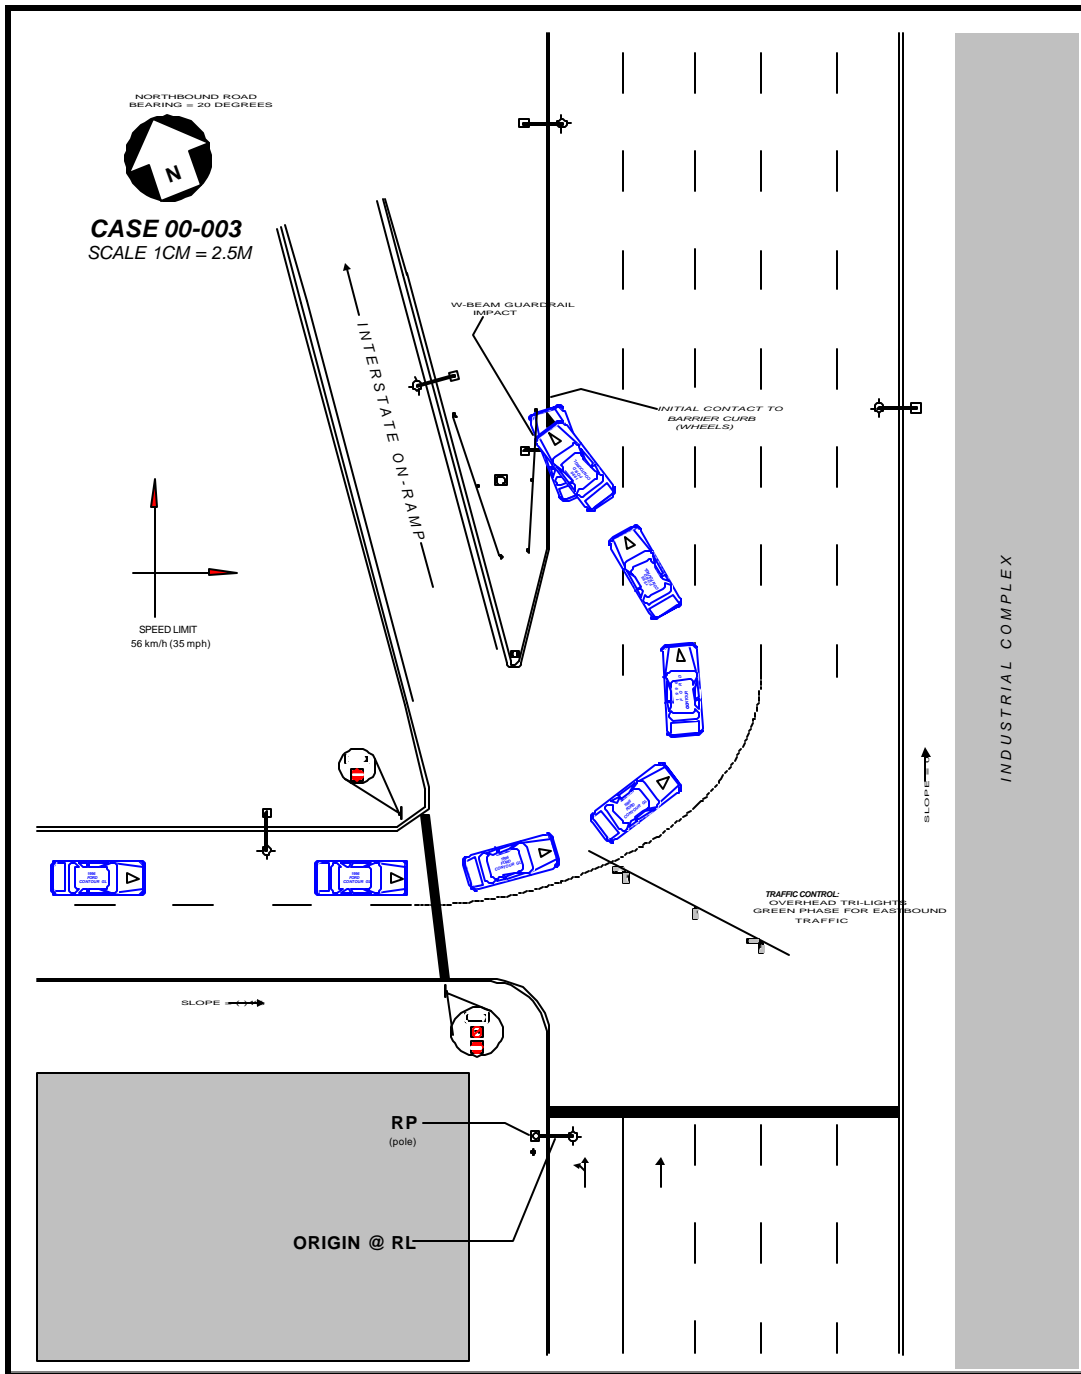
Figure 10. Scene Diagram

This single vehicle crash occurred during the early morning hours of January, 2000. At the time of the crash, it was dark (roadway illuminated by overhead halogen lamps) with no adverse conditions as the roads were dry. The crash occurred off the west pavement edge of a straight and level five lane (one-

way) asphalt roadway (see **Figure 10 - page 8**). The urban roadway was bordered by barrier curbs with W-beam guardrails 0.7 meters (2.3 feet) off the west pavement edge and an industrial complex to the east. Traffic flow through the 3-leg intersection was controlled by an overhead traffic signal system with a posted speed limit of 56 km/h (35 mph).
