TRANSPORTATION RESEARCH CENTER

REMOTE AIR BAG DEPLOYMENT REPORT

CASE NUMBER - IN00-007
LOCATION - OKLAHOMA
VEHICLE - 1997 HYUNDAI ACCENT
CRASH DATE - February 1998

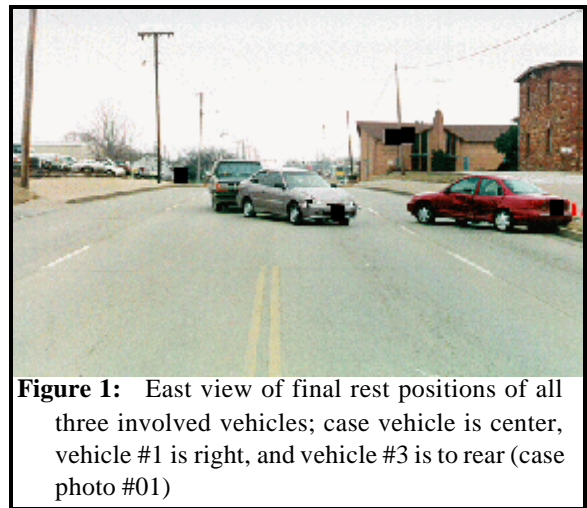
The case vehicle and vehicle #3 were both traveling west in the inside westbound lane of a four-lane, undivided city street, approaching a three-leg "T" intersection. Presumably, they were intending to continue their westbound travel paths (**Figure 1**). Vehicle #1 was traveling south in the southbound lane of a two-lane, undivided, intersecting city street, approaching the same three-leg "T" intersection and being controlled by a stop sign. Vehicle #1 was attempting to make a left-hand turn across the two westbound travel lanes and begin an eastbound travel path (**Figure 2**). The investigating officer indicated in the narrative section of the Police Crash Report that there was a non-contact vehicle traveling west in the outside westbound lane that may have been a partial view obstruction for the three involved vehicles. Additionally, witnesses stated that two other vehicles had to brake in order to avoid colliding with vehicle #1. The case vehicle's driver braked and steered to the left trying to miss vehicle #1. The crash occurred at or near the east-west center line in the middle of the intersection.

Figure 1: East view of final rest positions of all three involved vehicles; case vehicle is center, vehicle #1 is right, and vehicle #3 is to rear (case photo #01)

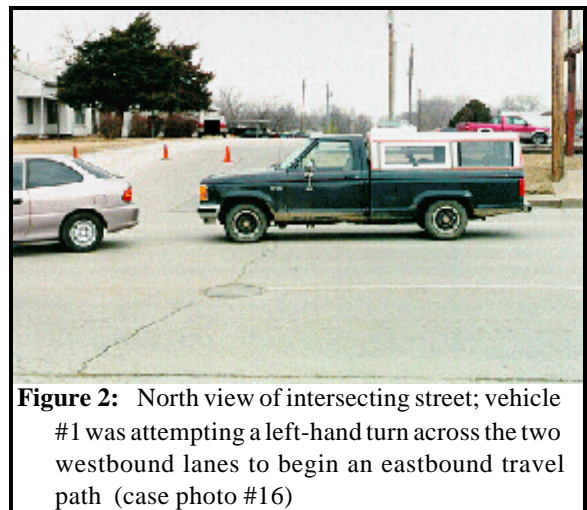
Figure 2: North view of intersecting street; vehicle #1 was attempting a left-hand turn across the two westbound lanes to begin an eastbound travel path (case photo #16)

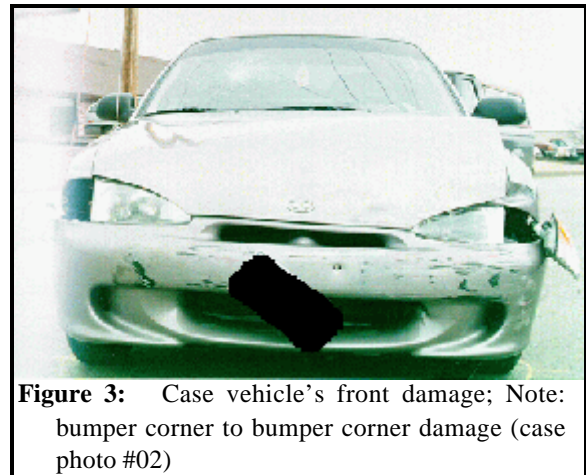
Figure 3: Case vehicle's front damage; Note: bumper corner to bumper corner damage (case photo #02)

From contact with vehicle #1, the case vehicle sustained direct contact damage to its front, virtually bumper corner to bumper corner (**Figure 3**). The residual damage was largely scraping with minimal rearward displacement to the front bumper fascia. The front edge of the hood was pushed rearward with its left side seam slightly tented. Induced damage included both turn signal assemblies being "popped out" of their respective locations and dangling by their wiring. Both the right front and left front fenders were slightly buckled. Also, photographs of the case

A CDC from police photographs was estimated for the case vehicle's most severe impact: **01-FDEW-1 (030)**. The WinSMASH reconstruction program, with CDC-only estimated crush profile, provided a borderline reconstruction, but the results appear reasonable. The Total, Longitudinal, and Lateral Delta Vs are, respectively: 23.5 km.p.h. (14.6 m.p.h.), -20.4 km.p.h. (-12.7 m.p.h.), and -11.8 km.p.h. (-7.3 m.p.h.).

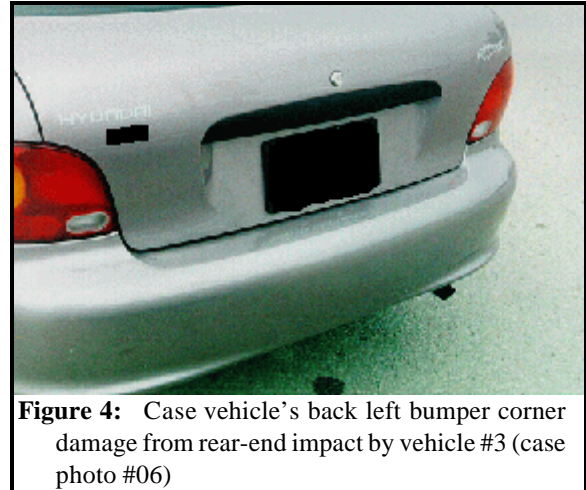
Figure 4: Case vehicle's back left bumper corner damage from rear-end impact by vehicle #3 (case photo #06)

The second impact to the case vehicle occurred when its rear left bumper corner was contacted by vehicle #3's front left bumper corner (**Figure 4**). A WinSMASH reconstruction run was not performed but a CDC for the case vehicle was estimated as: **07-BLLN-1 (220)**.

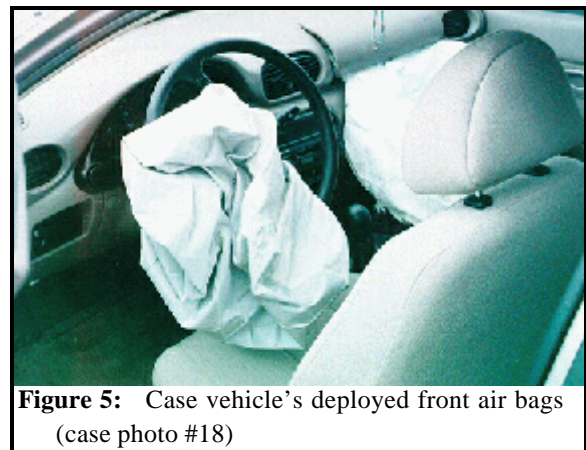
Police photographs show the case vehicle driver's air bag module was located in the steering wheel hub and the front right passenger's air bag module was located in a top-mount position on the right side of the instrument panel. The photographs verify that both air bags deployed (**Figure 5**). No photographs were available to indicate what type of cover flap configuration existed for the driver's module, but the right front passenger's module was equipped with a single, "J"-shaped (with the curved portion facing the vehicle's rear), vinyl covered, hinged towards the windshield, cover flap. As no photograph of the driver module's cover flap is available, it is unknown if the driver contacted it. No occupant contact can be detected on the driver's air bag fabric. As well, no occupant contact was discovered on the front right passenger's air bag fabric, but there were possible scratches/cloth transfers to the bottom left corner of the passenger's cover flap and just to the left of the cover flap's tear seam on the instrument panel's surface.

Figure 5: Case vehicle's deployed front air bags (case photo #18)

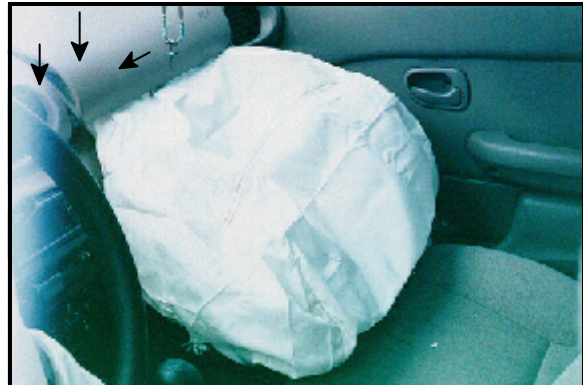
The case vehicle's driver air bag shape is not known. With a three-stitch, circular center, the driver's air bag is likely tethered. There is also visible evidence that the driver's air bag had at least one vent port. The front right passenger's air bag is rectangular in shape (**Figure 6**). Although there is one line of stitching visible on the passenger air bag, it is uncertain if it is tethered. No vent ports for the passenger's air bag were detected in available photographs.

Figure 6: Case vehicle's front right passenger air bag; Note: arrows point to possible occupant contact areas (case photo #21)

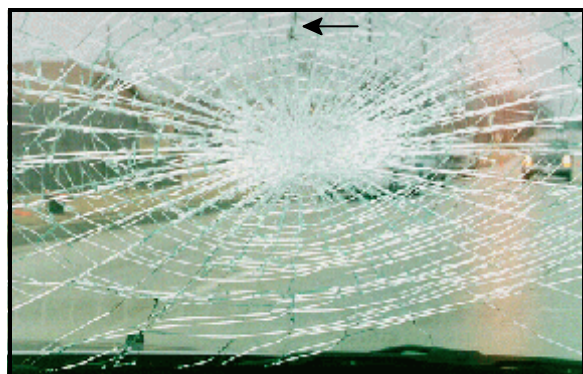
Figure 7: Case vehicle's windshield struck by the front right passenger; Note: arrow points to hair transfer (case photo #20)

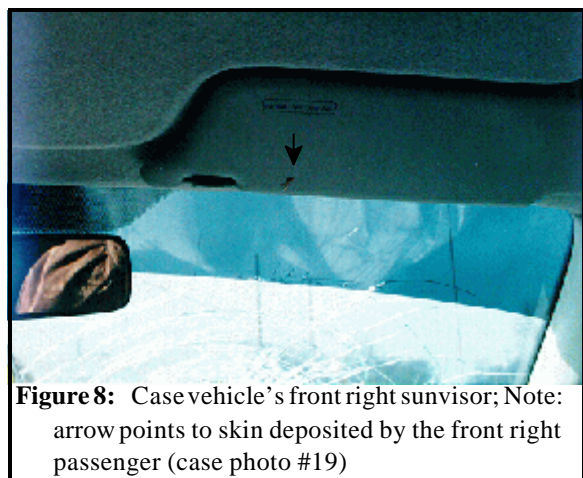
The case vehicle's driver steered left and braked prior to the initial impact. These maneuvers would have caused the front right passenger to move slightly to the right and forward. At impact with vehicle #1, her forward momentum possibly resulted in her striking the left vertical seam of the passenger's air bag module's cover flap with an unknown body part and the deploying air bag propelled her into the windshield, leaving hair in the cracks (**Figure 7**). The case vehicle's post-impact counterclockwise rotation would have caused a slight movement to the right. She deposited a piece of skin on the front right sunvisor (**Figure 8**) and possible scraping marks on the right front interior door panel.

Figure 8: Case vehicle's front right sunvisor; Note: arrow points to skin deposited by the front right passenger (case photo #19)

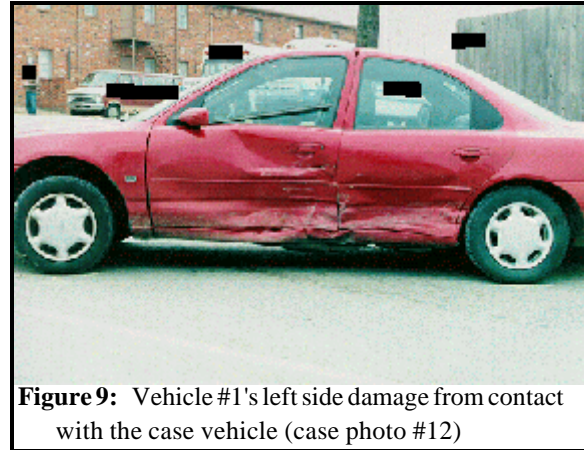
Figure 9: Vehicle #1's left side damage from contact with the case vehicle (case photo #12)

From the collision with the case vehicle, direct damage to vehicle #1 included lateral crush to the left front door panel, the left lower "B" pillar, the left rear door panel, the left rocker panel and the forward portion of the left rear wheel well (**Figure 9**). Induced damage consisted of sheet metal buckling at the rear portion of the left front fender. Intrusion, if any, would have been limited to the lower left areas of the left outboard seat positions. Based on police photographs, a CDC for vehicle #1's impact with the case vehicle was estimated as: **10-LPEW-2 (300)**. The WinSMASH reconstruction program, with CDC-only estimated crush profile, provided a borderline reconstruction, but the results appear reasonable. Vehicle #1's calculated Total, Longitudinal, and Lateral Delta Vs are: 18.3 km.p.h. (11.4 m.p.h.), -9.1 km.p.h. (-5.7 m.p.h.), and 15.8 km.p.h. (9.8 m.p.h.).

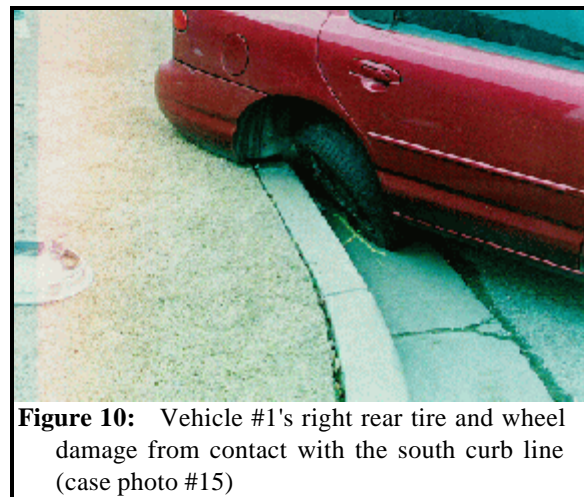
Post-impact, vehicle #1 rotated counterclockwise and its right rear tire and wheel struck the south curb. Direct damage was to the right rear tire and wheel, with it being knocked askew. The bottom of the tire and wheel was pushed inward and the top outward (**Figure 10**). There may have been some minor scraping to the underneath portion of the right rear bumper corner from contact with the top of the concrete barrier curb. An estimated CDC for the tire and wheel curb impact was: **03-RBWN-3 (090)**. This latter impact is outside the scope of the WinSMASH reconstruction program. Vehicle #1's driver (65-year-old male; race/ethnicity, height, and weight unknown) was reportedly wearing his available, manual, three-point, lap-and-shoulder, safety belt system. His pre-crash seat adjustments, steering wheel position, and posture are not known. He was transported from the scene by private vehicle to an unspecified location. Police assessed his injuries as "possible," with trauma to the trunk-internal, arm, and leg. His specific injuries and treatment status are not known.

Figure 10: Vehicle #1's right rear tire and wheel damage from contact with the south curb line (case photo #15)

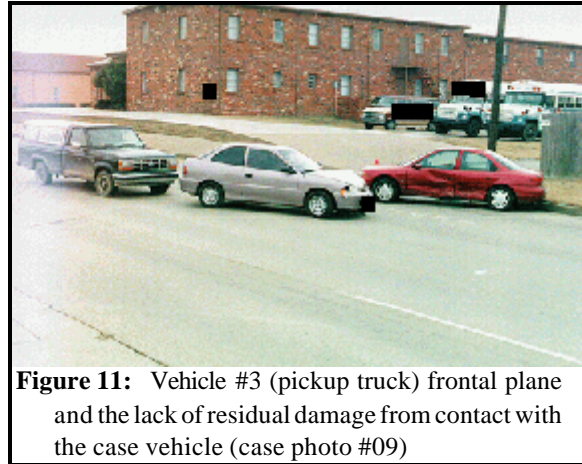
Figure 11: Vehicle #3 (pickup truck) frontal plane and the lack of residual damage from contact with the case vehicle (case photo #09)
