ON-SITE AIR BAG RELATED CHILD FATALITY INVESTIGATION

VERIDIAN CASE NO. CA00-010

VEHICLE - 1995 CHRYSLER CONCORDE

CRASH DATE - MARCH 2000

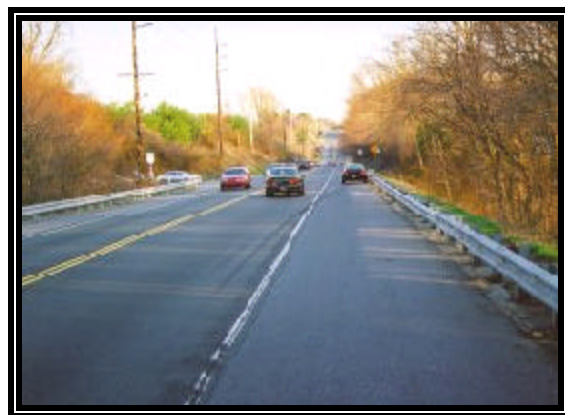
Figure 1: Southbound trajectory view of the 3-leg intersection.

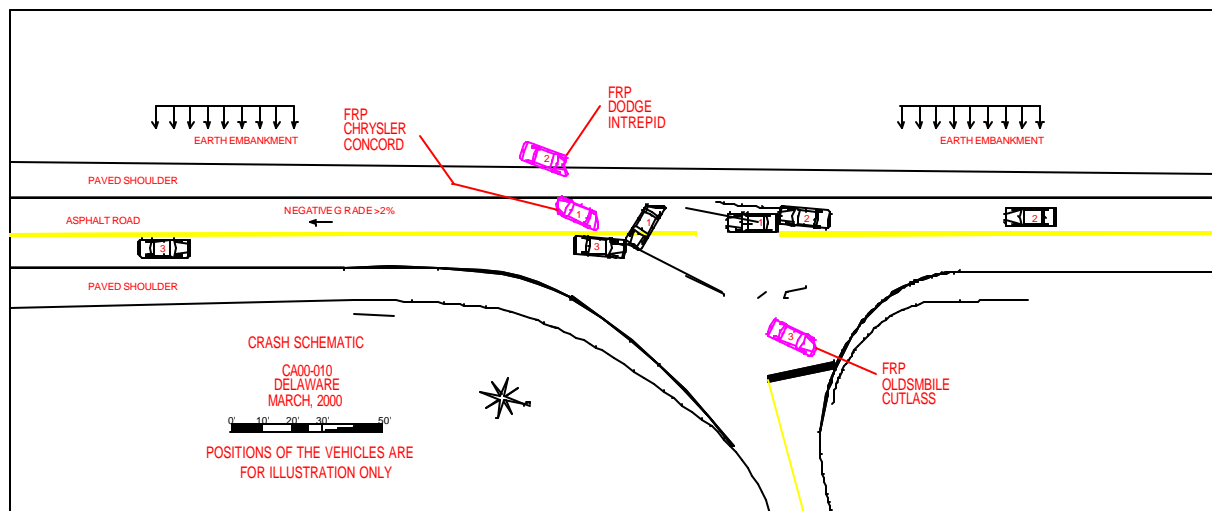
Figure 2 is a schematic of the crash scene. The first impact occurred when the driver of the Dodge Intrepid failed to recognize the stopped Chrysler Concord in sufficient time and struck the vehicle in an offset front-to-rear configuration. The offset impact configuration caused the Chrysler to begin to rotate counterclockwise and to be displaced forward and leftward into the opposing travel lane. The Barrier Equivalent delta V of the Chrysler's rear damage was 59.0 km/h (36.7 mph). The Dodge also rotated counterclockwise and slid approximately 26 m (84 ft) southwestward to rest. The Dodge came to rest facing northward against an earth embankment, bordering the roadway. Contact with the positive slope of the embankment caused the Dodge to come to rest prematurely, effectively shortening its post impact travel.

Investigation at the crash scene identified two skid marks located in the southbound lane. The beginning of the marks located the approximate point of impact and defined the post-impact trajectory of the respective vehicles. The outboard tire mark, attributed to the right front tire of the Dodge, measured 7.2 m (23.5 ft) and was directed southwestward toward the vehicle's final rest position.

The inboard tire mark was attributed to the right rear tire of the Chrysler. The mark measured 7.5 m (24.5 ft) and was also directed to the southwest. However, the width of the tire mark increased as the vehicle skidded forward over the mark's length. This change in the mark's width indicated the Chrysler was rotating counterclockwise during its forward displacement. The vehicle had rotated approximately 60 degrees CCW, relative to the road at the end of the tire mark. The counterclockwise rotation exposed the right frontal aspect of the vehicle to northbound traffic.

Figure 2: Crash scene schematic.

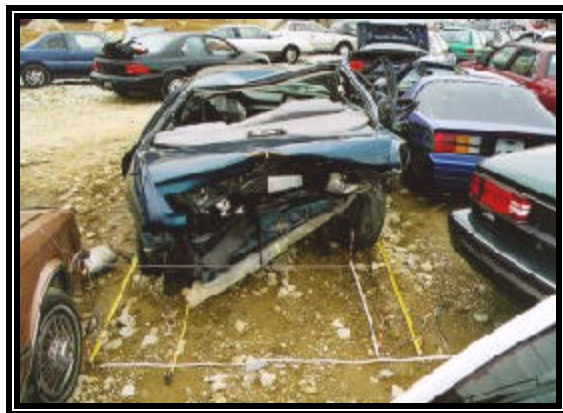
The Chrysler Concorde sustained impact damages to the back and front planes as a result of the multiple impact crash event. **Figure 3** is a rear view of the vehicle. The back plane sustained 94 cm (37 in) of direct contact damage. The direct contact began 18 cm (7 in) left of center and extended to the right corner of the rear bumper. The nature of the damage was indicative of a direct bumper to bumper impact with a subsequent override, as the Dodge drove through the impact. The crush profile (direct and induced damage) measured across the rear bumper reinforcement bar was as follows: C1=28 cm (11 in),

Figure 3: View of the rear impact damage.

C2=51 cm (20 in), C3=74 cm (29 in), C4=91 cm (36 in), C5=109 cm (43 in), C6=124 cm (49 in). The width of the crush profile measured 152 cm (60 in). The 6 o'clock direction of the impact force deformed the rear structures of the vehicle forward into the occupant compartment. The trunk space was collapsed. The roof in the area of the right C-pillar buckled vertically. The right rear axle was displaced forward approximately 39.4 cm (15.5 in). The left rear axle location was undisturbed. The backlight disintegrated during the impact. The right rear door was jammed shut by the deformation. The right front door was also jammed by the impact damage but was later opened during extrication. Intrusion into the rear right occupant space was an estimated 25 cm (10 in) longitudinal and 13 cm (5 in) vertical. The Collision Deformation Classification (CDC) was 06-BZEW-6. The total delta V of the impact calculated by Barrier Model of the WINSMASH program was 59.0 km/h (36.7 mph). The longitudinal and lateral components of the delta V were +58.1 km/h (+36.1 mph) and +10.2 km/h (+6.4 mph), respectively. The corrected PDOF was an estimated 190 degrees.

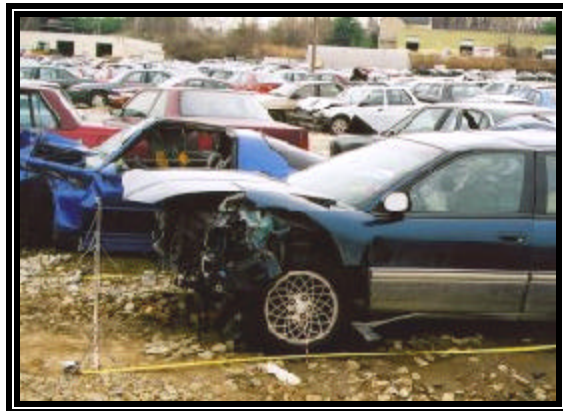
The Chrysler's direct frontal damage began on the right front corner and extended across the entire 152 cm (60 in) frontal width of the vehicle, **Figure 4**. The 2 o'clock direction of the impact force deformed the vehicle's frontal structures rearward into the engine compartment. The structures forward of the radiator support plane then sheared off as the Oldsmobile drove through the impact. The crush profile measured at front bumper mounting locations on the sub-frame were as follows: C1=48 cm (19 in), C6=33 cm (13 in). The location of the right frontal axle remained unchanged by the frontal impact. The left front axle was displaced rearward, foreshortening the left wheelbase 14.0 cm (5.5 in). The hood shifted rearward and buckled. The rearward hood shift fractured the lower outboard aspects of the windshield. The left front and rear doors remained closed during the impact and were operational upon inspection. The CDC of the frontal impact was 02-FDEW-2. The total delta V calculated by the Barrier Model of the WINSMASH program was 33.7 km/h (20.9 mph). The longitudinal and lateral components of the delta V were -21.7 km/h (13.5 mph) and 25.9 km/h (16.1 mph), respectively. A corrected PDOF of 50 degrees was used in the analysis.

Figure 4: Left lateral view of the frontal damage.

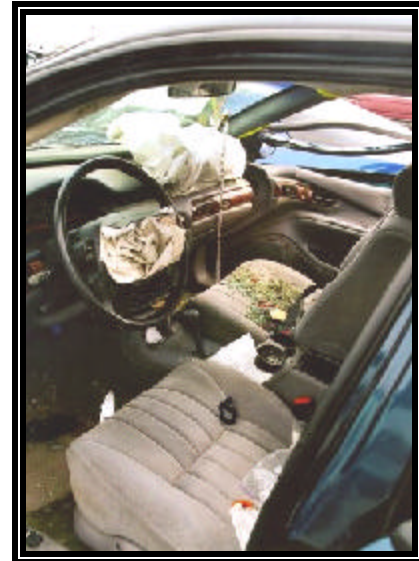
The front right seat was adjusted manually. The seat was adjusted to an estimated full forward position.

Floorpan deformation resultant to the rear impact restricted the adjustment of the seat. It could not be moved, therefore the seat track position had not been changed from its at-crash position. In this forward position, the leading edge of the seat cushion was in-line with the trailing edge of the instrument panel, **Figure 5**. The horizontal distance from the edge of the right front air bag module to the seat back measured 61.7 cm (24.3 in). The forward position of the seat was a causal factor in the front right occupant's fatal injury.

Figure 5: Interior view depicting the forward track position of the right seat.

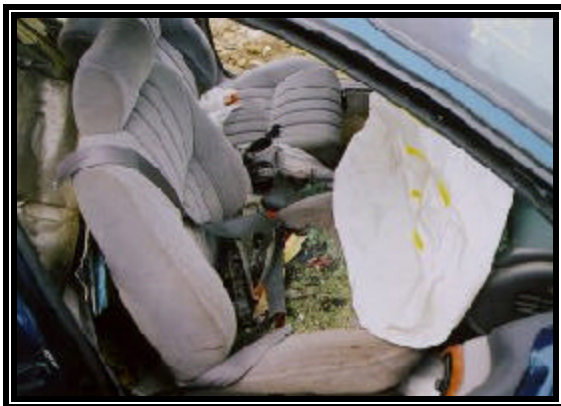
The front right restraint webbing was cut away from the occupant by EMS personnel during the extrication process. The latch plate was buckled in the inboard anchor at inspection and the section of cut webbing was looped through the hardware. The cut section measured 108.0 cm (42.5 in), 31.8 cm (12.5 in) extended over the lap and 76.2 cm (30.0 in) extended over the occupant's torso, **Figure 6**. The webbing section attached to the outboard lower anchor measured 43.2 cm (17.0 in). The webbing in the area of latch plate hardware loop was creased and stressed.

Figure 6: View of the front right restraint.

The right shoulder belt upper adjustment was in the full down position. Inspection of the surface of the D-ring revealed a witness mark, on its aft edge, indicative of restraint loading. The evidence identified during the inspection indicated the front right occupant was properly restrained and loaded the restraint system

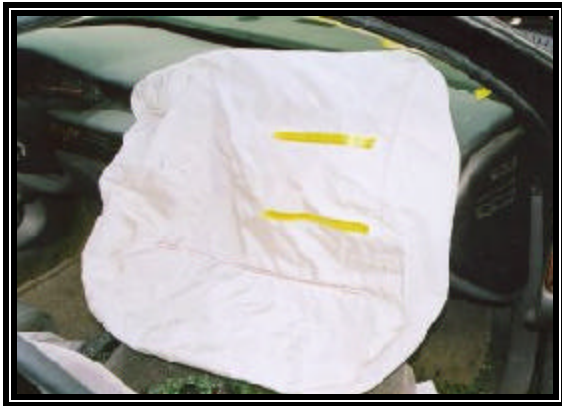
The face of the front passenger air bag measured 53 cm x 61 cm (21 in x 24 in), width by height. The bag extended 41 cm (16 in) from the module in its deflated state. The bag was tethered by a single strap sewn across the full width of the bag’s face. The air bag vented through the membrane’s porous fabric.

Figure 7: Front right passenger air bag.

Subtle evidence of direct occupant contact was identified on the right aspect of the bag’s face, **Figure 7**. The evidence consisted of two regions of blood smear transferred during contact with the child’s face. The child sustained a large abrasions over her right eye and cheek and lacerations of the right eyelid and external ear. A 13 cm (5 in) smear was located 14 cm (5.5 in) above the tether stitching and began 18 cm (7 in) left of the outboard side panel. The smear extended laterally to the right. A 3 cm (1 in) smear was located 23 cm (9 in) above the tether stitching and was centered 15 cm (6.0 in) left of the outboard side panel.

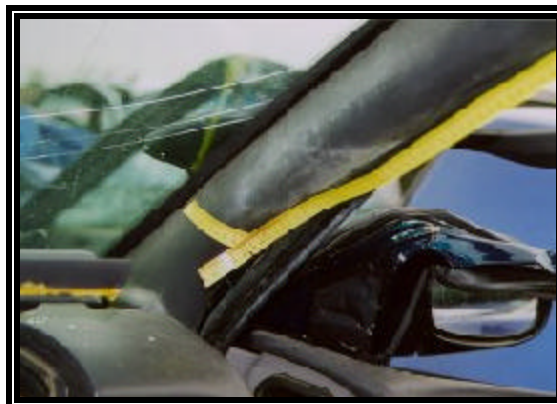
A large area of dispersed dirt and vinyl transfers was noted on the upper aspect of the bag's outboard side panel. The area measured approximately 30 cm x 15 cm (12 in x 6 in) and began on the upper perimeter of the side panel. A large spray of discharge, from the front right passenger air bag, was identified on the trim panel covering the right A-pillar, **Figure 8**. The area of discharge measured 8.9 cm x 18 cm (3.5 in x 7 in), width by height and began 15 cm (6 in) above the instrument panel. The location of the spray corresponded to the location of the transfers on the side panel of the bag. The forward position and kinematic pattern of the child altered the deployment path of the bag to the right. The generate discharge on the pillar was evidence of this altered deployment.

Figure 8: Discharge spray on the right A-pillar.

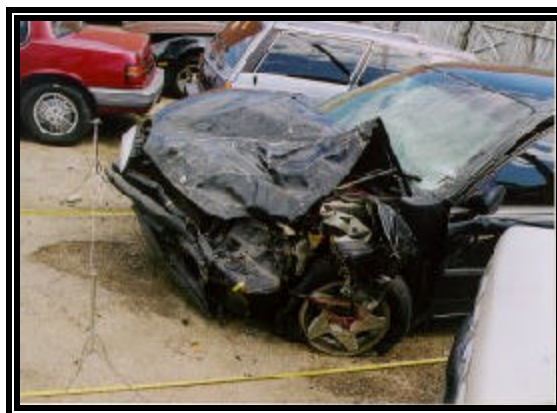
Figure 9 is a left view of the Dodge Intrepid. The vehicle sustained 92.7 cm (36.5 in) of direct contact damage to its front plane. The direct contact began 16.5 cm (6.5 in) right of centerline and extended to the left corner of the front bumper. The combined direct and induced damage extended across the entire 152 cm (60 in) frontal end width of the Dodge. The crush profile measured at the elevation of the bumper reinforcement was as follows: C1=51 cm (20 in), C2=53 cm (21 in), C3=43 cm (17 in), C4=33 cm (13 in), C5=10 cm (4 in), C6=0. The 12 o'clock direction of the impact force deformed the front

Figure 9: Left lateral view of the Dodge.

bumper and the left sub-frame rearward into the engine compartment. The left front fender and hood were buckled. The rearward displacement of these components contacted and fractured the windshield. The left side wheelbase was foreshortened 14.0 cm (5.5 in). The right wheelbase dimension was unchanged. The left front hinge pillar shifted rearward approximately 2 cm (1 in). The left front door opened during the crash. It could not be closed due to the left side deformation. The left rear and right side doors remained closed and were operational. The left aspect of the roof buckled in the area of the B-pillar.

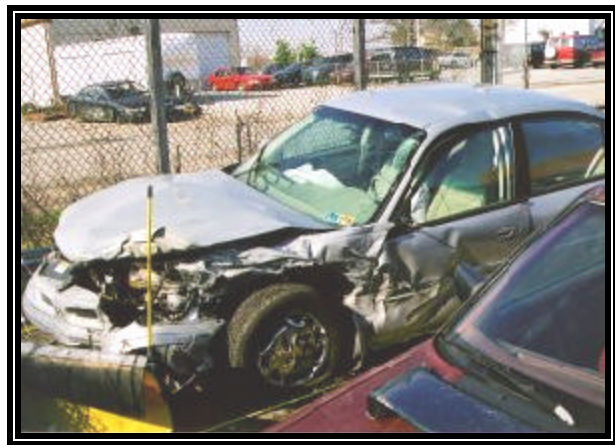
The frontal plane of the Oldsmobile sustained 46 cm (18 in) of direct contact damage. The direct contact began 28 cm (11 in) left of center and extended to the left corner of the front bumper. The undeformed end width measured 152 cm (60 in). The crush profile measured at the elevation of the bumper reinforcement was as follows: C1=23 cm (9 in), C2=13 cm (5 in), C3=7 cm (3 in), C4=5 cm (2 in), C5=0, C6=0. This contact extended along the left side of the vehicle to

Figure 10: Left front three-quarter view of the Oldsmobile.

approximately the B-pillar location, 259 cm (102 in) aft of the front plane. The left side damage was consistent with end-swipe contact between the Oldsmobile and Chrysler in the later stages of the impact. The hood and left front fender buckled and shifted rearward. The rearward shift of these components fractured the left lower aspect of the windshield. The left front rim was bent and the tire aired out. The left wheelbase was foreshortened 3.3 cm (1.3 in). The left front door shifted rearward and was jammed shut. The remaining doors were operational. The left center aspect of the roof buckled in the area of the B-pillar. The Barrier Model of the WINSMASH program calculated a total delta V of 21.1 km/h (13.1 mph). The longitudinal and lateral components were -21.1 km/h (-13.1 mph) and 0 km/h, respectively. The CDC of the damage was 12-FLEW-1.
