On-scene Advanced Occupant Protection Systems Investigation
Dynamic Science, Inc. / Case Number: DS00-011
2000 Mercury Sable LS
Texas
May, 2000

Dynamic Science, Inc.
Accident Investigation
Case Number: DS00-011

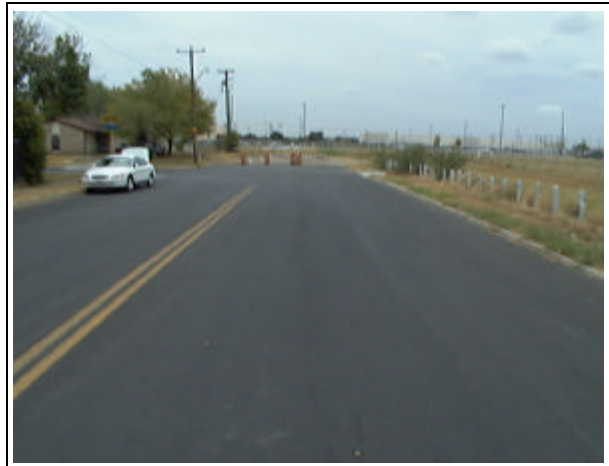
Figure 1. Direction of travel towards impact (south).

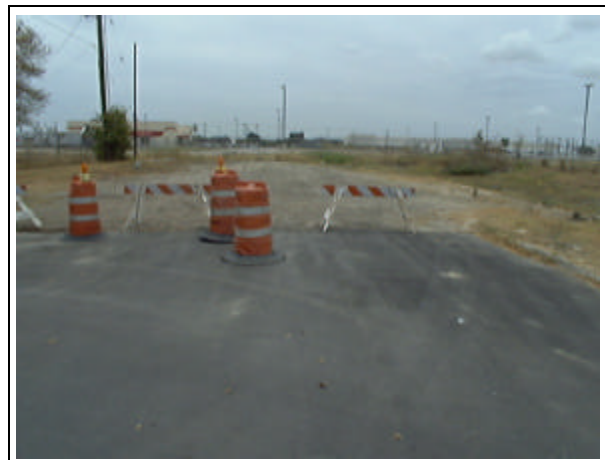
Figure 2. Traffic barriers

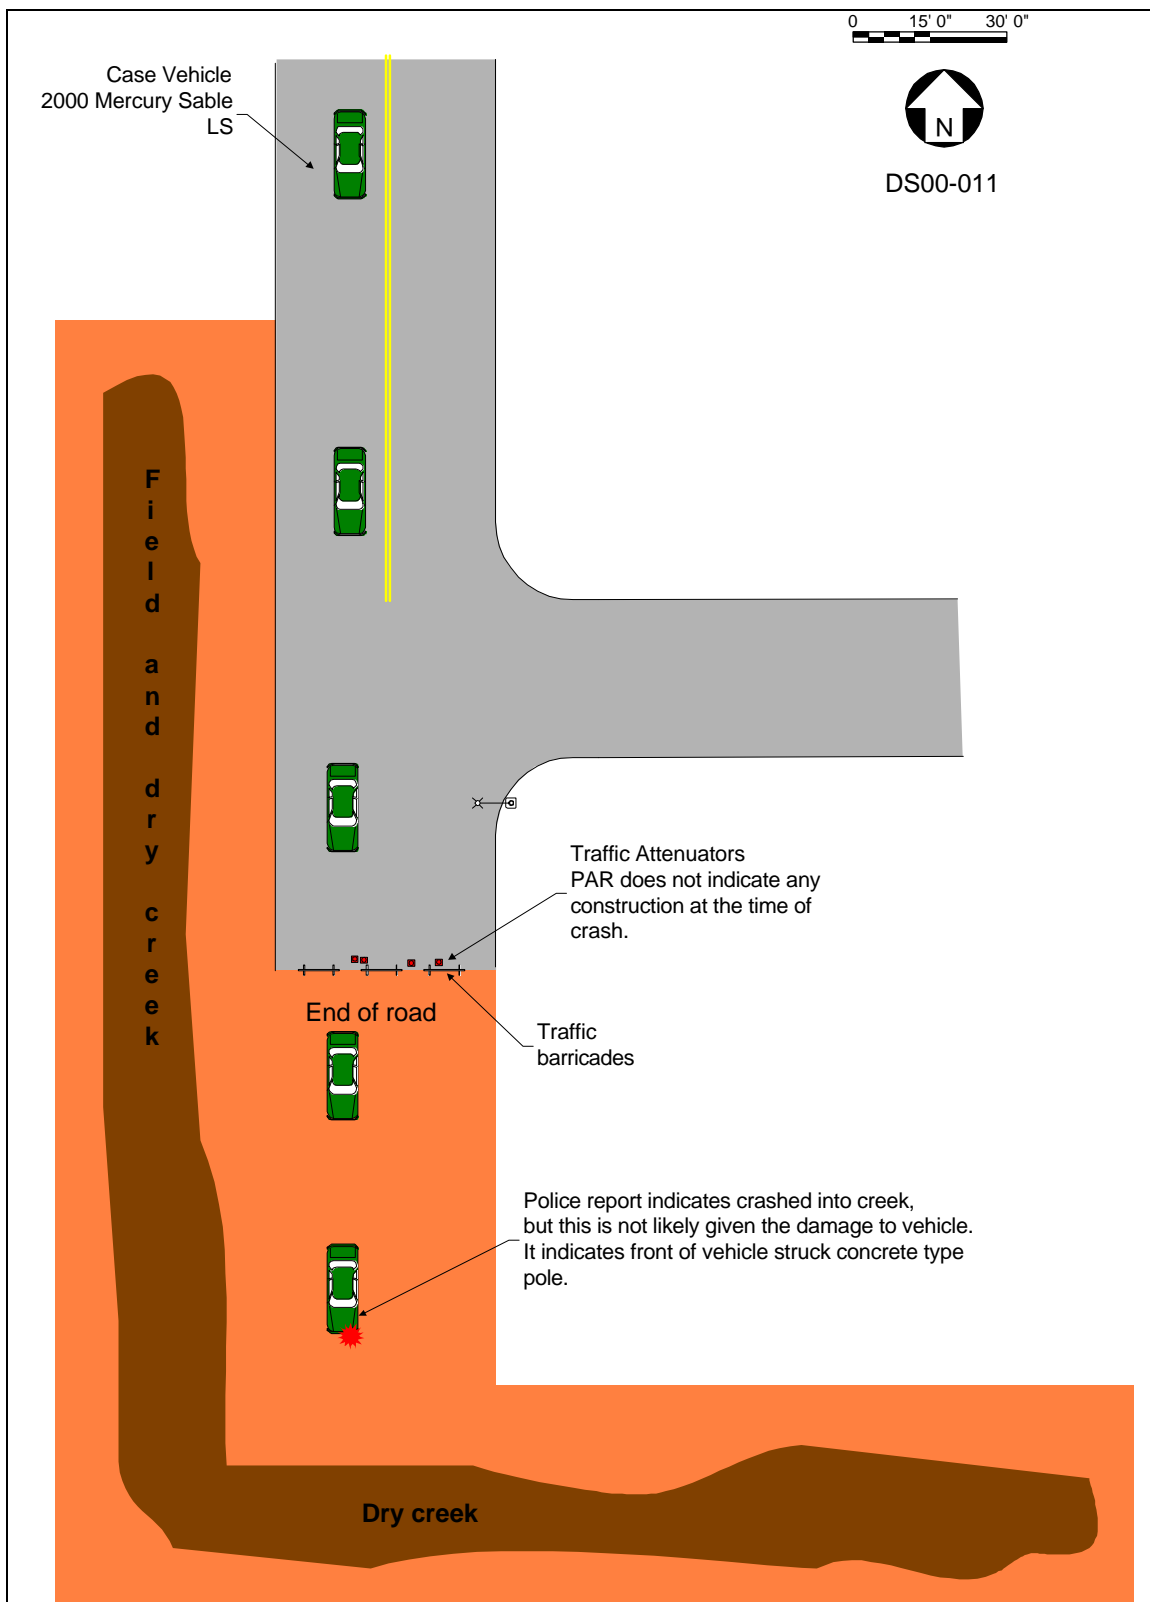
Figure 3. Scene diagram

As the case vehicle came to the end, it continued going straight rather than turning left onto the adjacent roadway. The police report indicates that the case vehicle departed the roadway and fell into the creek. The physical evidence on the vehicle indicates that it struck a concrete pole with its front left bumper corner. Since the crash scene has been altered recently, it appears that the object struck by the case vehicle no longer exists at this location. On impact with the concrete pole, both front air bags deployed.

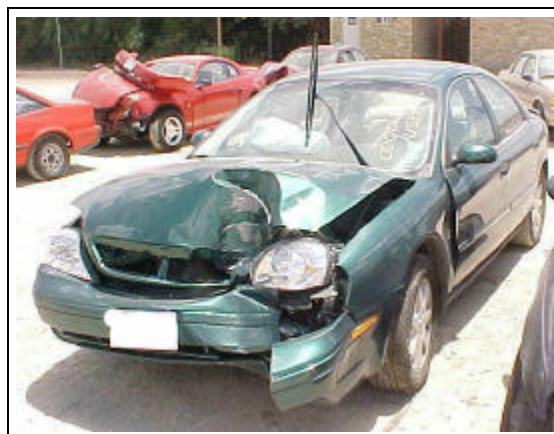
The case vehicle came to final rest in a dry creek bed off the paved roadway and facing south on the dirt field. The case vehicle sustained moderate damage to the front bumper, hood, grille area and left front fender. Induced contact damage produced buckling of the driver door. The case vehicle was towed from the scene, and was subsequently declared a total loss by the insurance company.

The Delta V for the case vehicle was computed, using WinSmash, as a total Delta v of 23.0 km/h (14.3 mph), a longitudinal Delta v of -23.0 km/h (-14.3 mph) and a latitudinal Delta v of 0 km/h (0 mph). This is a borderline reconstruction, but the results appear reasonable. The downloaded EDR data indicates a cumulative longitudinal Delta v of -26.0 km/h (-16.2 mph) and a cumulative lateral Delta v of 4.8 km/h (3.0 mph) at the 78 ms mark. The EDR report is included as an attachment to this report. The case vehicle was assigned a Collision Deformation Classification of 12FLEN2 and a PDOF of 0 degrees. The combined direct and induced damage width was 148 cm (58.3 in) [CRASH L = 148 cm (58 in)], and the maximum crush depth was 28 cm (11 in) located at C₂.

Description:	2000 Mercury Sable LS 4-door	
VIN:	1MEFM55S9YGxxxxxx	
Odometer:	8,431 km (5,239 miles)	
Engine:	3.0L 6 cyl	
Reported Defects:	None	
Cargo:	None	
Damage Description:	Moderate damage to front left. The front left door frame had induced damage.	
CDC:	12FLEN2	
Delta V:	Total	23.0 km/h (14.3 mph)
	Longitudinal	-23.0 km/h (-14.3 mph)
	Latitudinal	0.0 km/h (0.0 mph)
	Energy	36,446 joules (26,881 ft-lbs)

Figure 4. Exterior front damage to case vehicle

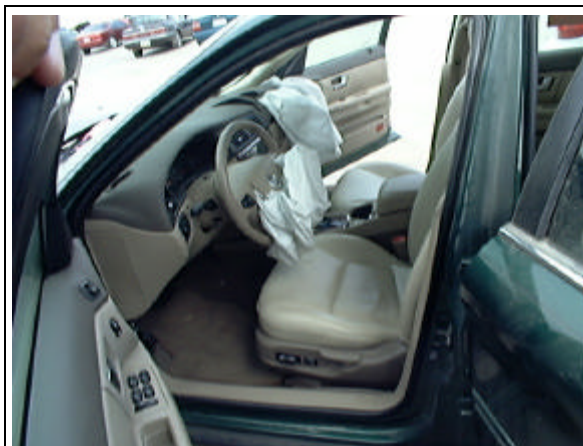
The case vehicle is equipped with beige leather-covered bucket seat in the outboard front seating positions and a leather-covered bench seat in the rear. The front left seat back was reclined rearward at a 22 degrees angle from vertical and the seat was adjusted to between middle and rear most track position. This seat position was equipped with a manual lap and shoulder belt and emergency locking retractor (ELR). The front right seat back was reclined rearward at an 18 degree angle vertical and the seat was adjusted to the rear most track position. This seat position was equipped with a manual lap and shoulder belt and a switchable retractor in ELR mode.

The 39-year-old female driver of the case vehicle was seated in a normal, upright fashion in the leather-covered bucket seat. She was wearing the available lap and shoulder safety belt; the pretensioner had deployed. The EDR showed that the seat buckle was engaged. The anchorage was adjusted to the full up position. The seat was adjusted to between the middle and rear most track position. At impact, the driver initiated a forward trajectory in response to the 12 o'clock impact force, and she loaded the lap and shoulder safety belt as the pretensioners fired. The driver engaged the deployed air bag in some fashion with her torso although there was no evidence of contact. She did complain of pain and an unknown type injury to her chest. As she contacted the air bag, the steering column shear capsules were not stroked. She rebounded backward and possibly struck the seat back.

Figure 5. Driver's seat area.

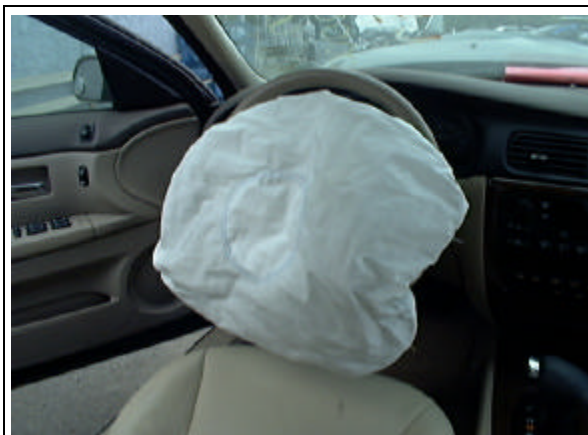
1. This was a first stage only deployment. The second stage was disposed.
2. The driver's seat was not in the forward position.
3. The left front seat buckle was engaged; the front right seat buckle was not engaged.
4. The time from algorithm wake-up to pretensioner deployment attempt was 7 milliseconds.
4. The time from algorithm wake-up to first stage - belted was 22 milliseconds.

The case vehicle was equipped with a driver's frontal air bag and a top-mount front right passenger's air bag. The driver's air bag was circular and measured 44 cm (17.3 in.) in diameter. It was equipped with two tethers and two vent ports. The dual module covers opened in an "H" configuration. There were no indications of any damage to driver's air bag or the module covers. The front right passenger's air bag was rectangular and measured 40 cm (15.7 in) high by 58 cm (22.8 in) wide. It was equipped with two vent ports and did not have any internal tether straps. On the face of the air bag there were vinyl transfers to the membrane from expansion within the module. The single flap module cover opened properly and was not damaged.

Figure 6. Deployed driver's air bag.

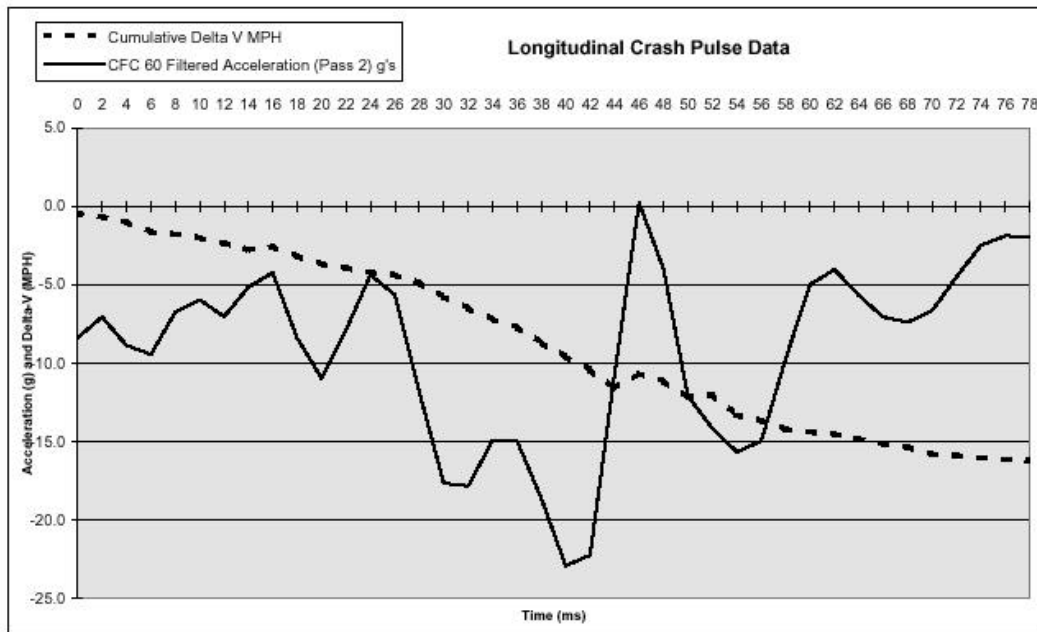
Longitudinal Cumulative Delta-V

Time (ms)	0	10	20	30	40	50	60	70	78
Delta-V (MPH)	-0.5	-2.0	-3.7	-5.8	-9.6	-12.2	-14.4	-15.8	-16.2

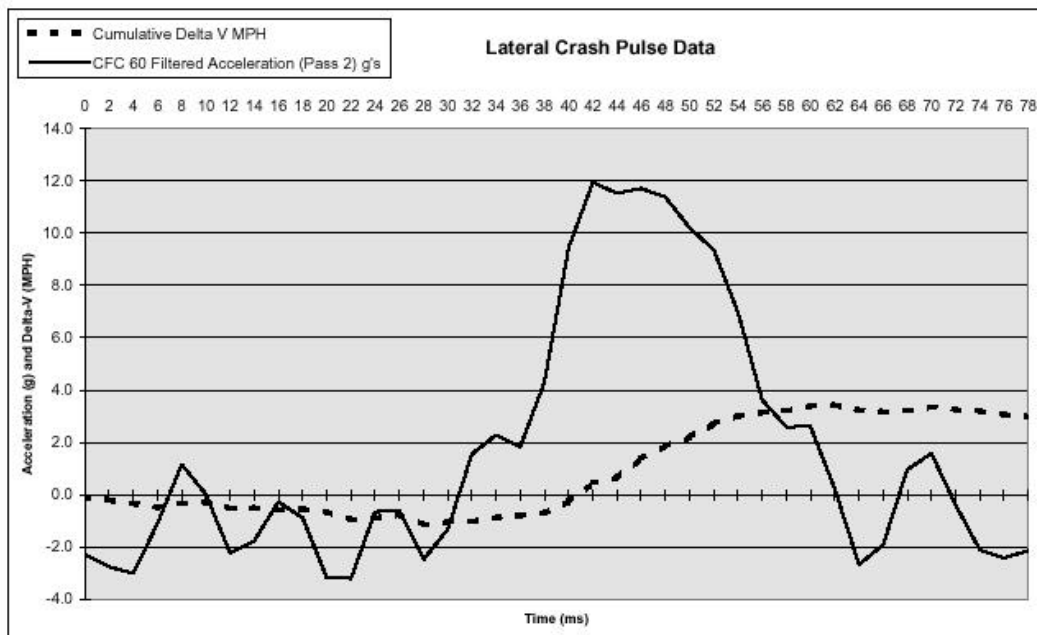
Lateral Cumulative Delta-V

Time (ms)	0	10	20	30	40	50	60	70	78
Delta-V (MPH)	-0.1	-0.3	-0.7	-1.0	-0.3	2.2	3.4	3.4	3.0
