**VERIDIAN REMOTE REDESIGNED AIR BAG RELATED
CHILD PASSENGER SERIOUS INJURY INVESTIGATION
VERIDIAN CASE NO. CA00-018
VEHICLE: 2000 KIA SPORTAGE
LOCATION: FLORIDA
CRASH DATE: JUNE 2000**

1. <i>Report No.</i> CA00-018	2. <i>Government Accession No.</i>	3. <i>Recipient's Catalog No.</i>	
4. <i>Title and Subtitle</i> Veridian Remote Redesigned Air Bag Related Child Passenger Serious Injury Investigation Vehicle: 2000 Kia Sportage Location: Florida		5. <i>Report Date:</i> March 2001

14. <i>Sponsoring Agency Code</i>	
15. <i>Supplementary Notes</i> Remote investigation of an intersection crash that resulted in air bag deployment and serious cervical injuries to a 3 year old female, front right passenger of a 2000 Kia Sportage.

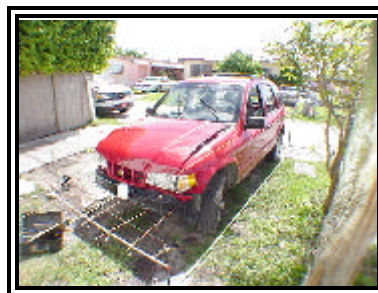
Figure 1. Front left view of the Kia Sportage.

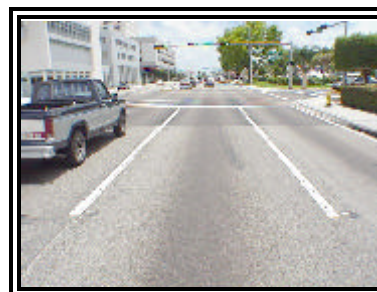
Figure 2. View of the crash site from the Kia's path of travel.

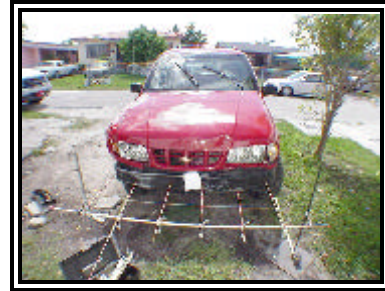
The Kia Sportage sustained moderate frontal damage (**Figure 3**) from the intersection crash with the Toyota Camry. The direct contact damage was distributed across the full frontal width of the vehicle with minor lateral displacement to support an 11 o'clock direction of force. Maximum crush was estimated at 15 cm (6") located at the left bumper corner. The impact crushed the front bumper and hood face and displaced both front fenders laterally to the right. A crush profile was estimated at bumper level as follows: C1= 15 cm (6"), C2= 10 cm (4"), C3= 15 cm (6"), C4= 13 cm (5"), C5= 15 cm (6"), C6= 15 cm (6"). A delta V was computed by the damage algorithm of the WinSMASH program 25.0 km/h (15.5 mph) which was sufficient to deploy the Kia's frontal air bag system. Although the damage was rated as moderate, the Kia was driven from the scene. The Collision Deformation Classification (CDC) was 11-FDEW-1.

Figure 3. Frontal damage to the Kia Sportage.

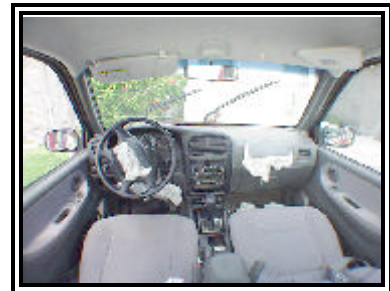
The interior of the Kia Sportage sustained minor damage that was associated with air bag deployment and occupant contact. The redesigned frontal air bags and the knee bolster air bag deployed as designed during the crash. The driver air bag module cover flaps and the mid mount passenger flap opened at the designated tear seams. The knee bolster air bag displaced the rigid bolster panel rearward from the breakaway fasteners. There was no visible intrusion into the passenger compartment. **Figure 4** is an overall view of the Kia's interior.

Figure 4. Overall view of the frontal air bag system and the Kia's interior.

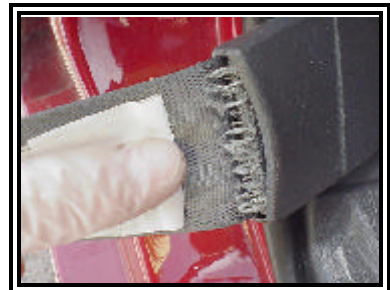
Figure 5. Partial separation of the right front lap belt energy management loop.

yield evidence of contact (i.e., tissue transfers). Blood stains were present on the inboard aspect of the seat back, above the seat belt buckle assembly. The lap belt segment of the front right 3-point belt system was equipped with an energy management loop. The loop was concealed within a vinyl sleeve above the outboard anchorage. The top row of stitching was partially separated (**Figure 5**) which indicated a load was placed on the manual belt system. This probably occurred during the air bag induced upward and rearward trajectory of the child passenger.

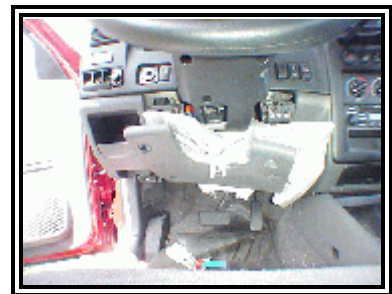
The knee bolster air bag deployed from behind the rigid plastic knee bolster panel, displacing the panel rearward toward the driver. The bolster panel released at the designated breakaway fastener locations during deployment. A probable knee scuff mark was visible on the upper left aspect of the bolster panel. **Figure 6** is a view of the deployed knee bolster air bag.

Figure 6. Deployed knee bolster air bag.

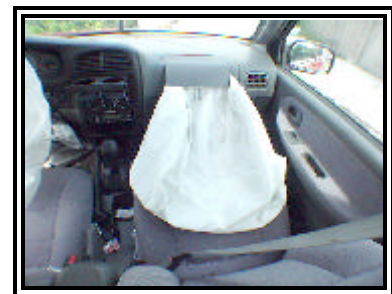
The redesigned front right passenger air bag deployed from a mid mount module that was concealed by a single cover flap (**Figure 7**). The flap opened in an upward direction toward the windshield. The front right passenger air bag membrane was non-tethered. There was no damage or contact evidence visible in the provided photographs.

Figure 7. Deployed mid mount front right passenger air bag.

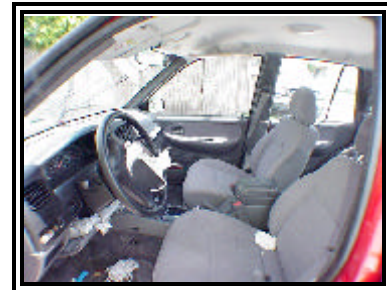
The driver of the Kia Sportage was seated in a presumed mid track positioned based on the available photographs. She was not restrained by the manual belt system. The driver's side energy management loop was intact within the vinyl sleeve. At impact, the driver initiated a forward and lateral left trajectory as she responded to the 11 o'clock impact force (**Figure 8**). She probably loaded the deployed redesigned driver and knee bolster air bag systems which protected her from contact with frontal components and possible injury.

Figure 8. Profile view of the driver's trajectory.

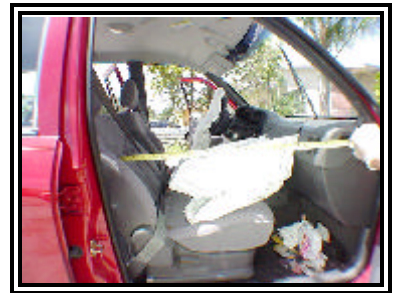
The improper use of the 3-point lap and shoulder belt system allowed the child's head and torso to move forward as a result of pre-crash braking. At impact, the child was in a close proximity the mid mount passenger air bag module with her arms extended in a forward direction. The 11 o'clock direction of force impact deployed the redesigned frontal air bag system. The top hinged cover flap did not contact the child, however, the expanding air bag membrane contacted the child's arms resulting in multiple abrasions of the right hand, bilateral forearms, and upper arms. This bag interaction displaced her arms outward which allowed the expanding air bag to contact the child under the chin, abrading her anterior neck. Continued expansion of the non-tethered air bag rotated the child's head rearward and hyper-extended the neck. The hyper-extension resulted in a fracture/dislocation of the odontoid process with an unspecified cord contusion. **Figure 9** is a profile view of the child passenger's seat track position and the rearward excursion of the air bag.

Figure 9. Profile view of the child passenger's seat track position and the deployed front right air bag.

The expansion of the redesigned passenger air bag contacted the child passenger in the upper abdomen resulting in a wide band abrasion of the epigastric area with underlying bilateral pulmonary contusions. The air bag lifted the child vertically as it displaced the child rearward. This motion allowed the child to load the lap belt in a vertical direction. The belt probably slid onto her thighs as evidenced by a 3 cm linear abrasion of the anterior left thigh. This vertical loading force on the lap belt produced a partial separation of the energy management loop that was incorporated into the outboard aspect of the lap belt.

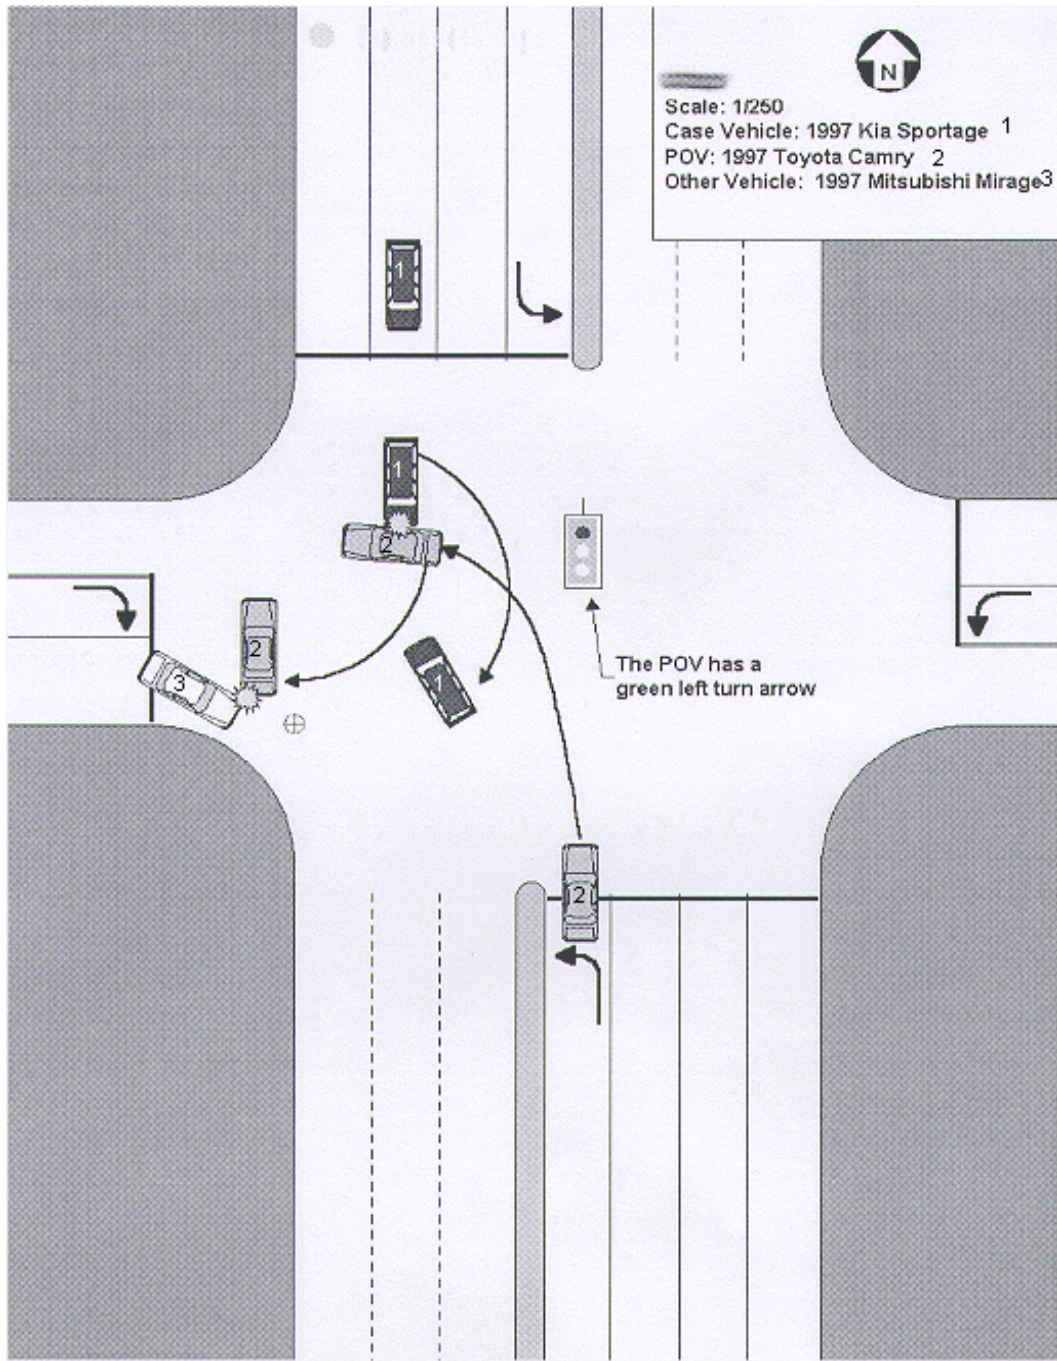
Figure 10. Crash Schematic

The full frontal area of the Kia Sportage impacted the right passenger compartment area of the Toyota. Resultant directions of force were within the 11 o'clock sector for the Kia and probably within the 2 o'clock sector for the struck Toyota. The impact crushed the front bumper of the Kia to a maximum depth of approximately 15 cm (6") which resulted in a WinSMASH generated delta V of 25.5 km/h (15.8 mph) with a longitudinal component of -23.5 (-14.6 mph) and a lateral component of 8.6 km/h (5.3 mph). The damage algorithm was utilized using an estimated crush profile for the Kia Sportage. The impact induced deceleration was sufficient to deploy the Kia's frontal air bag system. The crash schematic is attached as **Figure 10**, Page 8.
