On-scene Investigation / Vehicle to Vehicle
Dynamic Science, Inc. / Case Number: DS00-020
2000 Volvo V70XC AWD SE Station Wagon
Washington
October, 2000

1. Report No. DS00-020	2. Government Accession No.		3. Recipient Catalog No.	
4. Title and Subtitle In-Depth Accident Investigation		5. Report Date .		
		6. Performing Organization Report No.

**Dynamic Science, Inc.
Accident Investigation
Case Number: DS00-020**

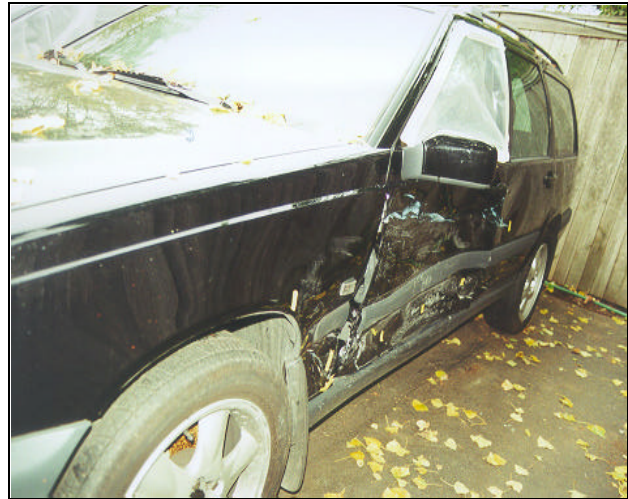
Figure 2. Left side damage to case vehicle.

Damage Description: The case vehicle sustained minor damage to the left side of the vehicle--primarily to the driver's door. The driver's side window disintegrated on impact with the other vehicle. The left sill intruded 4.5 cm (1.8 in.) into the driver's compartment area. There was no measurable intrusion of the driver's door panel area. Vehicle towed from scene, but not due to damage.

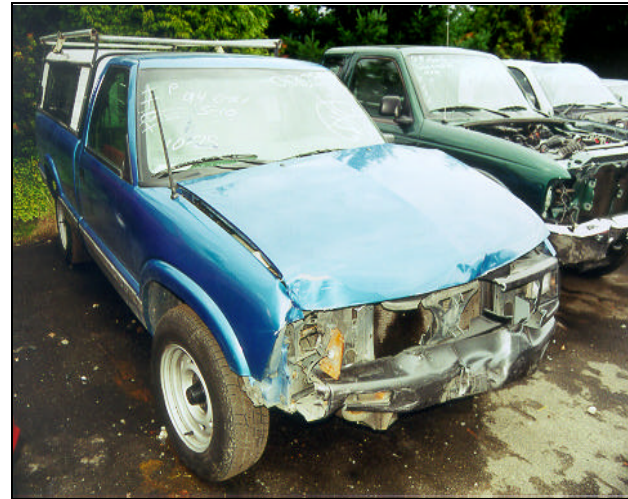
Figure 3. Frontal damage to other vehicle.

Description: 1994 Chevrolet S-10 4x2 Pickup
 VIN: 1GCCS14ZXR8XXXXXX
 Odometer: 124,244 km (77,204 miles)
 Engine: 4.3L, 6 cylinder
 Reported Defects: None
 Cargo: None
 Damage Description: Other vehicle sustained moderated damage to the front bumper, hood, grille, and both front fenders. Vehicle towed from scene due to damage.
 CDC : 01FDEW1
 Delta V (Impact 1 v. case vehicle):
 Total 13.0 km/h (8.1 mph)
 Longitudinal -11.3 km/h (-7.0 mph)
 Latitudinal -6.5 km/h (-4.0 mph)
 Energy 13,928 joules
 (10,273 ft-lbs)

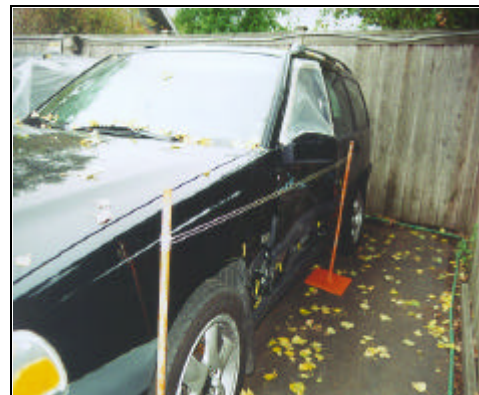
Total	10.0 km/h (6.2 mph)
Longitudinal	- 7.1 km/h (-4.4 mph)
Latitudinal	7.1 km/h (4.4 mph)
Energy	5,640 joules (4,160 ft-lbs)

Figure 5. Case vehicle--crush stands.

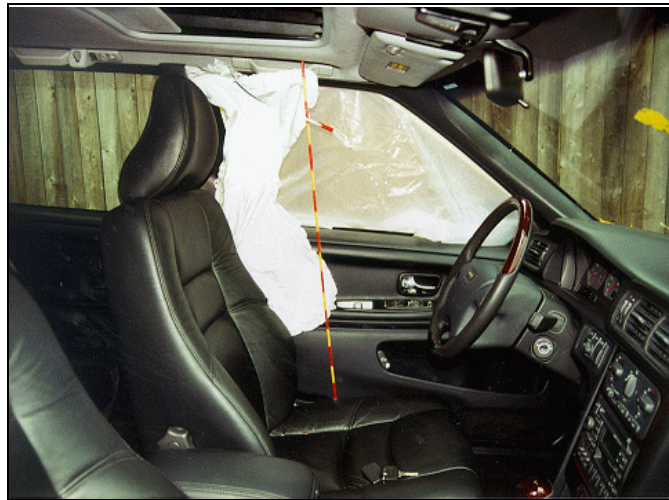
The SIPS consists of specially designed structural members of the passenger cabin, reinforcement inside the doors and seat mounted side air bags. The SIPS design transfers crash energy to the opposite side of the car via the reinforced cross members in the floor and roof. The entire seat mounted side air bags system is built into the seat and has no electrical components. A mechanical sensor mounted in the seat base triggers the system when an impact moves the door into contact with the seat. A firing charge in the sensor sends an ignition pulse. The driver's door intruded on impact with the other vehicle and the driver's seat mounted side air bag deployed. The single module cover measured 6 cm (2.4 in.) by 38.5 cm (15.2 in.). There was no visible damage to the module or the cover. The air bag was vaguely rectangular in shape. It measured 40 cm (15.7 in.) by 68 cm (26.8 in.). The side air bag was not tethered and did not contain any vent ports. There was no damage to the side air bag.

Figure 6. Case vehicle driver's side air bag.

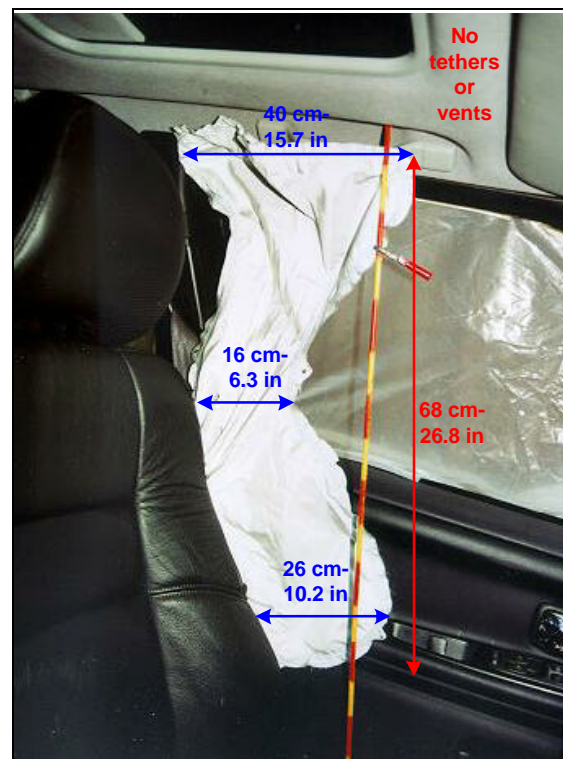
Figure 7. Case vehicle driver's side air bag dimensions.

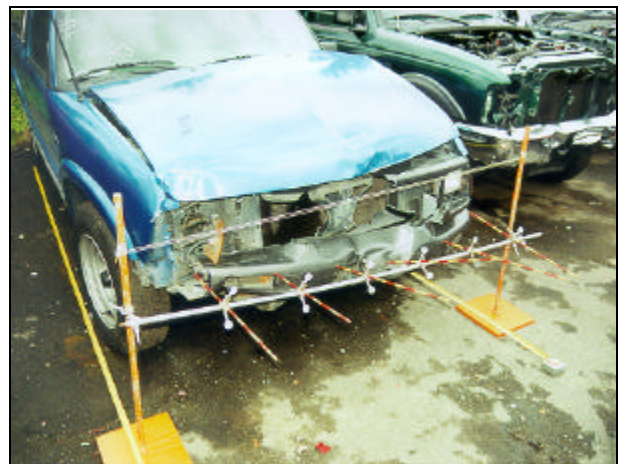
Figure 8. Other vehicle—crush stands.
