**ADVANCED OCCUPANT PROTECTION SYSTEM STUDY
2000 FORD TAURUS INVESTIGATION**

VERIDIAN CASE NO. CA00-023

LOCATION - TENNESSEE

CRASH DATE - JUNE 2000

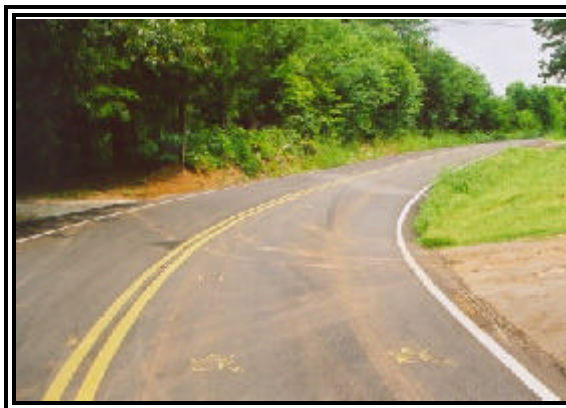
Figure 1: Trajectory view of the Ford Taurus.

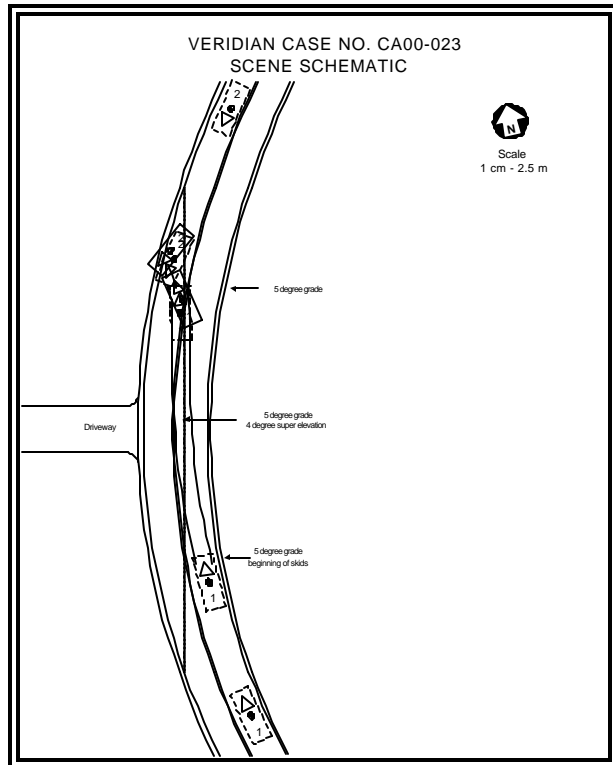
This two-vehicle crash occurred during the afternoon hours in June, 2000. It was daylight at the time of the crash and the weather was not a factor. The road surface was dry. The crash occurred on a two-lane north/south county roadway. At the scene, there was a right curve for northbound traffic with a positive eight percent grade. Refer to **Figure 1**. The radius of the curve measured 67 m (220 ft). The curve's super-elevation measured seven percent. Two skid marks in the northbound direction defined the pre-crash trajectory of the Ford Taurus. The skid marks measured 25 m (82 ft) in length. The point of impact was defined by a westward deflection of the skid marks and an area of pavement gouges. The speed limit in the area of the crash was 48 km/h (30 mph).

Figure 2: Crash scene schematic

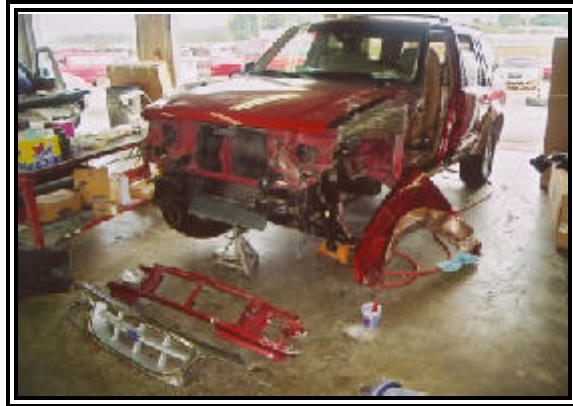
of the inspection and had been disassembled preventing crush measurements. The direct contact damage to the vehicle began 30 cm (12 in) left of center and extended 46 cm (18 in) left to the front bumper corner. Due to the higher frontal profile of the Explorer (relative to the braking Taurus), there was minimal damage to the upper radiator support and no damage to the hood. The Explorer's damage was localized to the left aspect of the lower radiator support and left front suspension. The left front fender buckled both longitudinally and laterally from the angular impact. The left side damage extended rearward to the leading edge of the front door. The Collision Deformation Classification was 11-FLEW-1.

Figure 3: Left front view of the Ford Explorer.

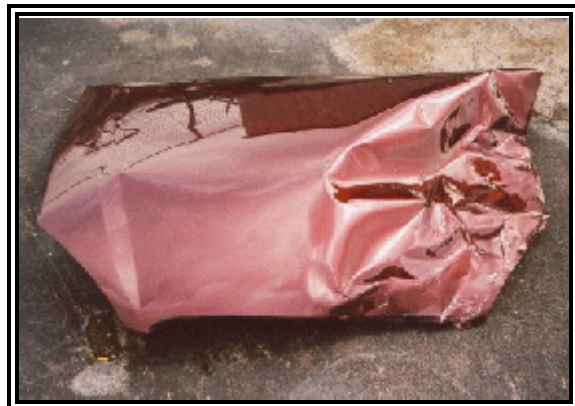
Figure 4 is a view of the damaged hood. Inspection revealed the direct contact began approximately on the vehicle's centerline and extended to the left front corner. **Figures 5 and 6** are front and left side views of the vehicle, respectively. The major damaged exterior components consisted of the hood, bumper fascia, reinforcement bar, radiator support and left front fender. Referring to Figure 5, the forward aspect of the left inner fender and left bumper reinforcement mounting structure were damaged as well. The left toe pan and the floorpan at the driver's seat were buckled approximately 2 cm (1 in).

Figure 4: View of the damaged hood.

The Collision Deformation Classification (CDC) of the damage was 11-FYEW-01. The severity of the crash was estimated to be moderate based on the vehicular damage analysis and SCI experience. The Restraint Control Module (RCM) measured and stored a longitudinal delta V of 12.4 mph at 78 milliseconds. The slope of the delta V curve was still rising. It should be noted that the RCM is not capable of recording and storing the entire crash pulse and the recorded delta V may not be the maximum delta V experienced in the crash. A stage 1 air bag deployment was commanded at 31 milliseconds. The data sheets from the RCM download are included at the end of this report as **Attachment A**.

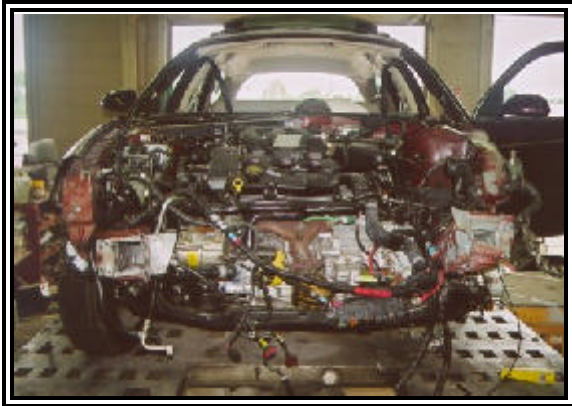
Figure 5: Front view of the Ford Taurus.

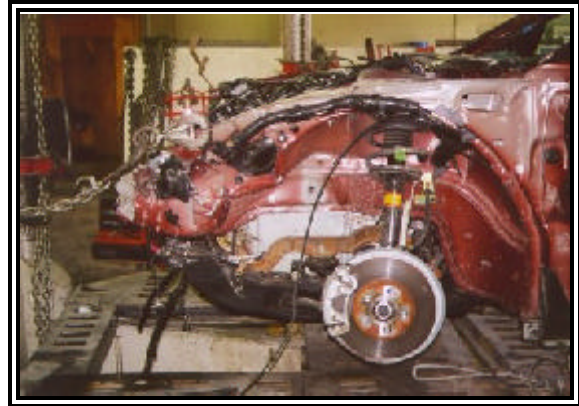
Figure 6: View of the left front suspension area.

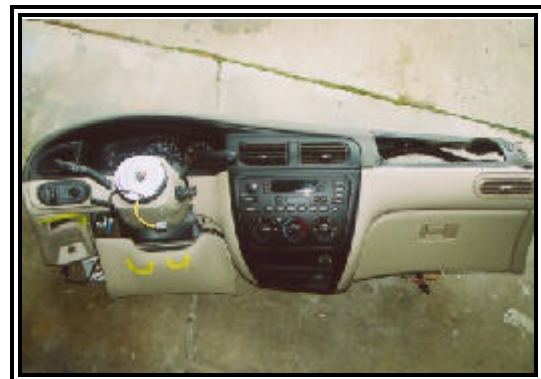
At the time of inspection, the entire interior of the Taurus had been disassembled and removed. **Figure 7** is an overall view of the instrument panel. The driver's knee bolster exhibited evidence of contact from the driver's right lower extremity. The contacts measured approximately 1 cm x 1 cm (0.5 in x 0.5 in) and were located symmetrically about the steering column centerline. It was probable only one of these contacts

Figure 7: View of the instrument panel.

was crash related. A second area of contact was identified on the left aspect of the mid panel, outboard of the bolster. This contact measured approximately 10 cm (4 in) in width and was consistent with contact from the left lower extremity. The mid-panel was crushed in approximately 5 cm (2 in). The steering column was still attached to the instrument panel at the shear capsules and lower bracket. Examination of the column revealed no damage to the column's components nor shear capsule movement.

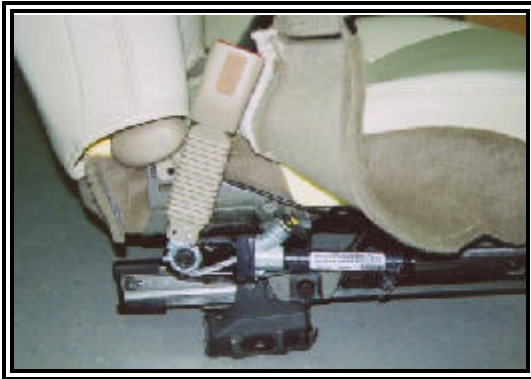
Figure 8: View of the buckle pretensioner.

The front seats had been unbolted from the floor pan and were found in a storage room adjacent to the repair bay. They were not damaged. **Figure 8** is a close-up view of the right aspect of the driver's seat and the buckle pretensioner. The pretensioner did not fire in the crash. The pretensioner's barrel length measured 110 mm (4.3 in).

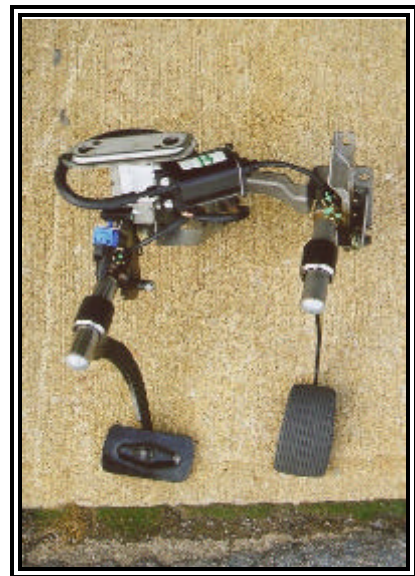
The Taurus was equipped with adjustable foot controls. The foot controls, **Figure 9**, were a complete assembly which bolted to the driver's toe pan. The mounting structure of the assembly was deformed by the force of the crash and toe pan intrusion. The assembly had been removed from the vehicle during its repair. The fore/aft adjustment of accelerator and brake pedals was controlled electronically. Switch actuation controlled an electric motor on the pedal assembly, which in-turn drove jack screws within the cylinders on which the pedals were mounted. The pedals had a 7.6 cm (3 in) range of motion and measured 4 cm (1.6 in) rear of most forward position (measured with respect to the vehicle). The foot pad of the brake pedal was noted to be rotated clockwise relative to the vertical mounting arm. This rotation occurred due to the off-center loading of the foot pad imparted by the driver's foot at impact. This evidence was linked to the driver's right ankle sprain and indicated the driver was braking with her right foot at the time of the impact.

Figure 9: View of the adjustable pedal assembly.

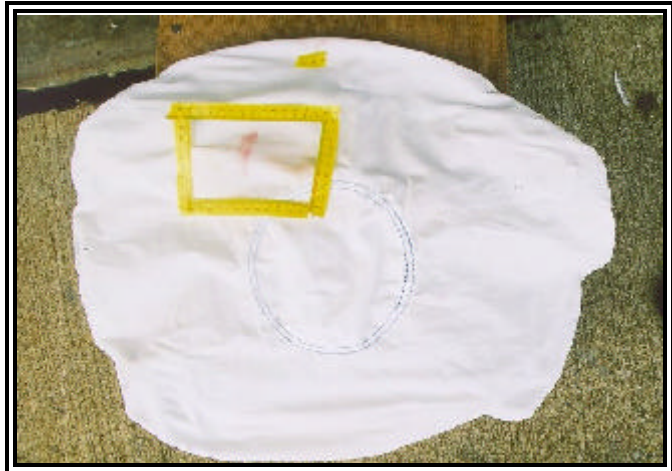
in). The deployed driver air bag, **Figure 10**, measured 53 cm (21 in) in diameter. It was tethered by 4 straps sewn to the face of the bag. The bag was vented by two 2.9 cm (1.1 in) ports located in the 10/2 o'clock position of the back side of the bag. The following nomenclature was found on a manufacturer's label fixed to the 12 o'clock sector of the module:

A tan make-up and red lip stick transfer was identified in the 10 o'clock sector of the face of the bag. The nature of the transfer indicated that the air bag was fully inflated at the time the driver contact. The contact area measured approximately 8 cm x 5 cm (3 in x 2 in), width by height, and was located 8.9 cm (3.5 in) left and 11.1 cm (4.3 in) above the center of the air bag. The red lipstick was oriented vertically, in the 12/6 o'clock direction and was concave to the right. The orientation of the lipstick indicated the steering wheel was rotated 90 degrees counterclockwise when contact occurred.

Figure 10: View of the driver air bag. Note, the 12 o'clock sector is at the top of the photograph.

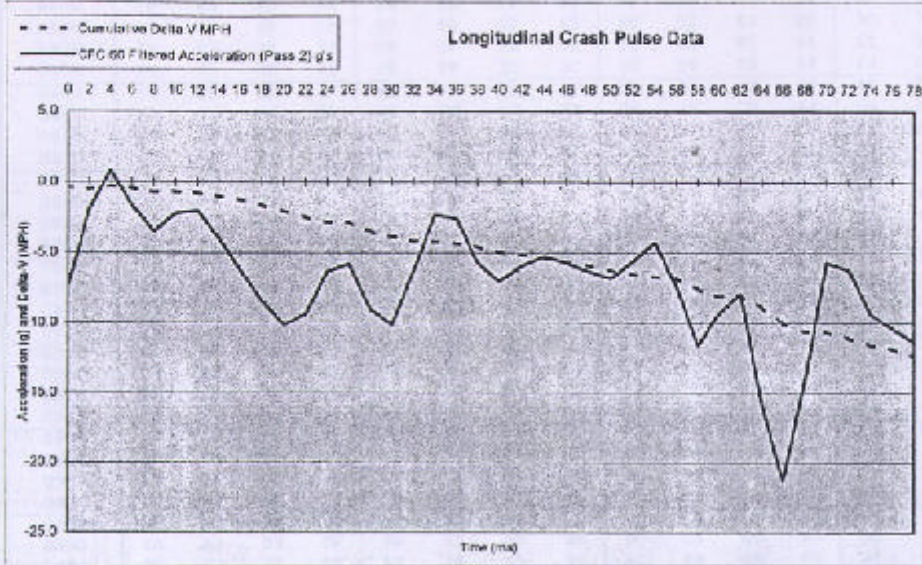
Longitudinal Cumulative Delta-V

Time (ms)	0	10	20	30	40	50	60	70	78
Delta-V (MPH)	-0.1	-0.7	-2.1	-3.9	-5.0	-6.3	-8.1	-10.5	-12.4

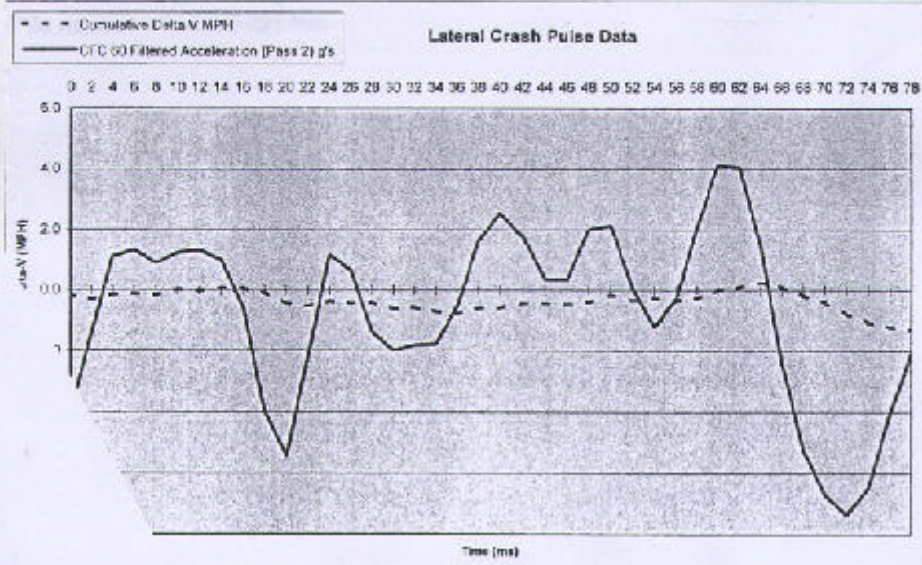
Lateral Cumulative Delta-V

Time (ms)	0	10	20	30	40	50	60	70	78
Delta-V (MPH)	-0.2	0.0	-0.4	-0.6	-0.6	-0.2	0.0	-0.4	-1.3
