**VERIDIAN ON-SITE AIR BAG ASYMMETRICAL  
DEPLOYMENT INVESTIGATION**

**VERIDIAN CASE NO. CA00-028**

**VEHICLE - 1996 DODGE CARAVAN SE**

**CRASH DATE - JULY, 2000**

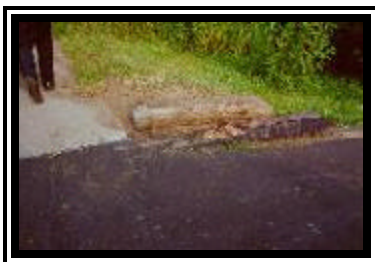
**Figure 2. Police photo (east) of struck landscaping ties.**

Direct contact damage was identified to the right side wheels from impact with the landscaping railroad ties. The right front temporary tire was deflated (not restricted) with significant rim damage. In addition, the lug nuts were found to be placed on backwards. The right rear tire was also deflated (not restricted)

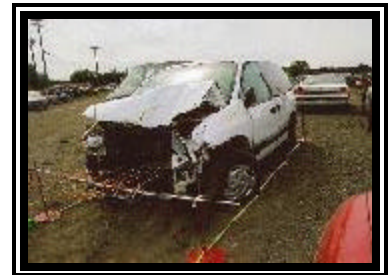
The Dodge Caravan sustained moderate frontal damage as a result of the impact with the large diameter tree (**Figure 5**). The direct contact damage began 8.0 cm (3.1 in) to the left of the vehicle centerline and extended inboard 34.0 cm (13.4 in). The impact deformed the full frontal width resulting in a combined direct and induced damage length (Field L) of 84.0 cm (33.1 in). Six crush measurements were documented at the level of the reinforcement bar (*bumper fascia separation*): C1= 10.0 cm (3.9 in), C2= 63.0 cm (24.8 in), C3= 63.0 cm (24.8 in), C4= 44.0 cm (17.3 in), C5= 26.0 cm (10.2 in), C6= 0 cm. The hood was deformed up and rearward from engagement against the tree. The left headlight and grille assembly separated from the vehicle during the crash sequence. The left fender was displaced rearward which restricted the left front wheel/tire (not deflated). Reduction in the left side wheelbase measured 6.5 cm (2.6 in). Elongation in the right side wheelbase measured 4.0 cm (1.6 in). Multiple fracture sites were noted to the windshield from exterior impact forces (only).

**Figure 5. Frontal and left side damage to the 1996 Dodge Caravan SE.**

Direct contact damage was also identified to the front left area attributed to the U-beam signpost impact. The direct contact damage began approximately 13.0 cm (5.1 in) inboard of the front left bumper corner with the impression most prominent along the forward edge of the left fender. Related direct contact damage was documented to the left side surface from the regulatory sign as it fell to the ground. The direct contact damage began 10.0 cm (3.9 in) forward of the left front axle and extended 325.0 cm (128.0 in) rearward, which confirms contact separation with the post and assignment of another event. A maximum crush value of 2.0 cm (0.8 in) was found at the left rear axle area. Although the contact pattern was concentrated below the level of the beltline, surface scratching was noted to the side mirror with the pattern tapered downward as it continued toward the rear of the vehicle (*i.e* "falling object"). Previous damage (body filler) was noted on the left front door and left fender areas. Superficial scratching was noted to the hood and roof areas from the subsequent brush contact.

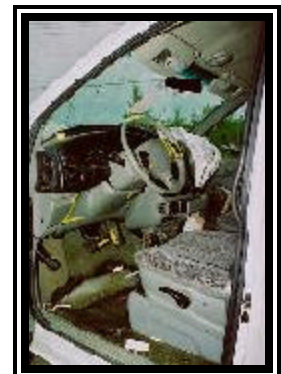
Interior damage to the Dodge identified through the vehicle inspection was moderate and was attributed to occupant contact and minimal component intrusion (**Figure 6**). Indentations and scuff marks were documented on the left knee bolster (rigid plastic type) with deformation of the reinforcement panel noted. Scuff marks and a small indentation were also found on the steering wheel hub (air bag module cover) along with deformation to the steering wheel rim which measured 4.5 cm (1.8 in) at the top section and 1.5 cm (0.6 in) at the right spoke area. Column compression measured 0.5 cm (0.2 in) with separation of the steering assembly noted. The brake/gas pedals were displaced to the left. Blood pooling was found on the driver's seat cushion and arm rest. A large scuff mark was documented along the right headliner which began at the second seated area and extended forward toward the front right passenger space. Deformation was also noted to the second seat back from the spare tire (originally the right front tire) impact. Longitudinal intrusions into the driver space involved 23.0 cm (9.1 in) of toe pan intrusion, 4.0 cm (1.6 in) of instrument panel intrusion, 7.0 cm (2.8 in) of brake/gas pedal intrusion and 3.0 cm (1.2 in) of center instrument panel intrusion.

**Figure 6. Interior view of the driver space.**

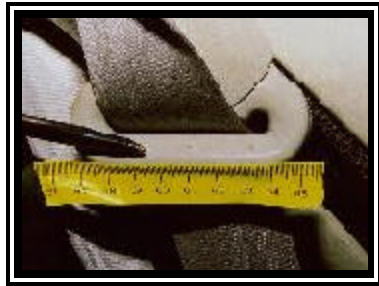
belt webbing with a sliding latchplate and dual mode retractors (inertial lock/belt sensitive). Loading evidence consisted of abrasions to the D-ring (**Figure 7**) and associated loading marks to the shoulder portion of the webbing (**Figure 8**). Loading marks were also identified to the lap portion of the webbing attributed to the sliding latchplate. In addition, the fractured B-pillar panel and blood spattering documented to the shoulder portion of the webbing also supported restraint usage. The front right 3-point manual lap and shoulder belt system consisted of a continuous loop belt webbing with a semi-locking latchplate and dual mode retractors (inertial lock/belt sensitive). The rear outboard seating positions were equipped with 3-point manual lap and shoulder belt systems which consisted of continuous loop belt webbings with semi-locking latchplates. The rear center seating position was equipped with a 2-point manual lap belt system with a locking latchplate.

**Figure 7.** Abrasions to the front left restraint D-ring.

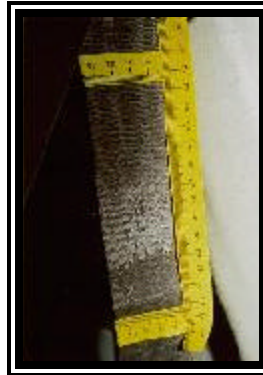
**Figure 8.** Loading marks to the front left shoulder belt webbing.

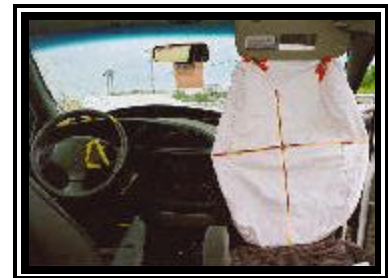
The Dodge Caravan was equipped with frontal air bags for the driver and front right passenger positions which asymmetrically deployed as a result of the impact with the large diameter tree (**Figure 9**). The driver air bag was housed in the center of the steering wheel with a horizontally oriented flap tear seam (H-configuration). The driver air bag module was identified by the Chrysler part number: \*P04680143\* with a bar coded lot number of: \*TCTDM0866M3097\*. Non-deployment of the driver air bag was possibly related to the clock spring assembly which was meticulously documented and removed by the SCI investigator (**Figure 10**). The SCI investigator first removed the air bag module and found the connector intact. A steering wheel puller was next used to gain access to the clock spring assembly which was noted to be in the (correct) upright position on the steering wheel shaft. The clock spring was identified by the Chrysler part number: 46876-30, 23199. The clock spring assembly was removed and forwarded to NHTSA's Office of Defect Investigations (ODI).

**Figure 9.** 1996 Dodge Caravan SE non-deployed driver air bag and deployed passenger air bag.

It should be noted that deployment of the driver frontal air bag would have provided additional crash protection for the driver against further contact to the air bag module cover and steering wheel spoke/rim, thus potentially mitigating the facial injuries he sustained from the steering wheel contact.
