**VERIDIAN ON-SITE SEAT BELT INVESTIGATION
VERIDIAN CASE NO. CA00-040
VEHICLE: 2000 FORD EXPLORER XLS SPORT
LOCATION: FLORIDA
CRASH DATE: SEPTEMBER 2000**

1. <i>Report No.</i> CA00-040	2. <i>Government Accession No.</i>	3. <i>Recipient's Catalog No.</i>	
4. <i>Title and Subtitle</i> Veridian On-Site Seat Belt Investigation Vehicle: 2000 Ford Explorer XLS Sport Location: Florida		5. <i>Report Date:</i> January 2002

14. <i>Sponsoring Agency Code</i>	
15. <i>Supplementary Notes</i> On-site investigation of a front-to-rear crash and a subsequent rollover of a 2000 Ford Explorer that resulted in the death of the belted 22 year old female front right passenger.

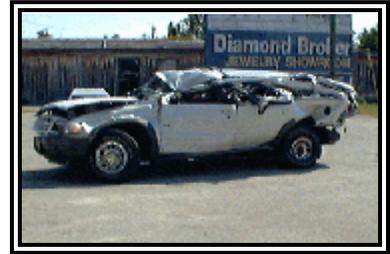
Figure 1. Rollover damage to the 2000 Ford Explorer.

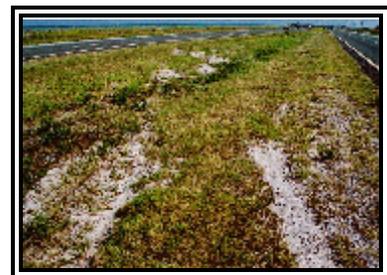
Figure 3. Right tire furrows in the sand median.

The Ford Explorer yawed approximately 57 degrees in a CCW direction onto the sand median. The right side tires furrowed into the soft surface (**Figure 3**) which tripped the vehicle into a lateral side-over-side rollover event, leading with its right side. At the time of the SCI scene inspection, six pronounced gouge marks remained present in the sand median that were located over a 13 m (43') longitudinal area. Inclusive to these gouge marks was the left rear quarter window trim of the Ford Explorer. From the on-set of the lateral rollover, the Explorer traveled approximately 26 m (85') before entering the westbound travel lanes. During this trajectory, the Explorer appears to have completed seven (7) quarter rolls, ejecting the driver onto the westbound travel lanes. He came to rest in a face down attitude with his head positioned near the centerline of the westbound travel lanes.

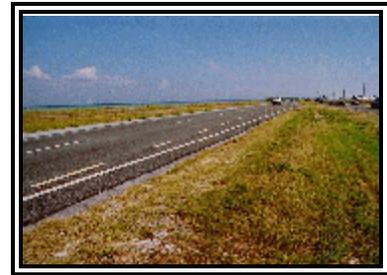
The Explorer continued to roll in a lateral mode across the westbound lanes as its center-of-gravity continued in a northeasterly direction (**Figure 4**). Two distinct gouge marks were present in the inboard westbound lane. The eastern most gouge mark was a semi-circular gouge indicative of a wheel impact to the pavement surface. The Explorer continued to roll across the westbound lanes and shoulders, coming to rest in an upright attitude 64.5 m (211.6') east of the trip point which initiated the rollover. It should be noted that the front right female passenger of the Ford Explorer was restrained by the 3-point lap and shoulder belt system, however, due to a belt system failure, she was partially ejected through the right front door window opening which resulted in a fatal crushing injury of her head. Due to the severity of the injury and the lack of sand within the injured area, it was determined the injury occurred as the vehicle was overturning on the hard asphalt road surface or shoulder.

Figure 4. Rollover trajectory of the Ford Explorer.

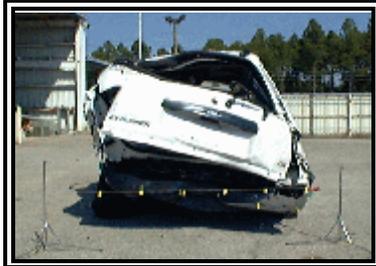
(58.0") along the damaged profile. The impact deflected the bumper downward, rotating the face of the bumper to a near 90 degree attitude. The crush profile, by protocol, was measured at the mid plane of the bumper face and was as follows: C1 = 33.7 cm (13.25"), C2 = 32.0 cm (12.6"), C3 = 33.8 cm (13.3"), C4 = 34.5 cm (13.6"), C5 = 21.0 cm (8.25"), C6 = 6.1 cm (2.4"). **Figures 7 and 8** depict the damage to the rear of the Explorer.

Figure 7. Rear impact damage to the Ford Explorer.

The 6 o'clock direction of force impact displaced the rear structure forward, compressing the rear leaf springs and the spare tire against the rear axle. The main leaves of the rear springs were bent in a U-configuration and the top mount of the left rear shock absorber was fractured by the damage. The spare tire separated from the undercarriage carrier during the crash. The OEM steel rim of the spare tire was deformed and the tire was fully deflated with the bead separated from the wheel. The Collision Deformation Classification (CDC) for this event was 06-BDEW-3.

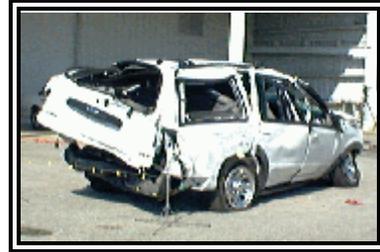
Figure 8. Right three-quarter view of the rear damage.

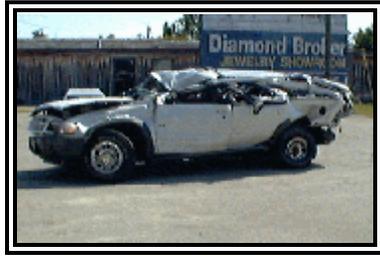
The direct contact damage, which consisted of abrasions to the painted surfaces, extended the full length and width of the Explorer. The left roof side rail area of the roof structure sustained the most severe damage. The junction of the left upper A-pillar, windshield header, and side rail was displaced 29.8 cm (11.75") vertically into the driver's compartment. The roof side rail at the mid aspect of the left rear door was crushed 24.1 cm (9.5") while the side rail at the mid point of the rear quarter window was displaced 27.9 cm (11.0") downward. The backlight header was crushed 29.2 cm (11.5") into the cargo area. It should be noted that the severe deformation to the driver's compartment occurred after his ejection from

Figure 9. Left side rollover damage to the Explorer.

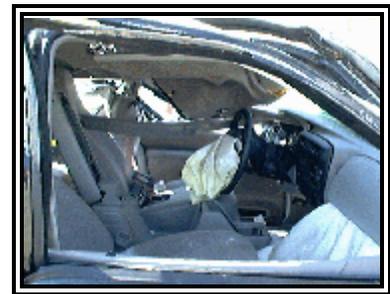
The front right and rear right occupant positions were minimally intruded by deformation of the roof structure (**Figure 11**). The vertical displacement of the right roof side rail was approximately 2.5 cm (1.0") while the roof panel was deflected upward as a result of lateral displacement of the left upper A-pillar. The right corner of the front bumper contacted the ground during the rollover event. The damage began 39.4 cm (15.5") right of center and extended 36.8 cm (14.5") to the right corner. This damage was the only direct contact damage to the frontal plane of the vehicle.

Figure 11. Front right passenger compartment.

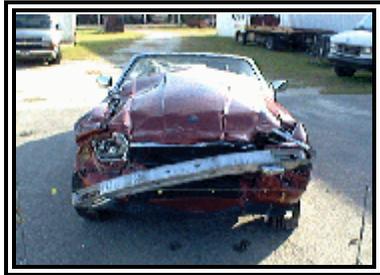
The 1992 Jaguar sustained moderate frontal damage (**Figure 12**) as a result of the front-to-rear impact sequence with the 2000 Ford Explorer. The initial contact involved the front bumper of the Jaguar against the rear bumper of the Explorer, however, as the vehicles crushed, the Jaguar underrode the rear of the Explorer. Maximum crush was approximately 47.2 cm (18.6") located at the leading edge of the hood, 20.3 cm (8.0") right of the centerline. The bumper was crushed to a maximum depth of 22.2 cm (8.75") located inboard of the right corner. The direct contact damage extended across the full width of the bumper resulting in a combined direct and induced damage length of 147.3 cm (58.0"). The underride resulted in vertical displacement of the Jaguar's frontal structure. The left frame rail was displaced 22.9

Figure 12. Frontal damage to the Jaguar XJS.

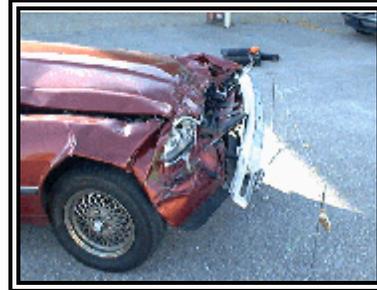
Figure 13. Profile view documenting the extent of frontal crush.

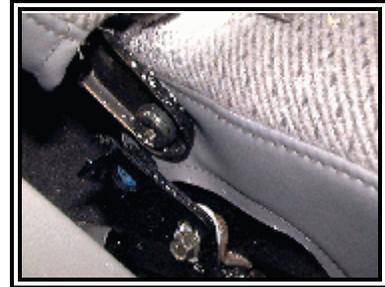
The outboard aspect of the buckle sleeve extended vertically from the attachment point at a forward angle along the inboard aspect of the seat cushion/seat back support. The seat back was attached to the cushion frame by a stamped U-channel bracket (**Figure 14**). This bracket was 3.2 cm (1.25") in width. The edges of the U-channel protruded outward from the body of the bracket by approximately 0.6 cm (0.25"). These edges were exposed (unprotected) to the outboard aspect of the vinyl sleeve of the buckle. When not in use, the sleeve was positioned away from the edges of the U-channel, however, when loaded, the sleeve engaged against the edges of the bracket.

Figure 14. Driver's side inboard seat back support bracket.

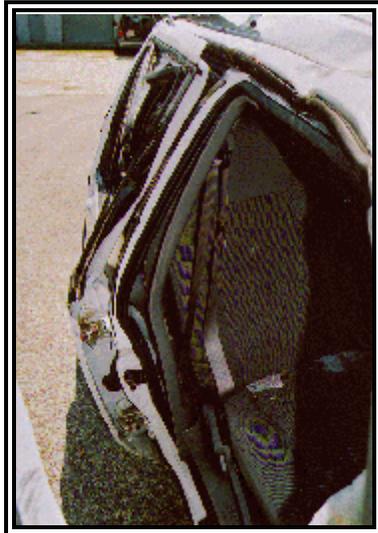
The SCI inspection of the buckle assembly found the buckle unit intact with the top mounted release button spring loaded and operational. The webbing tether had separated from the lower anchorage bracket which remained bolted to the seat frame bracket. The webbing tether was cut in an irregular pattern above the lower anchorage bracket. That is, removed from the vehicle, the outboard aspect side of the webbing tether (side exposed to the inboard aspect of the seat cushion) was shorter in length than the opposing aspect. The outboard aspect of the webbing tether measured 9.0-10.0 cm (3 9/16 - 3 15/16") in length from the base of the buckle unit to the frayed cut points. The opposing length ranged from 11.1-11.7 cm (4 3/8-4 5/8"). All stitching remained intact and was located above the cut location. **Figure 17** is a view of the partially retracted passenger's belt system.

Figure 17. Post-crash position of the retracted right front belt system.

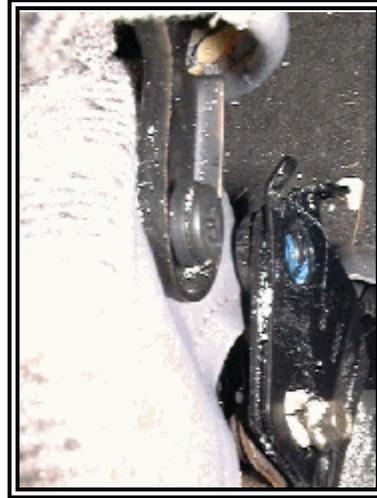
Figure 18. Inboard passenger's seat back rest support bracket.

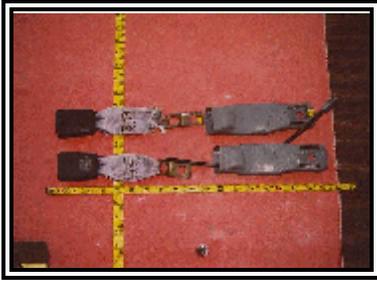
Figure 19. Removed buckle assemblies; top - passenger; bottom - driver.

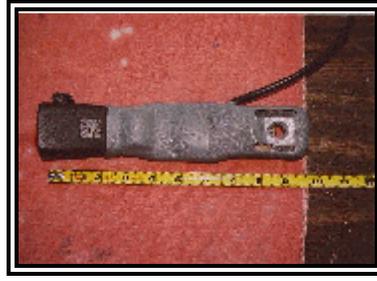
The lower of the two gouge marks was 1.6 cm (0.625") in length while the upper mark was 1.9 cm (0.75") in length. A third narrow scratch type mark was present parallel to and located immediately above these distinct gouges. The edge of the seat back support bracket did not cut through the vinyl sleeve.

Figure 20. Gouges on the driver's side buckle sleeve.

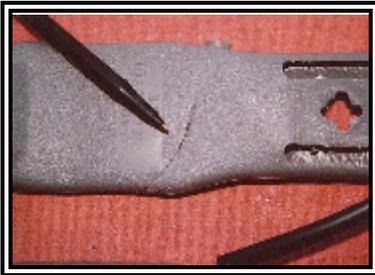
The vinyl sleeve was removed from the vehicle by removing the #50 TORX head bolt from the seat frame bracket. This allowed for the removal of the lower anchor bracket, which the webbing tether had separated from, and the sleeve. Inspection of the sleeve revealed a narrow, curved cut line that extended through the thickness of the sleeve. The cut was located on the outboard aspect of the sleeve, the aspect exposed to the inboard seat back support bracket (**Figure 18**). The diagonally orientated cut was 3.7 cm (1 7/16") in length and originated 7.9 cm (3 1/8") above the bottom of the sleeve. In addition, the cut

extended laterally across the sleeve from a point that began 0.6 cm (0.25") above the lower side of the sleeve to 0.3 cm (0.125") beyond the midpoint of the sleeve.

Figure 21. Cut line on the passenger's buckle sleeve.

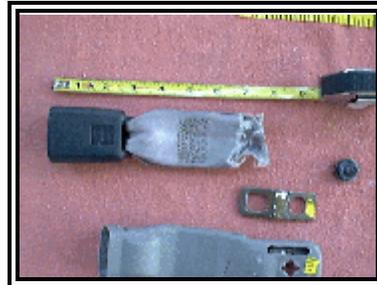
Figure 22. Cut passenger's side buckle tether.

The violent force of the rollover event was transmitted into the front right passenger. Her loading of the belt webbing tensioned all anchorage points which resulted in the abrasion patterns noted above. As a result of belt loading, the passenger sustained a laceration of the liver. The vinyl sleeve which concealed the buckle tether webbing at the seat frame anchorage point was pulled taut against the exposed seat back support bracket. The formed metal edge of this U-channel bracket cut through the vinyl sleeve and partially through the buckle webbing tether while the webbing was under tension due to the loading of the passenger. The webbing frayed at the cut point and completely separated from the lower anchor bracket. The buckle and webbing tether pulled out of the vinyl sleeve as the buckle/latchplate presumably remained fastened.

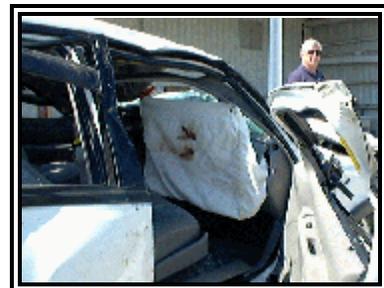
Figure 23. Blood stain on the front right passenger air bag.

A large blood stain was noted to the center face of the passenger bag (**Figure 23**). The stain probably occurred following the partial ejection of the front right occupant. This event resulted in massive destruction of the head. There was no damage to the instrument panel forward of the air bag, indicative of occupant loading through the air bag. The system was equipped with a single point air bag control module. This module did not have event data recording capabilities.
