**ADVANCED OCCUPANT PROTECTION SYSTEM STUDY
2000 FORD TAURUS INVESTIGATION**

VERIDIAN CASE NO. CA00-043

LOCATION - MICHIGAN

CRASH DATE - AUGUST 2000

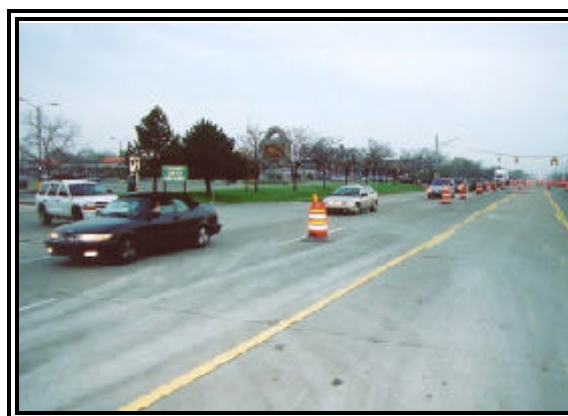
Figure 1: Southward trajectory view near the point of impact.

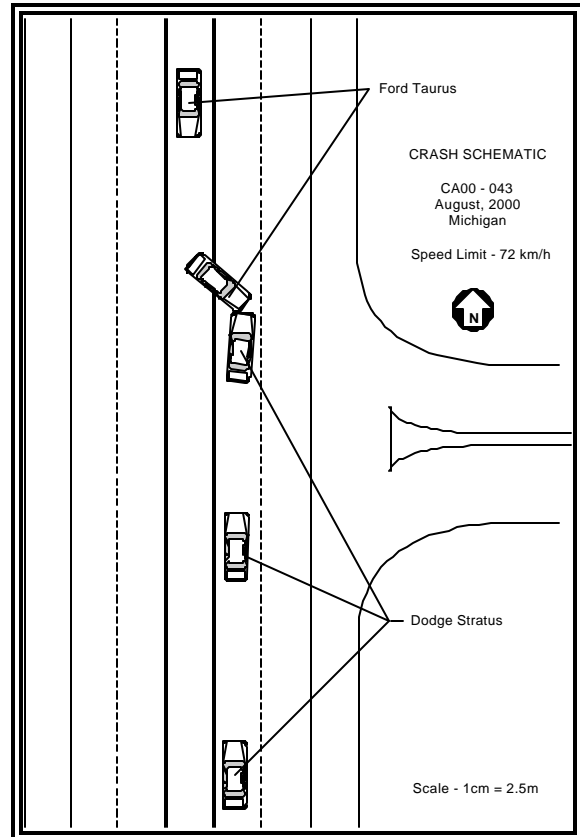
The crash occurred when the forward aspect of the Ford's right side was struck by the left frontal area of the Dodge in a 02/11 o'clock impact configuration, **Figure 2**. The force of the impact caused the deployment of the frontal air bag systems of both vehicles. The lateral impact of the Dodge, forward of the Ford's center of gravity, caused the Ford to rotate counterclockwise. The pre-crash steering of the Dodge coupled with the lateral momentum of the Ford caused the Dodge to rotate clockwise. As the respective vehicles rotated away from the initial impact, the left side of the Dodge impacted the right rear side of the Ford in a secondary side slap. The vehicles then came to rest in the northbound lanes of the roadway. Their exact final rest positions were unknown and not documented by the police investigation. Inspection of the crash scene, at the time of the on-site investigation, was unremarkable. Due to the delayed crash notification, any physical evidence of the crash at the scene had deteriorated. The total delta V's of the impact as calculated by the Missing Vehicle algorithm of the WINSMASH model were 31.2 km/h (19.4 mph) and 33.5 km/h (20.8 mph) for the Ford Taurus and Dodge Stratus, respectively.

Figure 2: Crash schematic.

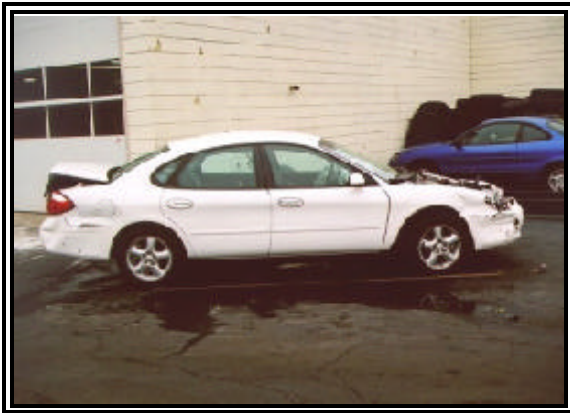
The vehicle was in a state of repair at the time of the SCI investigation. Reportedly, the frame had been partially straightened. **Figures 3 and 4** are right side and right front close-up views of the damaged vehicle. The forward aspect of the Taurus's right side sustained 54.6 cm (21.5 in) of direct contact damage, as a result of the initial impact. The direct contact began 30.5 cm (12.0 in) forward of the right front axle and extended forward to the right corner of the front bumper. This direct damage pattern wrapped around the corner an additional 16.5 cm (6.5 in). The force of the lateral impact to the front bumper shifted the vehicle's front clip (vehicle structure forward of the cowl) to the left. The operation of the left front door was restricted. There were no glass fractures. There was no measurable change in the wheelbase dimensions. Vehicle crush measurements were not taken, as the vehicle had been partially repaired and its crush profile had been altered. The Missing Vehicle algorithm of the WINSMASH model calculated a total delta V of 31.2 km/h (19.4 mph). The longitudinal and lateral delta V components were -15.6 km/h (9.7 mph) and -27.0 km/h (16.8 mph), respectively. The estimated Collision Deformation Classification (CDC) was 02-RFEW-2.

Figure 3: Right side view of the Taurus.

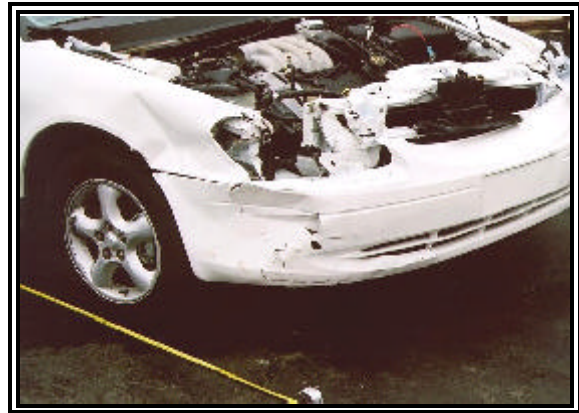
Figure 4: Close-up view of the right front damage.

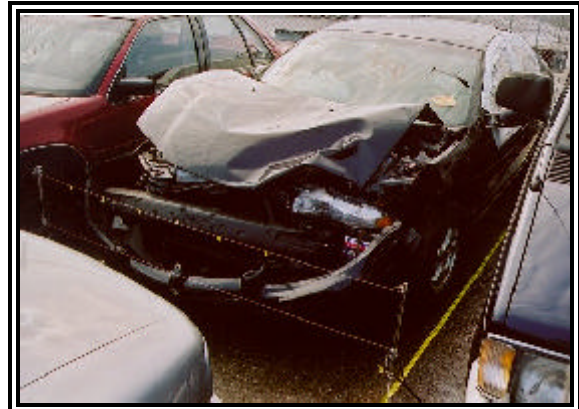
Figure 5 is a front view of the Stratus. The direct contact damage to the front of the Dodge measured 49.0 cm (19.3 in) in width. The direct damage began 24.9 cm (9.8 in) left of center and extended to the left front bumper corner. The combined direct and induced damage extended across the vehicle's entire 147 cm (58 in) frontal end width. The crush profile measured along the bumper reinforcement bar was as follows: C1=35.9 cm (14.1 in), C2=29.2 cm (11.5 in), C3=24.1 cm (9.5 in), C4=19.9 cm (7.9 in), C5=14.0 cm (5.5 in), C6=9.3 cm (3.7 in). The hood buckled rearward and contacted the windshield, fracturing the left lower aspect of the laminate. There was no measurable change in the wheelbase dimensions. The total delta V calculated by the WINSMASH model calculated a damage based delta V of 33.5 km/h (20.8 mph). The Collision Deformation Classification was 11-FLEW-2.

Figure 5: Frontal view of the Dodge.

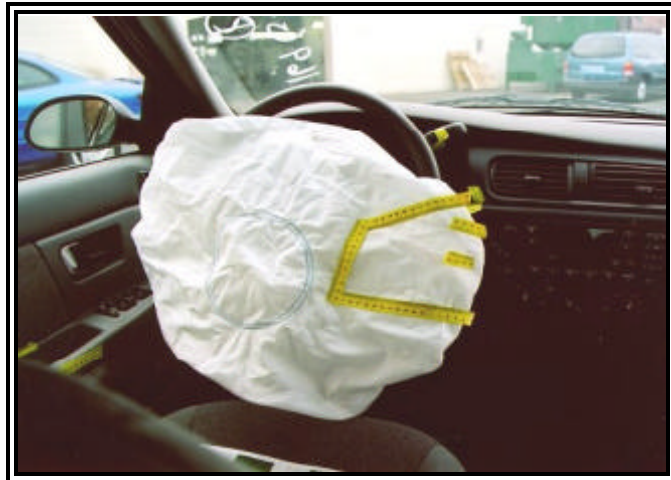
The driver air bag module was designed in the typical manner in the center of the steering wheel. The driver air bag (**Figure 6**) had deployed from the H-configuration module cover flaps. The cover flaps opened along the designated tear seams. The height of the upper and lower flaps measured 6.4 cm (2.5 in) and 4.6 cm (1.8 in), respectively. The width of the flaps measured 17.2 cm (6.8 in). There was no contact evidence on the cover flaps. The deployed driver air bag measured 53 cm (21 in) in diameter. It was tethered by four straps sewn to the face of the bag. The bag was vented by two 2.9 cm (1.1 in) ports located in the 10/2 o'clock position on the back side of the bag. A beige make-up transfer was identified on the face of the bag in the 2 o'clock sector. The transfer covered an area that measured approximately 10.2 cm x 8.9 cm (4.0 in x 3.5). Two faint red lipstick marks were located within the transfer, near the perimeter of the bag. The lipstick transfers measured 2.0 cm (0.8 in) in length. The following nomenclature identified the air bag:

Figure 6: View of the driver air bag.

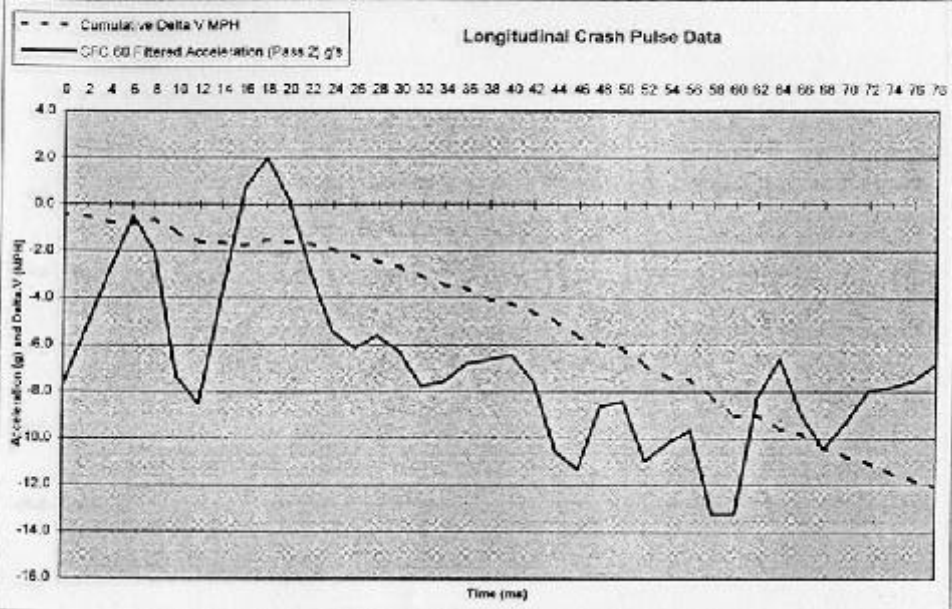
Longitudinal Cumulative Delta-V

Time (ms)	0	10	20	30	40	50	60	70	78
Delta-V (MPH)	-0.4	-1.2	-1.6	-2.7	-4.2	-6.1	-8.0	-10.8	-12.1

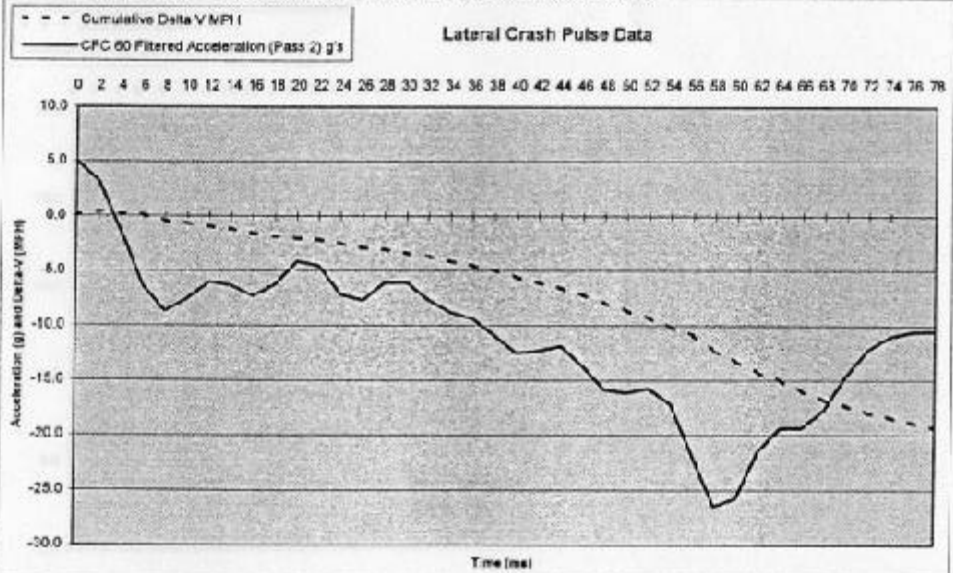
Lateral Cumulative Delta-V

Time (ms)	0	10	20	30	40	50	60	70	78
Delta-V (MPH)	0.2	-0.7	-2.0	-3.4	-5.6	-8.7	-13.3	-17.5	-19.3
