**VERIDIAN ON-SITE ALLEGED INADVERTENT AIR BAG  
DEPLOYMENT INVESTIGATION**

**VERIDIAN CASE NO. CA00-057**

**VEHICLE - 2001 FORD FOCUS LX**

**CRASH DATE - OCTOBER, 2000**

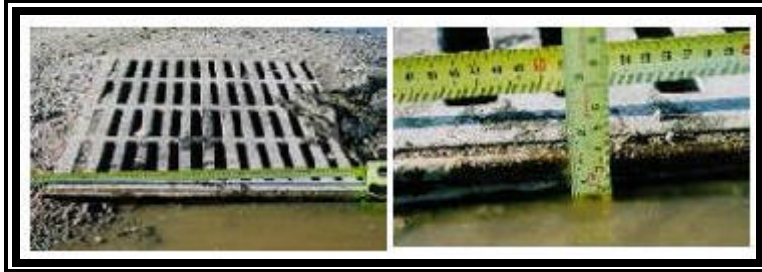
As the Ford straddled the sewer grate, the front undercarriage impacted the sewer grate (**Figure 2**) resulting in minor damage to the vehicle. The undercarriage impact produced a longitudinal pulse to the vehicle that deployed the frontal air bag system. This impact was classified as out-of-scope for the WinSMASH reconstruction program. Although the vehicle's electronic data recorder could not (*by design*) record a total Delta-V for this event, the algorithm "wake-up" was 5 milliseconds prior to deployment with a 24.5G spike (*see Figures 14 & 15*). This translated to a 2.4 km/h (1.5 mph) velocity change during only 5 milliseconds up to the time of deployment. The vehicle was driven to rest approximately 5.2 meters (17.1 feet) east of the point of impact facing east (**Figures 3 & 4**).

**Figure 2. North view of struck sewer grate and associated height measurement.**

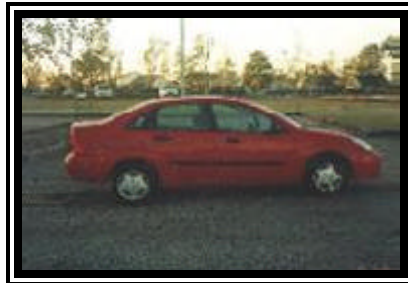
**Figure 3. North view of vehicle final rest position.**

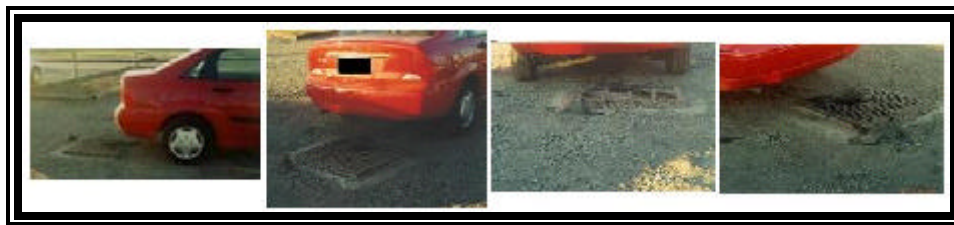
**Figure 4. Multiple views of vehicle final rest position east of struck sewer grate.**

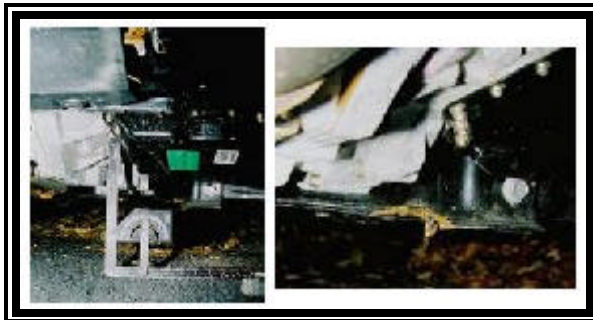
The 2001 Ford Focus LX sustained minor undercarriage damage as a result of the impact with the sewer grate. The direct contact damage was centered along the catalytic converter and extended 44.4 cm (17.5 in) laterally outward to the (front) lower suspension pivot supports (**Figures 6 & 7**). No contact damage was identified to the front air dam. Although the event could be considered a *low frontal* impact with a principal direction of force within the horizontal plane, this impact resulted in snagging of undercarriage components which tends to produce significant vertical as well as longitudinal components of force. Therefore, a Collision Deformation Classification (CDC) of 00-UFDW-1 was assigned to the Ford. The vehicle's ground clearance measured 15.2 cm (6.0 in) at the catalytic converter, 12.1 cm (4.8 in) at the leading edge of the exhaust pipe and 11.4 cm (4.5 in) at the pivot supports. Reduction in the right side wheelbase measured 2.0 cm (0.8 in).

**Figure 6. Contact damage to the left front lower suspension pivot support.**

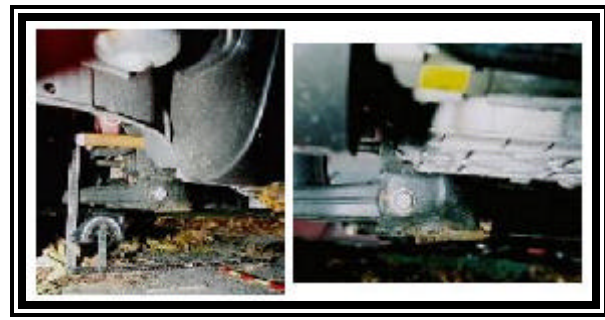
**Figure 7. Contact damage to the right front lower suspension pivot support.**

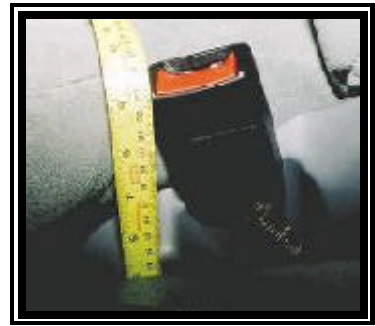
**Figure 8. Pretensioner deployment in the front right restraint buckle.**

The 26 year old male front right passenger of the 2001 Ford Focus LX was restrained by the available 3-point manual lap and shoulder belt system, seated in an upright posture with the seat track adjusted to the mid-to-rear position. Restraint usage was confirmed by the deployment of the buckle pretensioner.

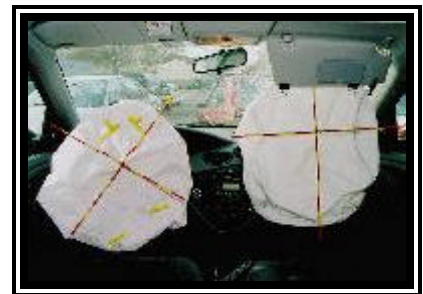
The 2001 Ford Focus LX was equipped with redesigned frontal air bags for the driver and front right passenger positions. The air bags had deployed as a result of the impact with the sewer grate (**Figure 9**). The driver air bag was housed in the center of the steering wheel with a horizontally oriented flap tear seam (H-configuration). No contact evidence was identified on the exterior surface of the module cover flaps. The flaps were trapezoidal in shape as the upper flap measured 17.7 cm (7.0 in) in width along the flap tear seam, 11.4 cm (4.5 in) in width along the upper portion and 5.3 cm (2.1 in) in height. The lower flap measured 17.7 cm (7.0 in) in width along the flap tear seam, 6.3 cm (2.5 in) in width along the lower portion and 7.6 cm (3.0 in) in height. The diameter of the driver air bag measured 59.4 cm (23.4 in) in its deflated state (**Figure 10**). Makeup transfers were documented to the upper left and lower right quadrants of the air bag face. The bag was vented by perforations in the rear (upper) centered portion of the air bag membrane (**Figure 11**) which consisted of two rows of semi-circular ports which (grouped) measured 14.0 cm (5.5 in) in width and 3.7 cm (1.5 in) in height. No conventional internal tether straps were present. Rearward air bag excursion measured 51.0 cm (20.1 in) from the center of the steering wheel hub.

**Figure 9. 2001 Ford Focus deployed redesigned frontal air bags.**

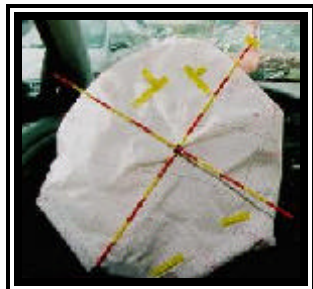
**Figure 10. 2001 Ford Focus deployed redesigned driver air bag.**

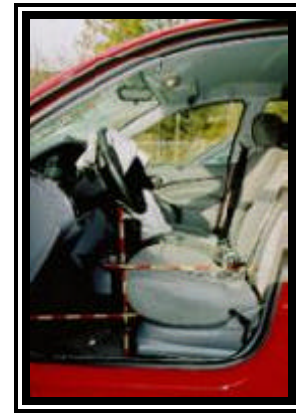
posture with the seat track adjusted to the mid-to-forward position (**Figure 13**). She stated her hands were placed at the 8 o'clock and 4 o'clock positions on the steering wheel rim. The driver further stated she was wearing the 3-point manual lap and shoulder belt system, however, there was no loading evidence to support belt use in this low Delta-V crash.

**Figure 13. Interior view of the driver space.**
