**VERIDIAN ON-SITE ADVANCED OCCUPANT PROTECTION
SYSTEMS INVESTIGATION
VERIDIAN CASE NO. CA00-059
VEHICLE: 2000 FORD TAURUS
LOCATION: VIRGINIA
CRASH DATE: NOVEMBER 2000**

1. <i>Report No.</i> CA00-059	2. <i>Government Accession No.</i>	3. <i>Recipient's Catalog No.</i>	
4. <i>Title and Subtitle</i> Veridian On-Site Advanced Occupant Protection Systems Investigation Vehicle: 2000 Ford Taurus Location: Virginia		5. <i>Report Date:</i> June, 2001

14. <i>Sponsoring Agency Code</i>	
15. <i>Supplementary Notes</i> On-site investigation of a 2000 Ford Taurus crash that resulted in deployment of the frontal Advance Occupant Protection System (AOPS).

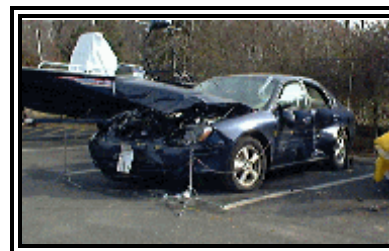
Figure 1. Front and side damage to the 2000 Ford Taurus.

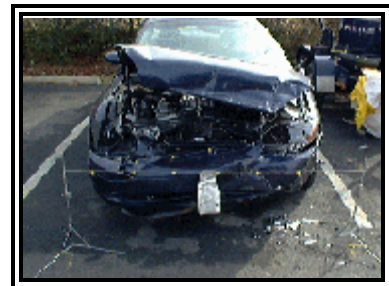
Primary - The full frontal area of the Taurus impacted the right front side area of the Tracer in an L-configuration impact sequence. As a result, the Taurus sustained moderate frontal damage (**Figure 4**) with a maximum crush value of 31.1 cm (12.25") located on the bumper beam 11.4 cm (4.5") left of the vehicle's centerline. The direct contact damage began at the front left corner of the bumper fascia and extended 130.2 cm (51.25") to the right. The impact displaced the bumper fascia and fractured the styrofoam filler panel, therefore the fascia was lowered and a crush profile was documented at the level of the bumper beam. The crush profile was documented along the profile of the bumper beam with a "Field L" damage length of 127.3 cm (50.1"). The following crush values are residual values with deductions made for free-space (contour, fascia, and filler panel): C1 = 12.1 cm (4.75"), C2 = 24.4 cm (9.6"), C3 = 30.7" cm (12.1"), C4 = 22.2 cm (8.75"), C5 = 14.6 cm (5.75"), C6 = 8.3 cm (3.25"). **Figure 5** is a profile view of the crush profile.

Figure 4. Frontal damage to the Ford Taurus.

Components damaged by the initial impact included the front bumper system, grille, both headlight and turn signal assemblies, hood, both front fenders, upper radiator support panel, air conditioning condenser, and the radiator.

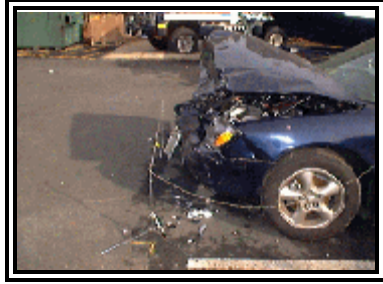
Figure 5. Profile view documenting the extent of frontal crush.

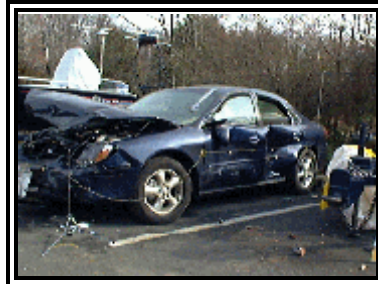
Figure 6. Left side sideslap damage.

Secondary - The Taurus was involved in a secondary sideslap impact sequence with the Tracer as both vehicles were deflected in opposite directions by the initial impact. The lateral 9 o'clock impact resulted in moderate damage to the left side doors of the Taurus (**Figure 6**). The direct contact damage began 52.1 cm (20.5") rearward of the left front axle position and extended 127 cm (50") to the rear, terminating 74.9 cm (29.5") forward of the left rear axle. The combined induced and direct contact damage began at the same start point and extended 211.8 cm (83.4") rearward, ending 16.2 cm (6.4") forward of the rear axle position. A crush profile was documented at the level of the rub strip and was as follows: C1 = 0 cm , C2 = 5.7 cm (2.25"), C3 = 8.3 cm (3.25"), C4 = 6.4 cm (2.5"), C5 = 3.5 cm (1.4"), C6 = 0 cm. Damaged components included both left doors, the leading edge of the left rear quarter panel, and the left rear door glazing.

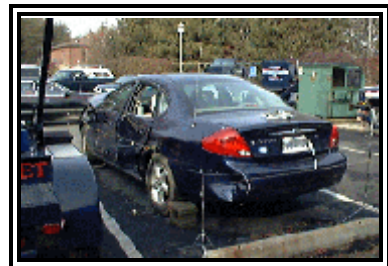
The Taurus was involved in a third impact sequence with a stopped 1999 Hyundai Elantra. The post-crash clockwise rotation of the Taurus resulted in the left rear corner area of the bumper fascia impacting the front left corner area of the Hyundai. The Taurus' direct contact damage began 61.2 cm (24.1") left of center and extended 9.9 cm (3.9") to the corner. The damage resulted in a large dent to the bumper fascia(**Figure 7**) with no residual crush to underlying structural components.

Figure 7. Left rear bumper fascia impact damage.

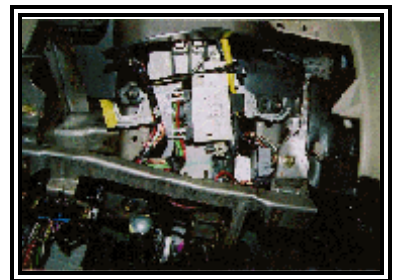
The driver loaded the manual belt system, however, there was no damage or loading evidence associated with his loading force. He braced against the steering wheel rim with both hands at driver estimated positions of 3 and 9 o'clock. The combination of his bracing action and the subsequent loading of the steering wheel rim by the unrestrained front right passenger resulted in deflection of the wheel hub and 2.5 cm (1.0") of left shear capsule separation and the fracture of the right shear bracket (**Figure 8**). The driver also braced with his right foot against the brake pedal as he braked with full force in an attempt to avoid the crash. His braking and loading force as he responded to the frontal impact force resulted in deflection of the adjustable brake pedal to the right.

Figure 8. Shear bracket separation.

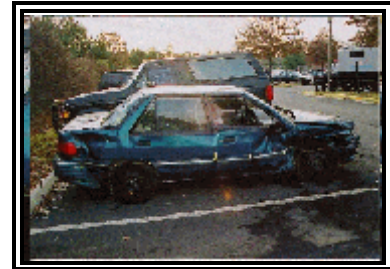
Primary - The right front side area (**Figure 9**) of the Tracer was impacted by the Ford Taurus resulting in a 02 o'clock impact force. The direct damage began at the front right bumper corner and extended 172.7 cm (68.0") rearward, terminating at a point on the right front door that was 141.6 cm (55.75") forward of the right rear axle position. Maximum lateral crush was 30.7 cm (12.1") located on the right front fender, 17.8 cm (7.0") forward of the right A-pillar. The combined induced and direct contact damage began at the right B-pillar and extended 215.9 cm (85.0") forward to the right front bumper corner. The crush profile was documented at the level of the rub strip and was as follows: C1 = 0 cm, C2 = 1 cm (0.4"), C3 = 15.9 cm (6.25"), C4 = 23.2 cm (9.2"), C5 = 25.7 cm (10.1"), C6 = 30.5 cm (12.0").

Figure 9. Front and rear impact damage to the right side of the Tracer.

Secondary - The secondary sideslap impact with the Ford Taurus resulted in moderate damage to the right rear side area (**Figure 9**) of the Tracer. Maximum crush was 15.2 cm (6.0") located at C2, 54.6 cm (21.5") rearward of the right rear axle. The direct contact damage began 32.3 cm (12.75") forward of the right rear axle and extended 125.7 cm (49.5") to the right rear bumper corner. The combined induced and direct contact damage began 99.7 cm (39.25") forward of the referenced axle and extended 193.0 cm (76.0") to the bumper corner. The crush profile was documented at the level of the rub strip and was as follows: C1 = 14.0 cm (5.5"), C2 = 15.2 cm (6.0"), C3 = 3.0 cm (1.2"), C4 = 0.5 cm (0.2"), C5 = 0 cm [-2.8 cm (-1.1")], C6 = 0 cm. The sideslap damaged the right corner of the rear bumper, the right quarter panel, and the right rear door.

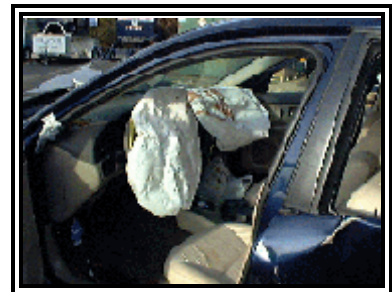
The 2000 Ford Taurus was equipped with an AOPS that consisted of frontal air bags with dual stage inflators for the driver and right passenger positions, a driver's seat positioning sensor, front seat belt buckle pre-tensioners, and an event data recorder (EDR). The AOPS was controlled by a Restraints Control Module (RCM) that monitored crash severity, belt usage, and the driver's seat position. Based on the severity of the crash and usage of the manual belt systems, the RCM could deploy the frontal air bags at various thresholds. The RCM had the capability to record crash data. This data was downloaded during the on-site investigation and forwarded to Ford for interpretation. The frontal air bags deployed and the driver's pre-tensioner fired as a result of the frontal impact sequence with the right front side of the Mercury Tracer (**Figure 10**).

Figure 10. Overall view of the deployed frontal air bags in the Ford Taurus.

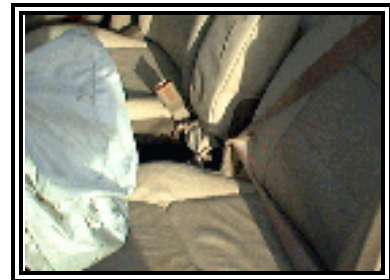
The driver was restrained by the manual belt system, therefore the pre-tensioner was armed and fired during the crash (**Figure 11**). The post-crash length of the barrel was 67.3 mm (2.625"). This equated to a piston travel distance of 42.7 mm (1.68"). The driver's pre-tensioner was identified by the bar coded label number F2B914701261527.

Figure 11. Buckle pre-tensioners.

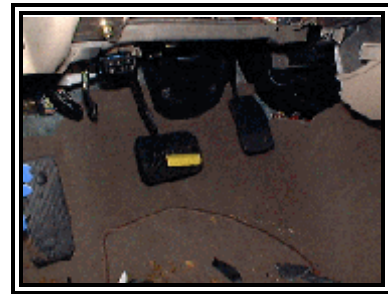
The driver's braking and subsequent loading force against the adjustable brake pedal deflected the right side of the pedal pad forward (**Figure 12**). Due to his rear and reclined seated position, the driver probably minimally loaded the deployed redesigned driver air bag. The combination of manual and automatic restraint systems provided the driver with maximum crash protection and prevented him from contact with interior components. It should be noted that there was no loading evidence on the knee bolster.

Figure 12. Deflection of the adjustable brake pedal.

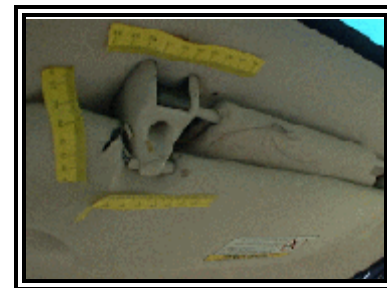
As the Taurus was deflected in a clockwise direction, the passenger continued to her left. This trajectory was accelerated by the subsequent left side sideslap impact sequence. The right shoulder of the passenger probably contacted the rear view mirror, displacing the mirror downward from its adjusted position. Her left chest area impacted the right edge of the steering wheel rim, displacing the wheel to the left. She sustained a left rib contusion as a result of the contact sequence. Her left temporal scalp contacted the inboard hinge point of the driver's sun visor which produced a 10 cm (4") laceration of the scalp. Hair and tissue evidenced the contact point (**Figure 14**).

Figure 14. Passenger's head impact to the sun visor bracket.

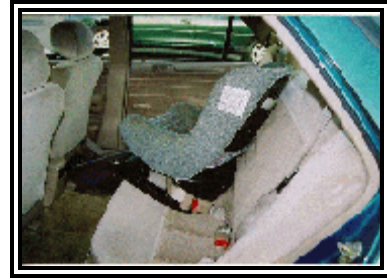
BTPDSE.90.144. This CSS was recalled for multiple issues and was removed from the market. The CSS was equipped with an integral 5-point harness and a swivel base. The base provided lateral positioning of the CSS. The safety seat was secured to the vehicle the center rear lap belt, however, the belt was loosely applied through the belt path (**Figure 15**). This allowed for approximately 30 degrees of lateral rotation in both directions. The child was reportedly secured in the safety seat by the integral 5-point harness system. The child sustained police reported minor injuries.

Figure 15. Improperly installed child safety seat.
