**REMOTE ADVANCED OCCUPANT PROTECTION SYSTEMS INVESTIGATION
SCI TECHNICAL SUMMARY REPORT**

NASS/SCI COMBO CASE NO. 01-43-019E

VEHICLE - 2000 BMW 328Ci

CRASH DATE - FEBRUARY 2001

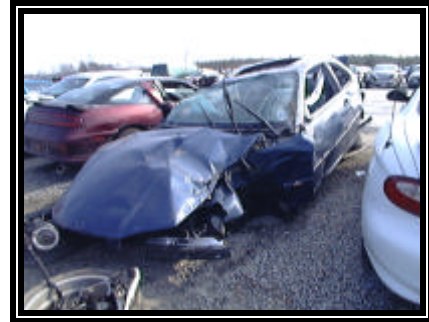
Figure 1. Damage to the 2000 BMW 328Ci

The occupants of the BMW loaded the manual restraints, and since they were properly restrained, they remained in position during the rollover and subsequent impacts. The driver sustained a cervical spine strain from head motion and abrasions to the left shoulder from loading the shoulder belt. Contact with the driver's redesigned frontal air bag resulted in facial abrasions. The front right passenger sustained a right acromioclavicular joint dislocation from loading the shoulder belt webbing. He sustained multiple minor abrasions, lacerations and contusions of the upper and lower extremities from interior contacts and flying glass during the rollover. He also had complaints of a chest contusion from loading the manual restraint, a facial contusion, and a scalp laceration from interior contacts. The rear left occupant sustained seat belt related contusions, minor facial lacerations, and minor left arm abrasions and lacerations from interior contacts. The rear right occupant sustained minor facial lacerations, minor scalp contusions, abrasions, and lacerations, and a right arm abrasion and laceration from contact with the right C-pillar, interior surfaces, and flying glass. He also sustained a facial contusion from probable contact with the front right seat back. The occupants were transported by private vehicle to a local hospital and treated and released.

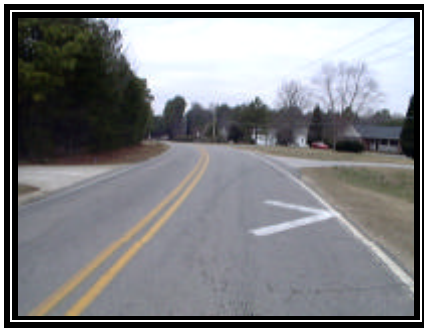
The 15-year-old licensed male driver was operating the BMW northbound on a two-lane state roadway during daylight hours. The driver was reportedly operating the vehicle northbound at a high rate of speed on approach to a left curve (**Figure 2**). The estimated travel speed was police-reported at 137 km/h (85 mph). The driver failed to negotiate the curve and lost control of the vehicle. The BMW traveled onto the dirt shoulder and into the grassy drainage ditch (**Figure 3**). The BMW was equipped with anti-lock brakes (ABS) and the driver attempted to regain control by braking (without lockup) and steering left, which caused the BMW to initiate a counterclockwise (CCW) yaw in the drainage ditch. Tire marks in the ditch were documented by the NASS researcher from the right front and right rear tires of the BMW. The right front tire mark measured 10.6 m (34.8') and the right rear tire mark measured 6.4 m (21.0').

Figure 2. Pre-crash trajectory of the BMW

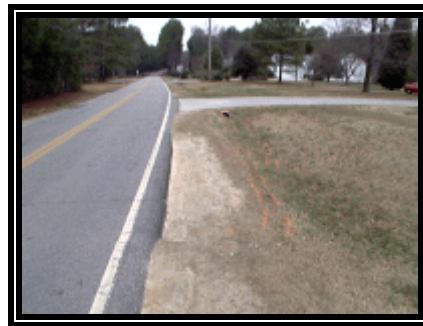
Figure 3. Point of roadway departure

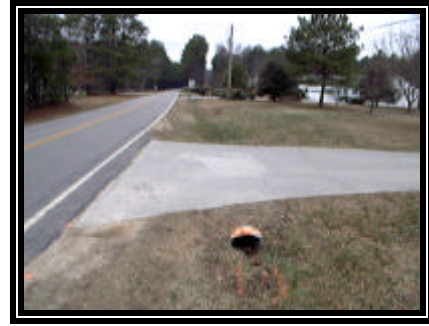
The 2000 BMW 328Ci impacted a driveway culvert with the front right undercarriage area (**Figure 4**). The direction of force could not be determined due to overlapping damage. However, the frontal impact to the undercarriage area was sufficient to fire the frontal seat belt buckle pretensioners and deploy the redesigned frontal air bag system in the BMW. The forward momentum of the BMW combined with the undercarriage impact caused the BMW to vault over a private driveway and initiate a rollover. The exact rollover sequence was not confirmed due to the nature of the crash and overlapping damage. However, based on the scene evidence and vehicle damage it appears that the BMW rolled laterally a total of ten quarter turns with the right side leading. The approximate total distance traveled during the rollover was of 65 m (215') along the roadside. The right front passenger's side air bag and right side HPS probably deployed as the right plane of the BMW struck the ground on the first quarter turn. A large gouge mark was present in the vehicle's trajectory as a result of ground contact with the roof and left side plane as it rolled (**Figure 5**). As the BMW entered the fifth quarter-turn, the rear aspect of the car was vaulted upward as the right front corner gouged the roadside surface. The BMW impacted a wood fence with the right rear area during this portion of the rollover. While the vehicle was upside down in the sixth quarter turn, it impacted a utility pole with the left front area (**Figure 6**). This impact with the pole probably deployed the driver's side air bag and left side HPS. The BMW rotated counterclockwise (CCW) through the pole, across a private driveway and impacted the ground, evidenced by a gouge. It rolled an additional four quarter-turns and impacted a second wood fence. The fence was fractured and collapsed from sustained contact as the vehicle rolled on top of it. The BMW came to rest on its roof against the fence facing southwest (**Figure 7**).

Figure 4. Point of impact with the culvert

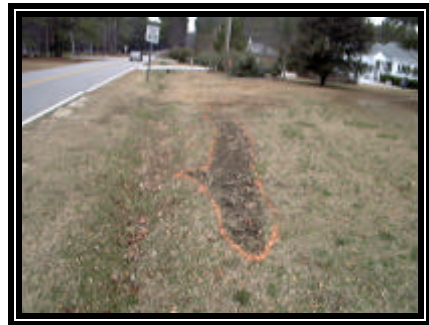
Figure 5. Gouge mark

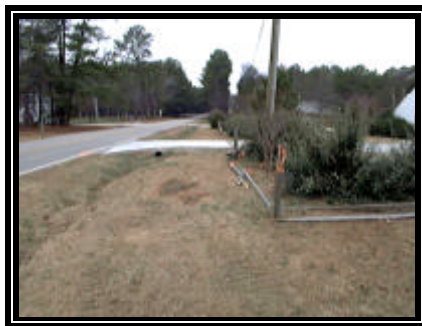
Figure 6. Wood fence impact and utility pole (replaced)

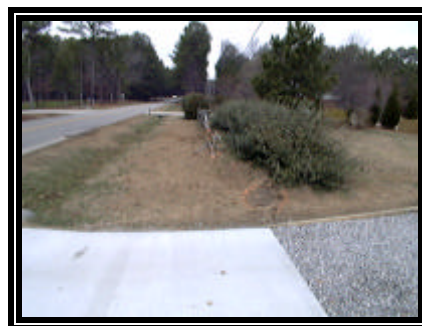
Figure 7. View showing gouge, second wood fence impact, and final rest position

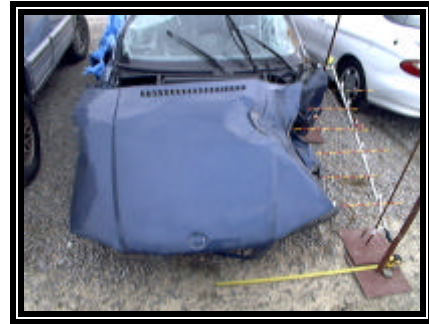
The 2000 BMW 328Ci sustained moderate damage as a result of the multiple-event crash. Due to the overlapping nature of the damage from the multiple events, damage measurements were not recorded by the NASS researcher. The bumper fascia was separated from the vehicle, and deformation was noted on the frontal plane below the hood. The hood was buckled rearward slightly and displaced laterally to the right. The hood sustained direct contact damage on the left side from the utility pole impact, and the left front fender sustained lateral and rearward crush (**Figure 8**). The maximum lateral crush to the left front fender was approximately 40 cm (16"). The right edge of the hood was also deformed and abraded. Both front wheels were separated from the vehicle. Direct contact damage was noted on the entire left side of the BMW from the rollover. The left side mirror was separated from the vehicle. The roof side rail was laterally abraded, the left rear quarter panel was deformed and abraded, and the left rear wheel was partially separated from the vehicle. The trunk lid was open and deformed. Vertical abrasions and dirt patterns were identified on both rear bumper fascia corners. Both rear brake lights were fractured and displaced. The right fender, right door, and right rear quarter panel sustained direct contact damage (**Figure 9**). The right rear quarter panel was crushed laterally and sustained

Figure 8. Damage from utility pole impact

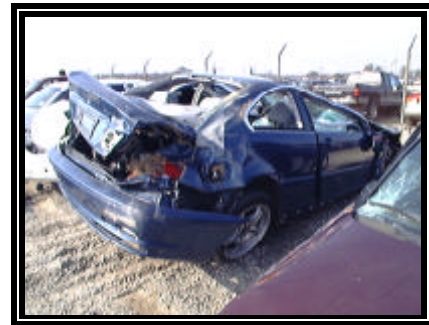
Figure 9. Right side damage

longitudinal abrasions across the area of the fuel filler cap. The fuel filler door was separated from the vehicle, and fragments of grass and dirt were embedded into the filler cap and the deformed edges of the quarter panel. Grass and dirt were also deposited along the rear edge of the right C-pillar window trim and right edge of the backlight frame. The right A-pillar was crushed vertically and the front right aspect of the roof and right aspect of the windshield header were also crushed. The right side mirror was partially separated from the vehicle and lateral abrasions were noted on the right roof side rail and right roof area. Collision Deformation Classifications (CDC's) were coded for the rollover event and the impact with the utility pole. The CDC for the rollover was 00-TDDO-9 and the CDC for the utility pole impact was 09-LYEW-9. The remaining impacts were not assigned CDC's due to overlapping damage.

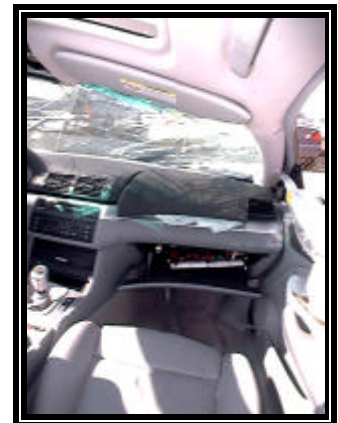
Interior damage to the 2000 BMW 328Ci was moderate and was attributed to passenger compartment intrusion and occupant contact. The NASS researcher documented integrity loss in the side window and backlight. The windshield laminate was in place and cracked from impact forces, and the tempered glazing in the side door windows, side windows, and backlight was disintegrated from impact forces. According to the left-rear occupant, his left arm was partially ejected out of the left rear side glass opening after the glazing had disintegrated. The power sun/moon roof was fully retracted prior to the crash and was not damaged. Multiple intrusions were identified in the BMW. The location of the most severe intrusion was the front right position, where intrusions of the right A-pillar, right toe pan, and windshield were identified (**Figure 10**). Occupant contact evidence was noted on both frontal redesigned air bag membranes. Occupant contact evidence was also noted on the front left and rear right manual 3-point lap and shoulder belts, evidenced by scuff marks. The bottom rear aspect of the front right seat back was also scuffed from occupant contact. The glove box door opened as a result of the crash.

Figure 10. Multiple passenger compartment intrusions

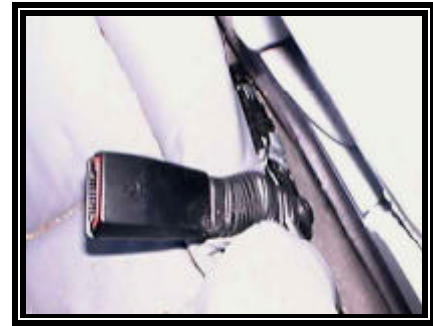
The front seat manual restraints were equipped with buckle pretensioners that were located longitudinally along the inboard aspects of the front seat tracks (**Figure 11**). Both front seated occupants were restrained by the manual 3-point lap and shoulder belt system, therefore the pretensioners were armed at the time of the crash. Both pretensioners fired as a result of the frontal impact with the culvert.

Figure 11. Driver's buckle pretensioner

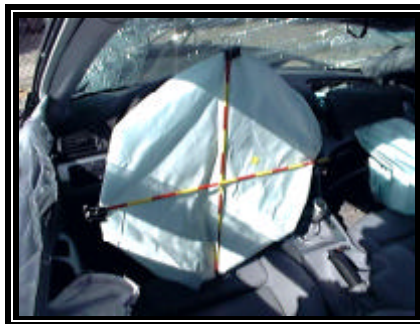
The 2000 BMW 328Ci was equipped with redesigned frontal air bags for the driver and front right positions that deployed as a result of the impact with the culvert (**Figures 12 and 14**). The delta-V probably exceeded 24 - 26 km/h (15 - 16 mph), which is an approximate threshold for air bag deployment with restrained occupants. The driver's redesigned air bag was housed in the center of the steering wheel with a single cover flap design hinged at the top aspect. The cover flap measured 15 cm (6") in width and 12 cm (5") in height. The redesigned air bag measured 57 cm (22") in diameter in its deflated state. It was vented by a single port located at 12 o'clock on the rear aspect of the air bag (**Figure 13**). The driver's air bag was not tethered. A blood smear was noted on the upper right quadrant on the face of the air bag.

Figure 12. Driver's redesigned air bag

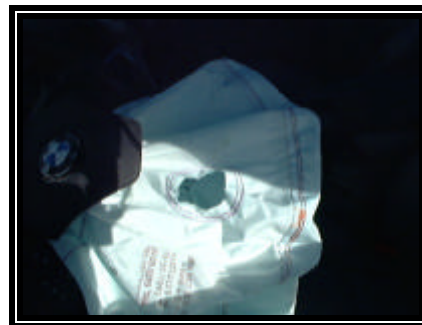
Figure 13. Single vent port on driver's redesigned air bag

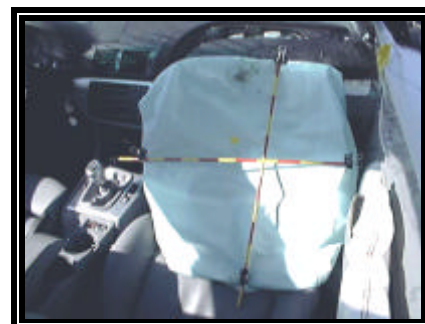
The front right passenger's air bag deployed from a mid-mount module with a single tethered cover flap design. The cover flap measured 60 cm (24") in width and 20 cm (8") in height. The redesigned front right passenger's air bag was rectangular in shape and measured 54 cm (21") in width and 60 cm (24") in height. A blood smear was noted on the upper left quadrant on the face of the air bag. The air bag was vented by two ports located on the side aspects at the 9 and 3 o'clock positions. The

Figure 14. Front right passenger's redesigned air bag

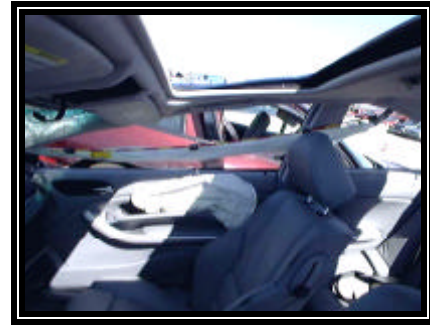
The 2000 BMW 328Ci was equipped with door-mounted side air bags and HPS for both front seated positions (**Figure 15**). The sensors for the HPS system and side air bag system were located on the lower aspect of the B-pillars. The door mounted side air bags deployed as a result of the rollover event. Both side air bags deployed in a lateral direction from the interior door panels above the arm rests. The cover flaps were in the shape of parallelograms and were hinged at the bottom aspects. The cover flaps measured 40 cm (16") in width and 12 cm (5") in height. The side air bags offered thorax protection and measured 47 cm (19") in width and 26 cm (10") in height. Each side air bag was tethered by one internal strap.

Figure 15. Deployed right front side air bag and right HPS
