**VERIDIAN REMOTE SIDE IMPACT OCCUPANT PROTECTION INVESTIGATION  
SCI TECHNICAL SUMMARY REPORT**

**NASS/SCI COMBO CASE NO. 01-45-044A**

**VEHICLE - 2000 LINCOLN TOWN CAR**

**CRASH DATE - APRIL 2001**

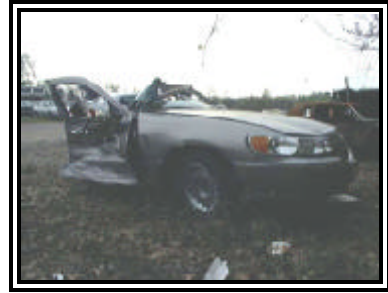
**Figure 1. Damaged 2000 Lincoln Town Car**

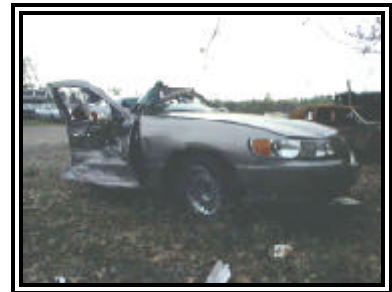
The 2000 Lincoln Town Car sustained severe damage as a result of the right side impact with the Mercury Cougar (**Figure 5**). The vehicle was partially separated in half laterally on the right side as a result of the impact, and according to a witness, the Town Car almost completely severed when the roof was removed. Rescue personnel completely separated the vehicle in half aft of B-pillar areas by cutting through the frame on the left side. Due to the vehicle separation, it was not possible for the NASS researcher to measure an accurate crush profile. The direct damage from the right side impact began 37 cm (15") aft of the right rear axle and extended forward 233 cm (92") along the right side of the Town Car. The combined direct and induced damage could not be determined due to the vehicle separation. The maximum crush was estimated to be 55 cm (22") forward of the right rear axle and measured approximately 55 cm (22"). Abrasions and paint transfers were identified on the right front door, right rear door, and right rear quarter panel from direct contact. The right B-pillar was crushed laterally and rotated slightly clockwise. The displacement of the B-pillar resulted in the failure of the latch/striker on the right front door (**Figure 6**). The right sill was crushed and showed evidence of being torn aft of the right B-pillar. The hinges on the right rear door failed which allowed the right rear door to separate from the B-pillar.

However, the latch/striker remained engaged on the rear aspect of the door, and the right rear door remained attached to the rear portion of the vehicle, while the remaining three side doors remained attached to the front portion. Both A-pillars were cut at the base and at the roof, and the roof was cut away from the top aspects of the B-pillars to allow the roof to remain attached to the rear portion of the Town Car. The right rear area was displaced rearward and upward and the left rear area was displaced downward.

**Figure 5. Right front damage to the Town Car**

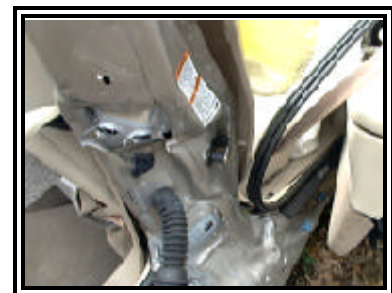
**Figure 6. View of right front door striker and lower B-pillar area**

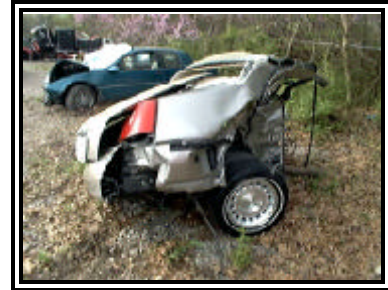
The trunk was displaced upward on the right side. The left rear wheel was rotated in a CW direction and restricted against the left rear quarter panel. The right rear wheel was restricted from rearward and lateral displacement (**Figure 7**). The CDC for the right side impact to the Town Car was 02-RZAW-4.

**Figure 7. Rear portion of the 2000 Lincoln Town Car**

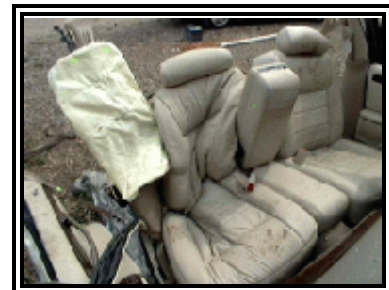
The interior damage to the Lincoln Town car was a result of compartment intrusion and occupant contact. Passenger compartment integrity was lost through the right front door as a result of the latch/striker failure. Integrity was also lost through the right rear door due to the hinge failure, the backlight, and the side windows. All of the tempered glazing disintegrated as a result of impact forces. The laminated windshield was in place and cracked from impact forces, and removed by rescue personnel. The NASS researcher documented multiple intrusions, the most severe being the lateral intrusion of the right rear door that measured 62 cm (24"). The bottom half of the steering wheel rim was displaced forward 4 cm (2") and the rigid plastic knee bolster was displaced from driver loading. The driver's sun visor exhibited a blood smear, possibly from contact with the driver's head. Strands of hair were also noted on the center portion of the windshield header that were most likely from the driver. Based on the 188cm (74") height of the driver, he may have been displaced forward enough to contact the visor and windshield header with his head if he was wearing the manual restraint improperly, although the blood smear does not exhibit a trajectory consistent with the impact. It was not known if the vanity mirror on the bottom aspect of the visor was damaged. Neither contact could be confirmed with the available information. Each front seat position was displaced from compartment intrusion (**Figure 8**). The front left seat was leaning toward the left side due to the right side intrusions. The folding center arm rest contacted by both front seat occupants and was displaced due to the front right seat intrusion. The armrest was wedged between the seats in a near vertical orientation. Blue fabric transfers were noted on the lower right aspect from the right front passenger loading. Its pre-crash orientation was probably full-down, but it could not be confirmed. The front right seat was displaced and crushed laterally to the left, and the front right seat back was rotated in a slight CW direction. The interior panel of the right front door was also displaced and intruded laterally 13 cm (5").

**Figure 8. Displaced front seating positions in the 2000 Lincoln Town Car**

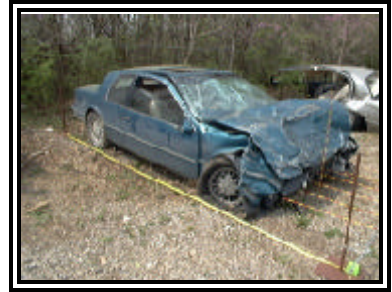
The Mercury Cougar sustained moderate frontal damage (**Figure 9**) as a result of the impact with the Town Car. The direct damage involved the entire frontal plane of the vehicle and measured 136 cm (54"). The

maximum longitudinal crush was located 15 cm (6") to the right of C3 and measured 63 cm (25"). The left front fender was crushed rearward and displaced the leading edge of the left front door. The hood was crushed rearward and buckled at the designated fold points. The right front wheel was restricted from rearward displacement and the left front tire was deflated. The windshield laminate was cracked from impact forces. The CDC for the frontal impact with the Town Car was 11-FDAW-3. Six crush measurements were taken at the bumper level by the NASS researcher and were as follows: C1 = 32 cm (13"), C2 = 39 cm (15"), C3 = 61 cm (24"), C4 = 59 cm (23"), C5 = 50 cm (20"), C6 = 54 cm (21").

**Figure 9. Frontal damage to the 1993 Mercury Cougar**

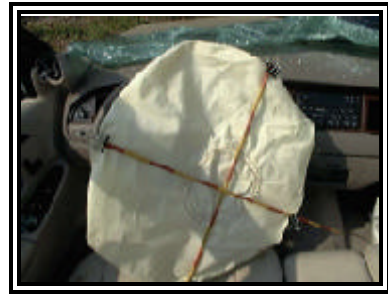
The 2000 Lincoln Town Car was equipped with redesigned frontal air bags for the driver and front right passenger positions that deployed as a result of the right side impact with the Mercury Cougar. The driver's redesigned air bag was housed in the center of the steering wheel with a single cover flap design hinged at the top aspect. The cover flap measured 12 cm (5") in height, 10 cm (4") in width at the top aspect and 14 cm (6") in width at the lower aspect. The driver's redesigned air bag measured 50 cm (20") in diameter (**Figure 10**). A scuff mark was noted on the upper right quadrant of the air bag membrane. The air bag was tethered by 2 internal straps and vented by two ports located at the 11 and 1 o'clock sectors on the rear aspect.

**Figure 10. Deployed redesigned driver's air bag**

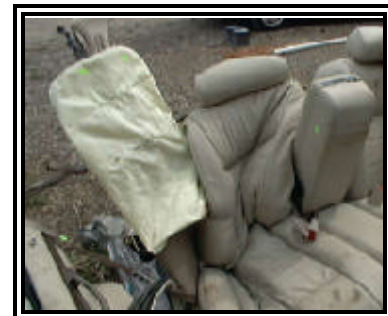
The 2000 Lincoln Town Car was equipped with head/thorax side air bags that were located in the front outboard seat backs. The right front passenger's side air bag deployed as a result of the right side impact with the Mercury Cougar (**Figure 11**). The tear seam for the right side air bag measured 38 cm (15") in height. The tear seam was open 10 cm (4") wide at the top aspect and 5 cm (2") wide at the bottom aspect. The right front passenger's side air bag measured 60 cm (24") in height and 35 cm (14") in width. The air bag was tethered by two internal straps and vented by one port located on the forward center aspect of the outboard aspect of the air bag. Contact evidence on the air bag included a scuff on the rear inboard aspect, blood spattering on the inboard aspect, and small blood spattering on the outboard aspect of the air bag.

**Figure 11. Deployed right front passenger's side air bag**
