On-scene Investigation / Vehicle to Vehicle
Dynamic Science, Inc. / Case Number: DS01001
1995 Plymouth Grand Voyager SE
Idaho
December, 2000

1. Report No. DS01001	2. Government Accession No.	3. Recipient Catalog No.	
4. Title and Subtitle In-Depth Accident Investigation		5. Report Date March 22, 2001

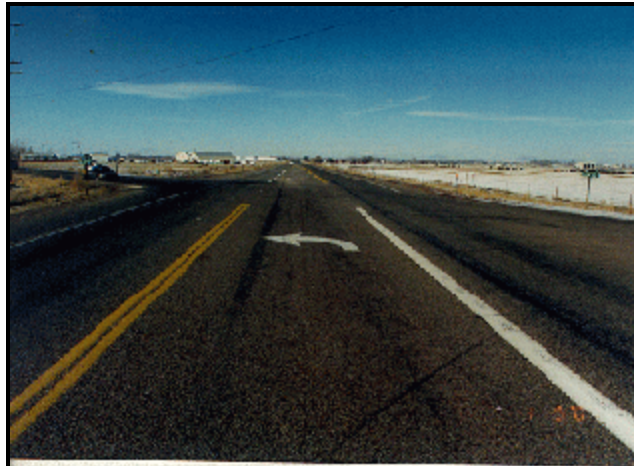
Figure 1. Case vehicle approach to area of impact

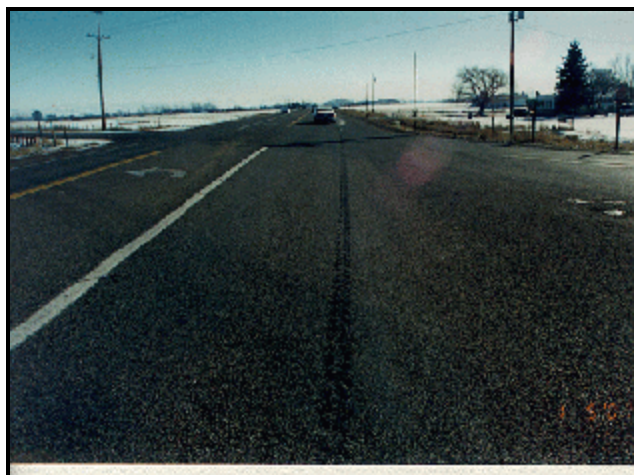
Figure 2. Other vehicle approach to area of impact

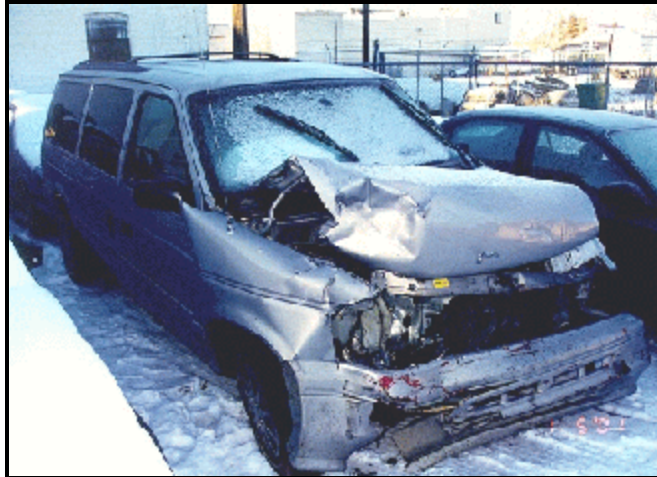
Figure 3. Case vehicle (1995 Plymouth Grand Voyager)

Damage Description: Moderate right to left front damage to front bumper, grille, hood, and right fender. Vehicle towed from the scene due to damage. There was 4 cm (1.6 in.) of intrusion through the right front toe pan. Left front side window disintegrated—possibly by driver’s left hand/arm. Police estimated damage at \$8000.

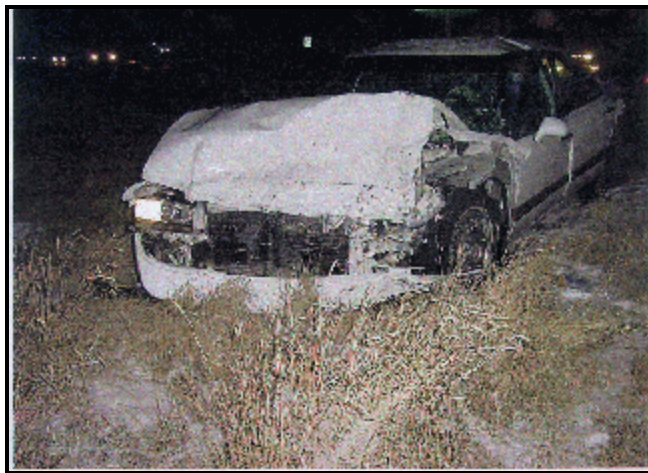
Figure 4. Other vehicle (1993 Buick LeSabre)

Description:	1993 Buick LeSabre 4-door sedan	
VIN:	1G4HP53L8PHxxxxxx	
Odometer:	Unknown	
Engine:	3.8 L V6	
Reported Defects:	None	
Cargo:	Unknown	
Damage Description:	Moderate to major frontal damage to bumper, grille, and hood. Towed from the scene due to damage. Police estimated damage at \$8000.	
CDC:	12FDEW2	
Delta V:	Total	35.9 km/h (22.3 mph)
	Longitudinal	-35.8 km/h (-22.2 mph)
	Latitudinal	3.1 km/h (1.9 mph)
	Energy	154,633 joules (114,120 ft-lbs)

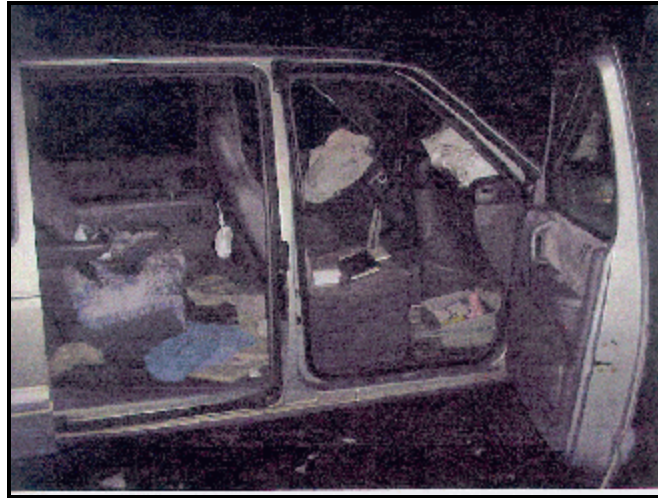
Figure 5. Interior, case vehicle

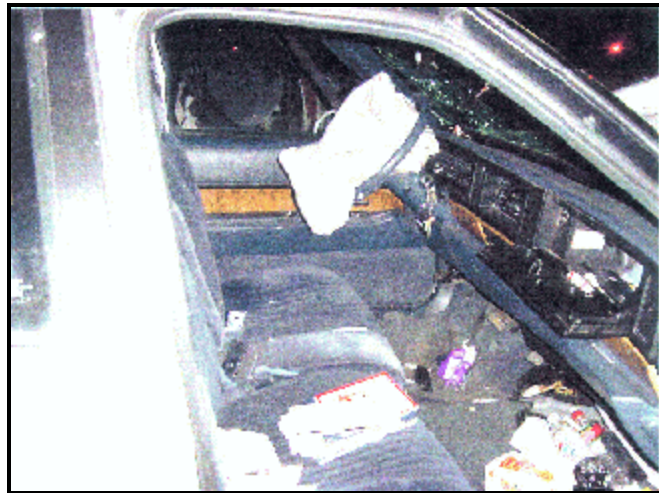
Figure 6. Interior, other vehicle

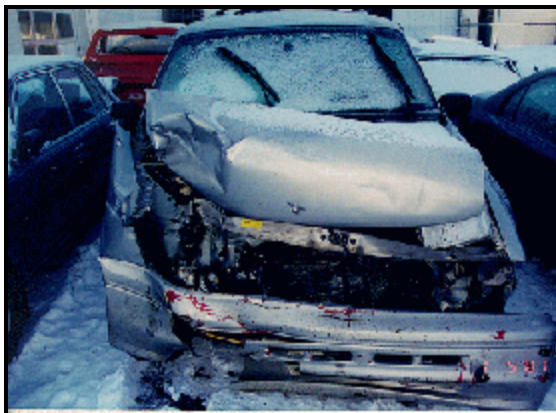
Figure 8. Front view, case vehicle

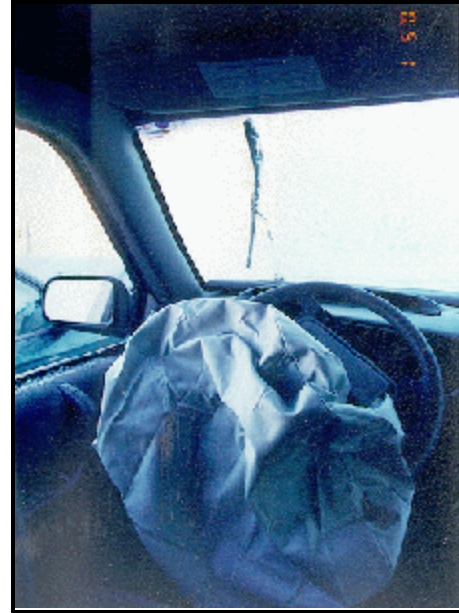
The driver’s air bag module cover had an “H” pattern and opened in the proper fashion along the seams. The driver’s air bag was 60 cm (23.6 in.) in diameter. It had two vent holes and was not tethered. There were 8 vertical folds across the face. There was a skin transfer to the upper left quadrant of the face of the air bag.

Figure 13. Driver's air bag

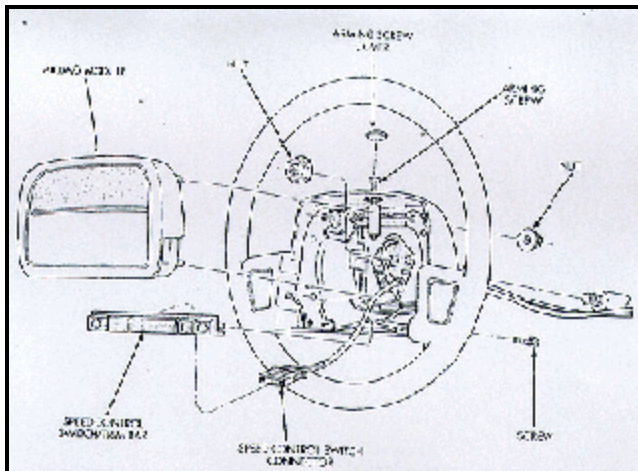
Figure 10. Driver's air bag

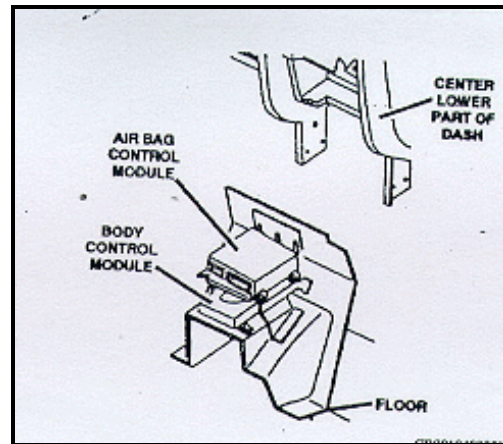
Figure 11. Air bag Control Module location

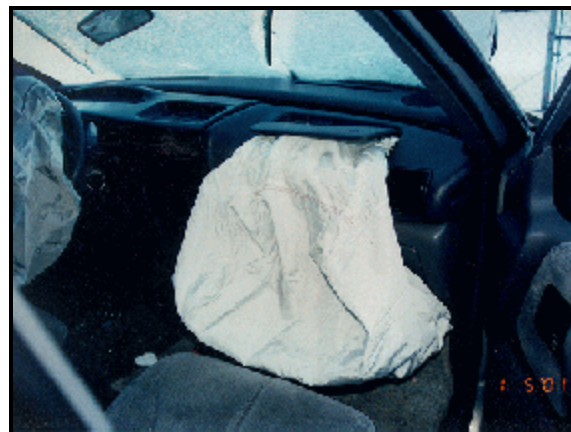
The front right passenger’s air bag had a single top mount module cover that measured 32 x 13 cm (12.5 x 5.2 in.). The air bag itself measured 73 cm (28.7 in.) high by 45 cm (17.7 in.) wide. The air bag was equipped with two tethers and no vent holes.

Figure 12. Front right passenger's air bag

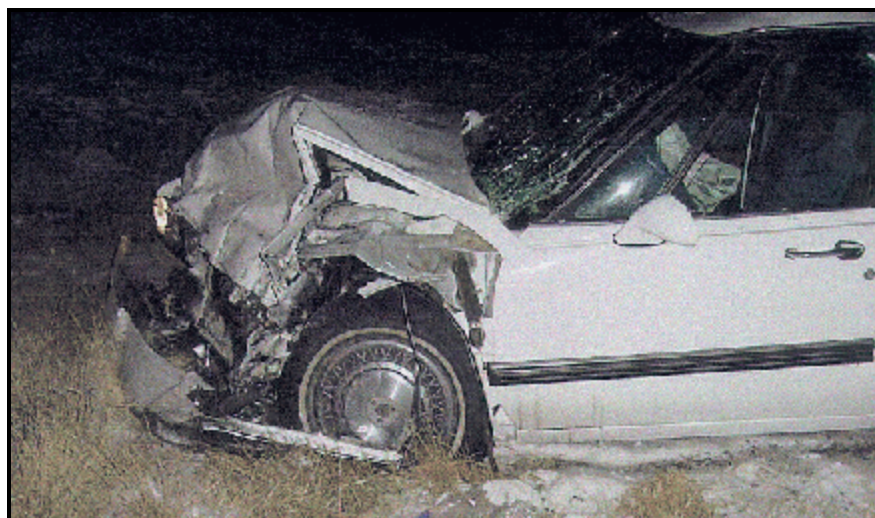
Figure 13. Exterior, other vehicle

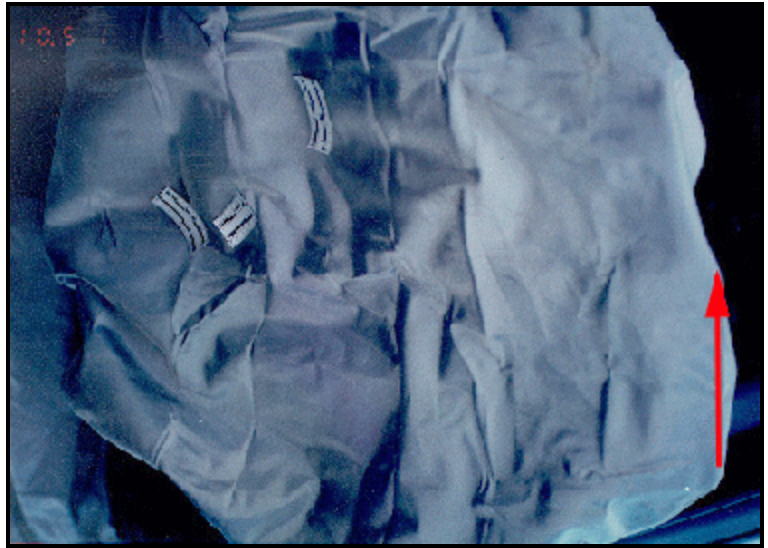
Figure 14. Driver's air bag

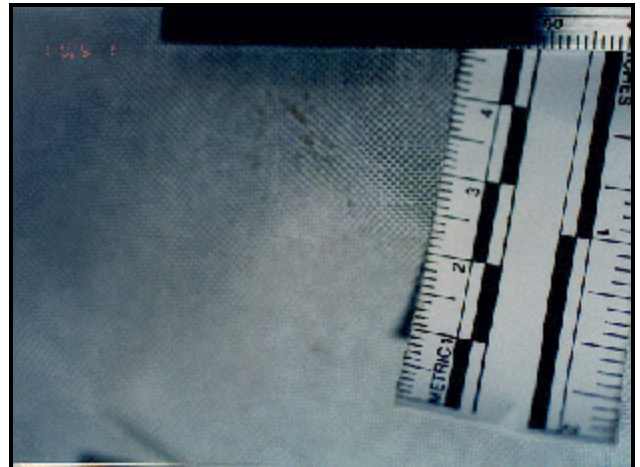
Figure 15. Skin transfer, driver's air bag

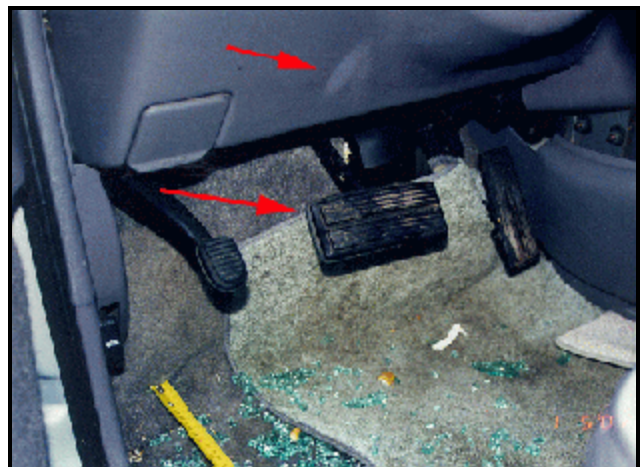
Figure 16. Left knee contact/deformed brake pedal 11

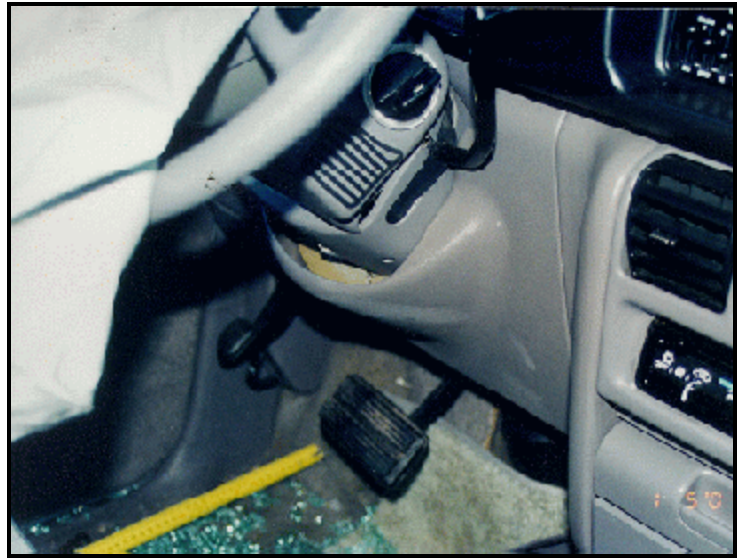
Figure 17. Right knee contact
