**REMOTE AIR BAG RELATED CHILD PASSENGER FATALITY INVESTIGATION  
SCI TECHNICAL SUMMARY REPORT**

**VERIDIAN CASE NO. CA01-003**

**SUBJECT VEHICLE - 1996 NISSAN QUEST**

**CRASH DATE - JANUARY 1998**

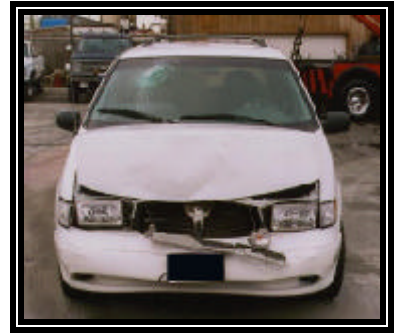
**Figure 1. 1996 Nissan Quest**

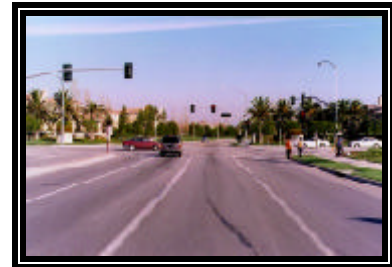
The 26-year-old female driver of the 1996 Nissan Quest was operating the vehicle northbound on approach to the four-leg intersection (**Figure 2**) when she became inattentive. The traffic signal for northbound traffic was in the green phase, however, northbound and southbound traffic was stopped at the intersection to yield the right of way to a westbound emergency vehicle. The driver of the Quest failed to detect the stopped 1990 Nissan Pathfinder in the northbound lane. According to the witness statement from the driver of the Pathfinder, there were also two uninvolved vehicles stopped in the intersection in front of the Pathfinder. When the driver of the Quest realized the impending harmful event, she applied the brakes in an attempt to avoid the collision. Due to the wet road surface, the investigating officer did not document any skid marks in the Quest's trajectory.

**Figure 2. Northbound approach for the Nissan Quest**

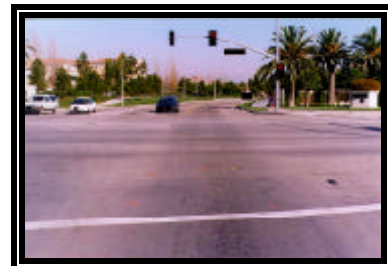
As the Nissan Quest entered the intersection, the front area impacted the rear area of the Nissan Pathfinder (**Figure 3**). The Quest underrode the bottom edge of the spare tire which caused the spare tire to engage the area above the bumper. The spare tire was centered on the rear of the Pathfinder on a bracket that was hinged on the right side, and protruded approximately 30 cm (12") rear of the bumper. Impact resulted in moderate damage to the Quest and minor damage to the Pathfinder. The resultant directions of force were in the 12 o'clock and 6 o'clock sectors for the Quest and the Pathfinder, respectively. The damage algorithm of the WinSMASH program was used to calculate the Delta-V of the Quest based on estimated crush profiles. Due to the spare tire on the rear of the Pathfinder, the Delta-V for the Quest was computed twice, using the Barrier and Missing Vehicle routines. The Barrier routine computed a total velocity change of 19.5 km/h (12.1 mph). The Missing Vehicle routine computed a total velocity change of 20.4 km/h (12.7 mph). These results appeared reasonable.

**Figure 3. Point of impact and marked final rest position**

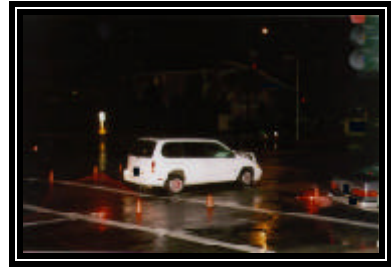
The Pathfinder was redirected forward and came to rest in the center of the intersection. The Quest traveled forward approximately 2 m (5') and came to final rest facing north in the southeast quadrant of the intersection (**Figure 4**).

**Figure 4. On-scene photograph looking northwest showing final rest position**

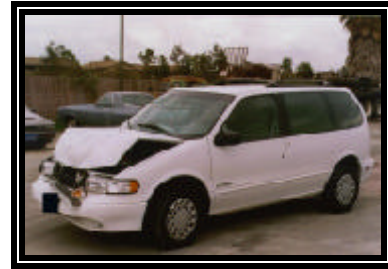
The 1996 Nissan Quest sustained moderate frontal damage as a result of the impact with the Nissan Pathfinder (**Figure 5**). The direct contact damage began approximately 41 cm (16") left of center on the bumper fascia and extended laterally to the right bumper corner. The combined direct and induced damage involved the entire frontal width of the vehicle. The bumper fascia was deformed and fractured approximately 41 cm (16") left of center from engagement with the left rear bumper corner of the Pathfinder. The bumper fascia and bottom right corner of the front license plate were fractured from contact with the Pathfinder's rear trailer hitch. The grille was fractured approximately 5 cm (2") to the left of center, and the top aspect of the grille was displaced forward onto the top aspect of the bumper fascia. The upper radiator support and radiator core were crushed rearward, and maximum crush was approximated at C4 and was estimated to be 15 cm (6"). The leading edge of the hood was crushed rearward and the hood was buckled at the designated fold points. Semi-circular damage from the Pathfinder's spare tire was noted on the hood which measured 64 cm (25") in diameter (**Figure 6**) based on measurements in police photographs. The center of the semi-circular damage was located approximately 15 cm (6") to the right of center. The Collision Deformation Classification (CDC) for this impact to the Quest was 12-FDEW-1. Six crush measurements were estimated at the level of the upper radiator support, and were as follows: C1 = 5 cm (2"), C2 = 8 cm (3"), C3 = 11 cm (4"), C4 = 15 cm (6"), C5 = 10 cm (4"), C6 = 5 cm (2").

**Figure 5. Damage to the Nissan Quest**

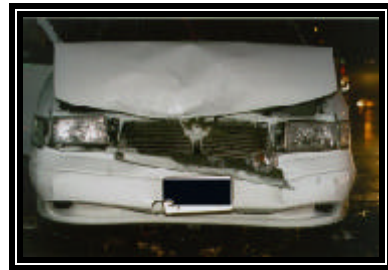
**Figure 6. Frontal damage showing damage from the Pathfinder's spare tire**

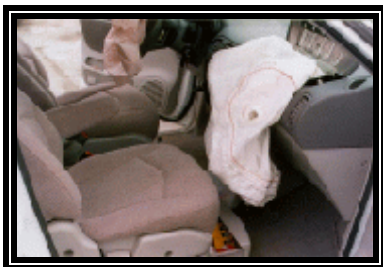
Interior damage to the 1996 Nissan Quest appeared to be moderate and was attributed to occupant contact. There appeared to be no intrusion of the passenger compartment (**Figure 7**). The windshield was cracked in a spider-web pattern directly over the center of the front right passenger's air bag cover flap from occupant contact (**Figure 8**). The windshield fracture also exhibited an outward deflection. The center of the windshield strike was located 35 cm (14") vertically from the windshield header and 35 cm (14") inboard of the right A-pillar, based on measurements in the police photographs. There was no hair noted in the fractured glass. The leading edge of the head liner had longitudinal abrasions and contained hair strands from the 4-year-old child. The leading edge of the front right sun visor had longitudinal abrasions and also contained hair strands from the child (**Figure 9**). The front right sun visor was displaced rearward out of its clasp.

**Figure 7. Interior view from right side**

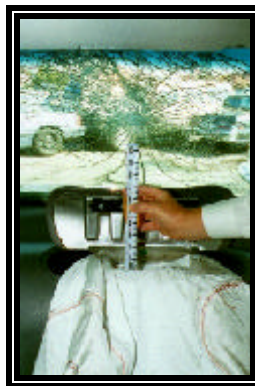
**Figure 8. Interior view showing windshield strike**

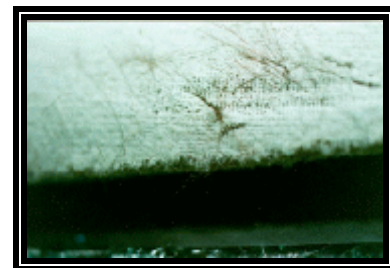
**Figure 9. Leading edge of right front sun visor showing abrasions and hair strands**

from the occupant contact and probable contact with the expanding air bag. Strands of the child's hair were visible on both the windshield header and forward aspect of the sun visor. The contact with the windshield header produced a diastatic fracture of the calvarium involving the frontal, sagittal and lambdoid sutures and extending into the base of the skull, subarachnoid hemorrhage, cerebral edema, a basilar skull fracture, contusions of the right basal ganglion posteriorly, focal areas of cortical contusions on the undersurface of the temporal areas, contusions of the centrum ovale bilaterally, and contusions of the temporal cortex. The air bag expansion against the 4-year-old's chest and abdomen resulted in a heart contusion, lung contusions, a liver contusion, and a liver laceration. The continued expansion of the air bag displaced the child rearward, possibly into the right B-pillar. Although there was no interior contact evidence visible in the police photographs to support this head strike, the extensive subaponeurotic hemorrhage in the right occipital area suggests an impact to the rear aspect of the child's head.

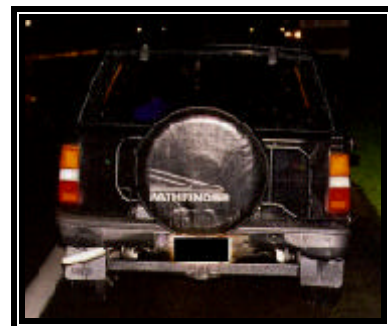
The 1990 Nissan Pathfinder sustained minor rear damage as a result of the impact with the Nissan Quest (**Figure 10**). The rear bumper was displaced slightly rearward and downward. The left side of the rear bumper was deformed and scuffed approximately 66 cm (26") left of center from contact with the front bumper fascia of the Quest. The spare tire cover had a semi-circular gouge mark that followed the contour of the spare tire rim. It measured 30 cm (12") from corner to corner based on police photographs, and was located approximately 14 cm (6") above the bottom edge of the spare tire.

**Figure 10. Damage to Nissan Pathfinder**

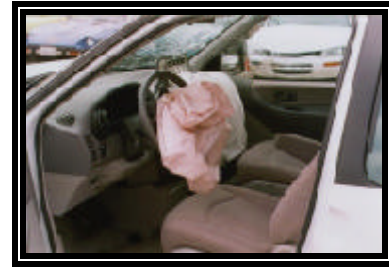
The 1996 Nissan Quest was equipped with air bags for the driver and front right passenger positions that deployed as a result of the impact with the Nissan Pathfinder (**Figure 11**). The driver's air bag was housed in the center of the steering wheel with asymmetrical H-configuration module cover flaps. A vent port was visible in the 11 o'clock position in the police photographs.

**Figure 11. Frontal air bag system in the Nissan Quest**

The front right passenger's air bag deployed from the right upper-instrument panel with a single cover flap design hinged at the top aspect. The cover flap was rectangular in shape with a slight contour along the leading edge. The front right passenger's air bag had two vent ports located at the 10 and 2 o'clock positions in the police photographs.
