On-scene Investigation / Vehicle to Vehicle
Dynamic Science, Inc. / Case Number: DS01007
2001 Mercury Sable
Kansas
January, 2001

1. Report No. DS01007		2. Government Accession No.		3. Recipient Catalog No.	
4. Title and Subtitle In-Depth Accident Investigation				5. Report Date	
				6. Performing Organization Report No.

Dynamic Science, Inc.
Accident Investigation
Case Number: DS01007

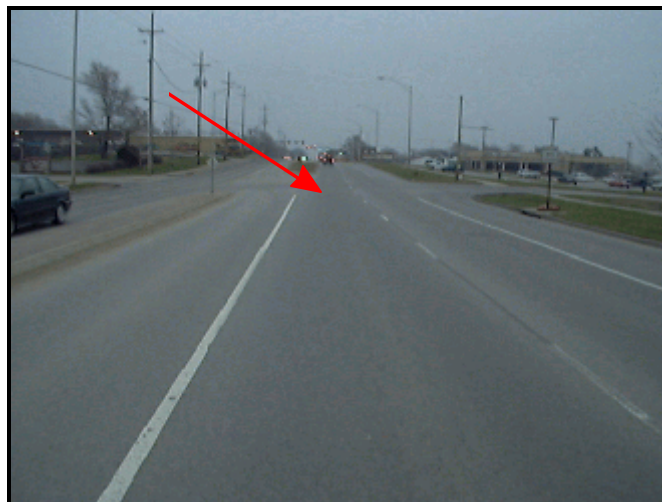
Figure 1. Direction of travel for case vehicle towards the impact area (east).

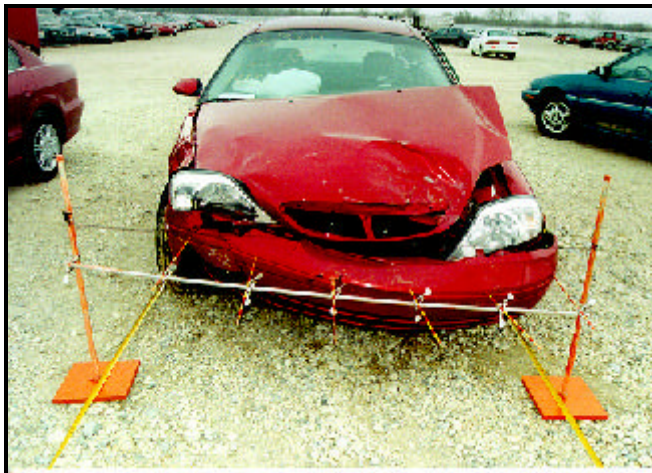
Figure 2. Front, case vehicle

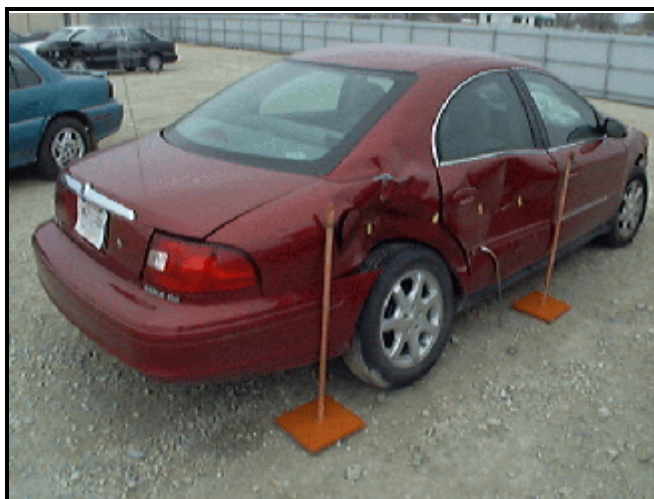
Figure 3. Second impact-side slap to case vehicle.

After impact, the case vehicle rotated slightly counterclockwise and the Plymouth rotated clockwise. There was a second impact with the right side (03RZEW2) of the case vehicle side-slapping the rear left (09LBEW2) of the Plymouth. The case vehicle sustained a latitudinal delta v of -11.5 km/h (-7.1 mph).

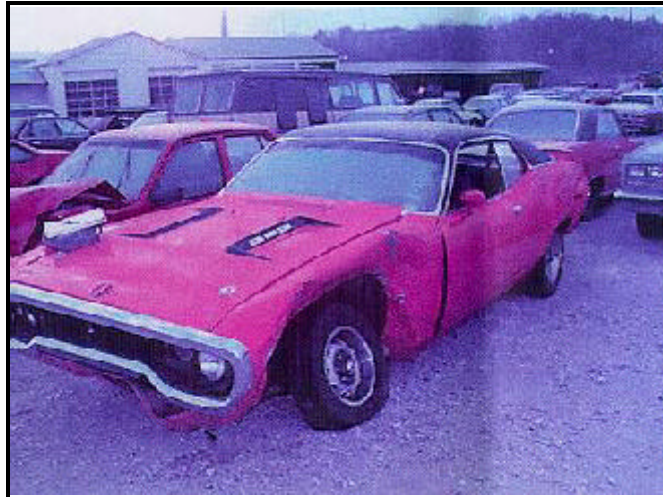
Figure 4. Exterior damage to Plymouth.

Description:	1971 Plymouth Road Runner	
VIN:	RM23N1Rxxxxxx	
Odometer:	139,210 km (86,504 miles)	
Engine:	383 CID V8	
Reported Defects:	None	
Cargo:	Unknown	
Damage Description:	Moderate lateral crush to left front fender and tire. Minor side slap damage to the left rear quarter panel.	
CDC:	Impact 1: 10LFEW3 Impact 2: 09LBEW2	
Delta V (Impact 1):	Total	16.3 km/h (10.1 mph)
	Longitudinal	-6.9 km/h (-4.3 mph)
	Latitudinal	14.8 km/h (9.2 mph)
	Energy	34,977 joules (25,824 ft-lbs)

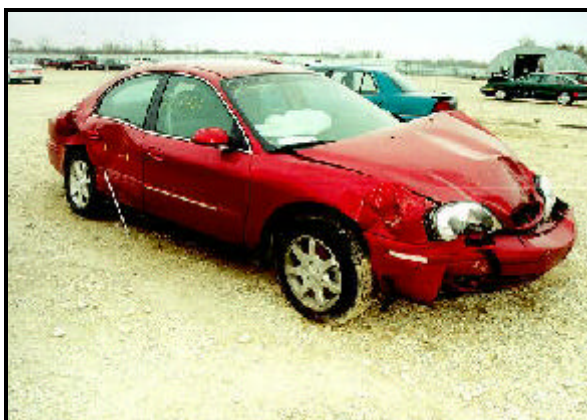
Description:	2001 Mercury Sable four door sedan (rental)	
VIN:	1MEFM50U91Gxxxxxx	
Odometer:	2,242 km (1,393 miles)	
Engine:	3.0 L (182 CID), 6 cylinder	
Reported Defects:	None	
Cargo:	None	
Damage Description:	Moderate frontal damage to bumper, grille, and hood. Moderate side slap damage to right side above right tire and extending across right rear door.	
CDC:	Impact 1: 01FDEW1 Impact 2: 03RZEW2	
Delta V (Impact 1):	Total	18.2 km/h (11.3 mph)
	Longitudinal	-15.8 km/h (-9.8 mph)
	Latitudinal	-9.1 km/h (-5.7 mph)
	Energy	22,769 joules (16,791 ft-lbs)

Figure 6. Front right, case vehicle

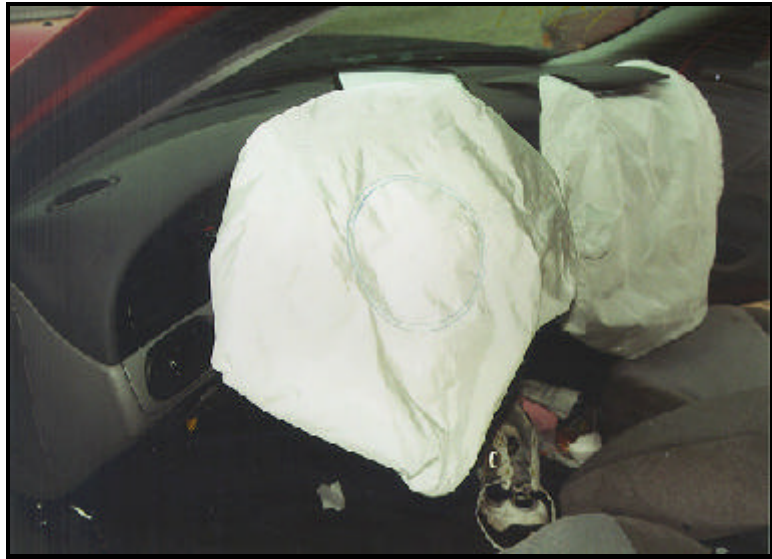
Figure 7. Front air bags

The case vehicle was equipped with a driver's and front right passenger's air bags. The driver's steering wheel mounted air bag was circular and measured 45 cm (17.7 in.) in diameter. It was equipped with two tethers and two vent holes. There was no evidence of driver contact although she possibly did contact the air bag. The dual module covers opened in a typical "H" configuration. There

were no indications of any damage to the covers. The front right passenger's top mounted air bag was rectangular and measured 61 cm (24.0 in.) by 48 cm (18.9 in.). It was equipped with two vent ports and did not have any tethers. On the face of the air bag there was cover-related scuffing. The single flap module cover did not sustain any damage.

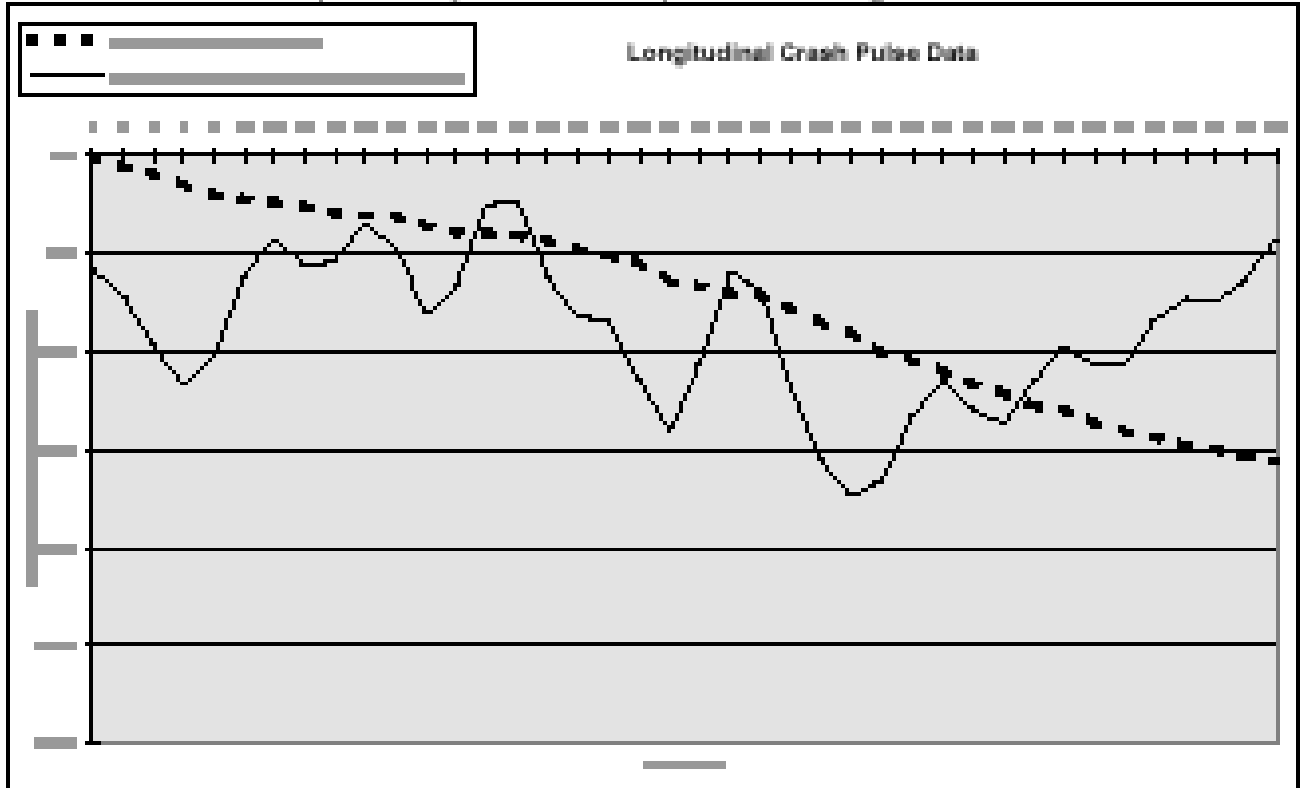
Longitudinal Cumulative Delta-V

At impact the case vehicle sustained a total Δv of 18.2 km/h (11.3 mph), a longitudinal Δv of -15.8 km/h (-9.8 mph) and a latitudinal Δv of -9.1 km/h (-5.7 mph) as computed by WinSmash. The downloaded Electronic Data Recorder (EDR) data indicates a cumulative longitudinal Δv of -24.9 (-15.5 mph) and a cumulative lateral Δv of -14 km/h (-8.7 mph) at the 78 ms mark.

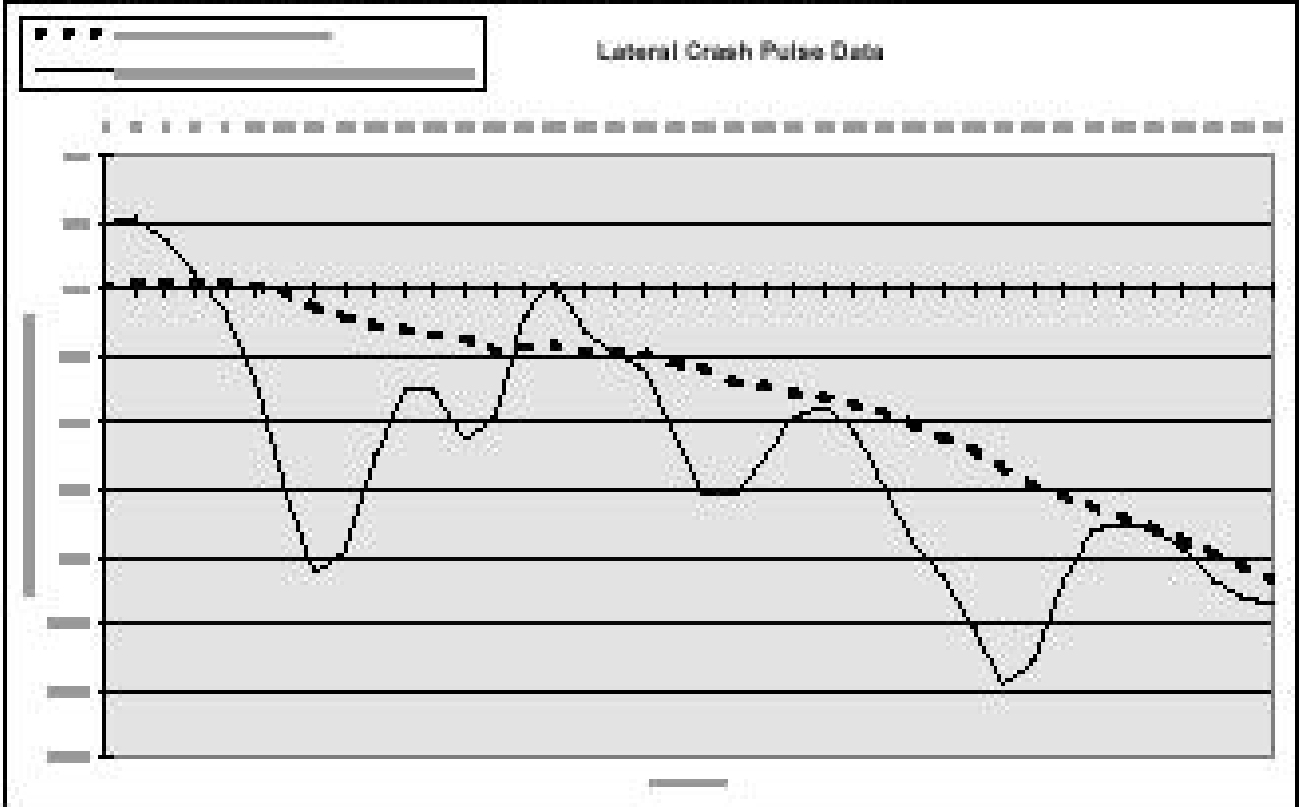
Lateral Cumulative Delta-V

Time (ms)	0	10	20	30	40	50	60	70	78
Delta-V (MPH)	0	0	0	0	0	0	0	0	0
